#### Isles of Scilly Water Interests Survey

### Report on Flood Defences

11/8185 Issue 1 | August 2011

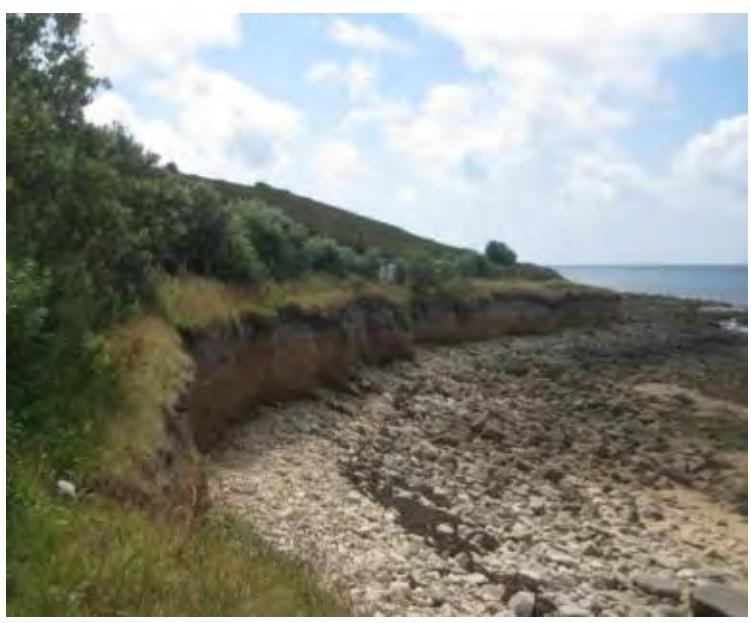
The islands have low cliffs of unconsolidated head material, known locally as "ram", overlying the granite and which are prone to erosion. They are positioned immediately behind many of the beaches and foreshores and are almost all actively eroding and retreating landward. Examples were noted at the eastern end of Porthcressa, where the coastal footpath has had to be closed, at Porthloo beneath the residential properties on the north side of the bay and at Old Town Beach, south of the church on the west side of the bay.

Figure 2: Ram Cliff east side of Porth Cressa, below allotments where coastal footpath has been diverted inland (July 2011)

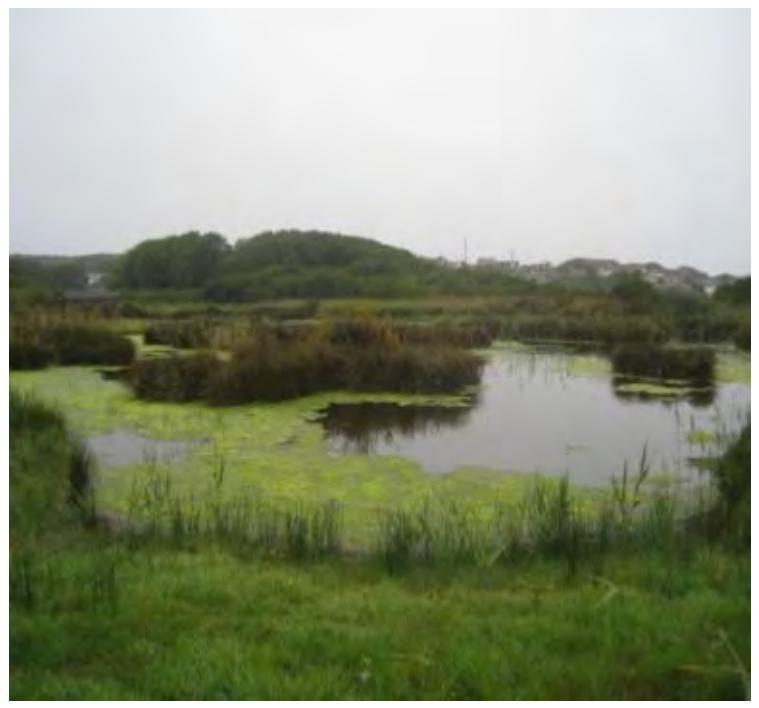
Surplus water from the Lower Moor drains into Old Town Bay via a small leat. At high tide seawater makes its way into the leat, even though there is a flap valve near the downstream end of the system. This was witnessed during the site visit. This means that the Lower Moor water body is saline.

Figure 7: Lower Moor sitting below property on the east side of Hugh Town

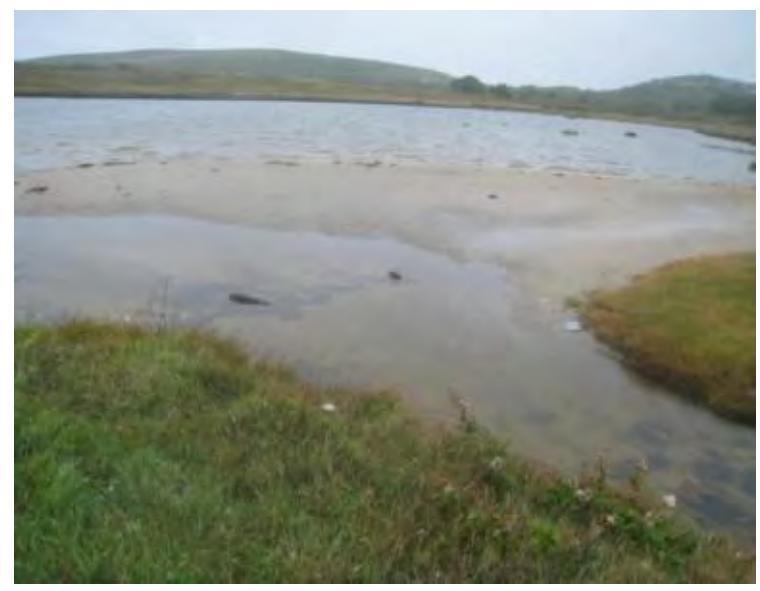
There is a small pool of water, known as Great Pool, located on the west coast of Bryher, close to the hotel and out-falling to Great Porth. Saline intrusion was noted during the inspection due to the sand deposits at the mouth of the pool. There are three water abstraction boreholes on Bryher supplying fresh water to the island. These are all located just to the north east of Great Pool.

Figure 14: Great Pool on the west side of Bryher

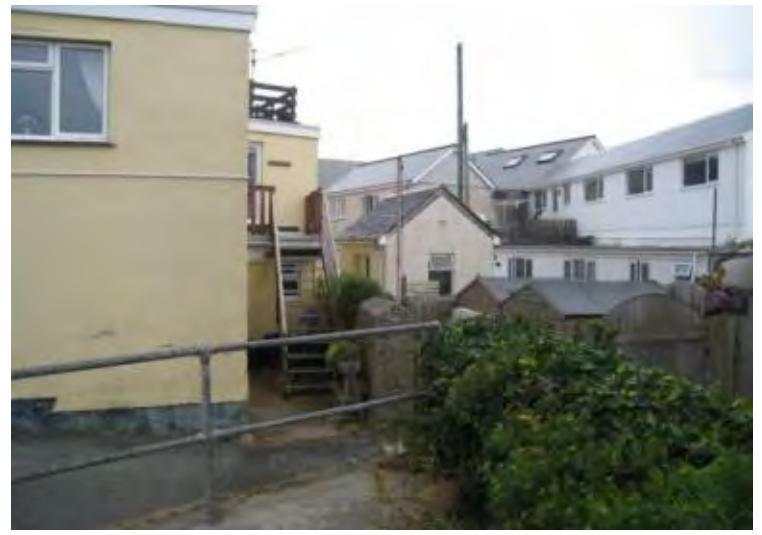
The Hugh Town foul sewerage system is a gravity system and extends as far as the Hospital to the south east and the trading estate to the north east. The system drains to a pumping station in Portheressa View. The building is now surrounded by residential development and the rising main which takes the effluent out to Morning Point, on the south east corner of the Garrison, has been built over. This makes any future up-grade at this location very difficult.

Figure 16: Sewage Pumping Station, in the heart of Hugh Town

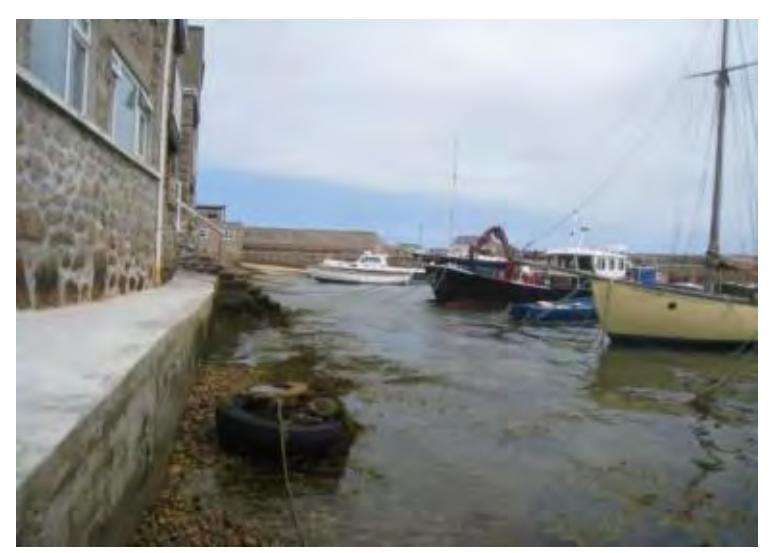
The foul sewer runs along the top of Town Beach and here the manholes have been raised and bolted down to try and avoid the system being swamped by high tides.

Figure 18: Foul sewer running along the top of Town Beach

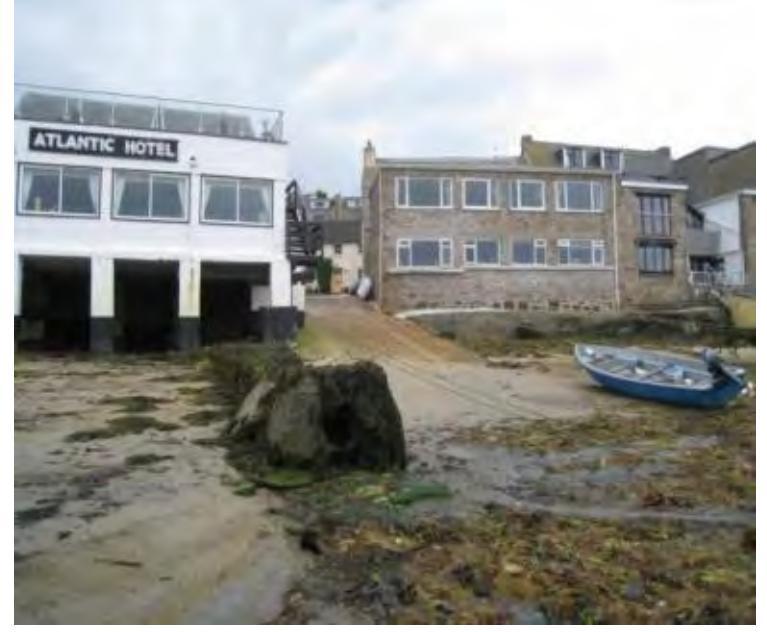
Figure 19: Surface water outfall onto Town Beach behind the Atlantic Hotel, Hugh Street

Inundation of the surface water system by seawater occurs regularly given that the run crosses the top of Town Beach. Manholes in this location were reported to be filled with sand. This is along the downstream end of the surface water run so is unlikely to create an immediate flood risk.

Flooding of Hugh Street via the surface water system is not that uncommon either during particularly high tides, with seawater coming up through the road gullies near the Atlantic Hotel. However, no property flooding has been reported as a result. It was noted that the flap valve on the Town Beach surface water outfall was detached from the end of the pipe and the pipe was cracked a short distance back from the end.

A further issue occurs in this location. It is possible for foul effluent to back up and flow into the surface water system at the slipway by the Atlantic Hotel, as part of an informal Combined Sewer Overflow arrangement, and discharge onto Town Beach via the existing but fractured surface water outfall.

High tides sometimes inundate Hugh Street, via the slipway and surface water drainage system at the Atlantic Hotel, formerly the Custom House. Both these inundation routes have since been fitted with stop logs to help prevent serious inundation but the surface water drainage system remains a flood route, until the flap valve and discharge pipe are repaired.

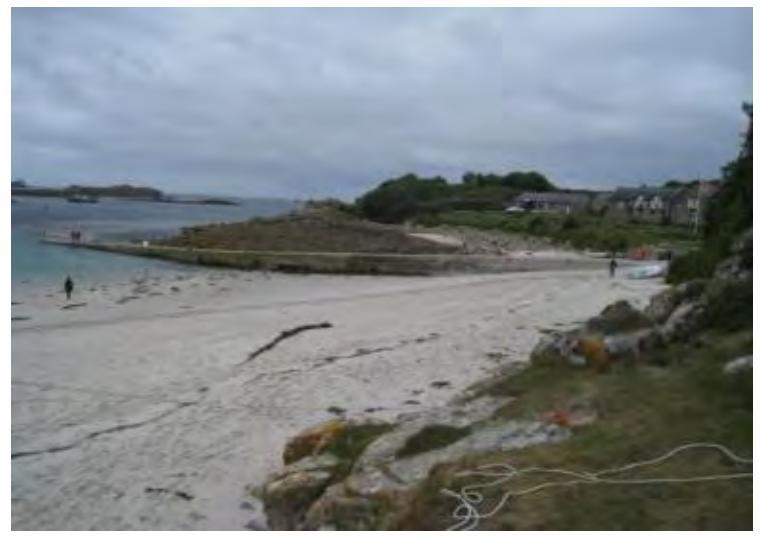
There are no formal defence structures on St Martin"s although there would appear to have been some recent revetment works undertaken in front of the hotel but behind the quay wall at Lower Town.

Figure 23: Revetment works in front of the hotel at Lower Town, St Martin's

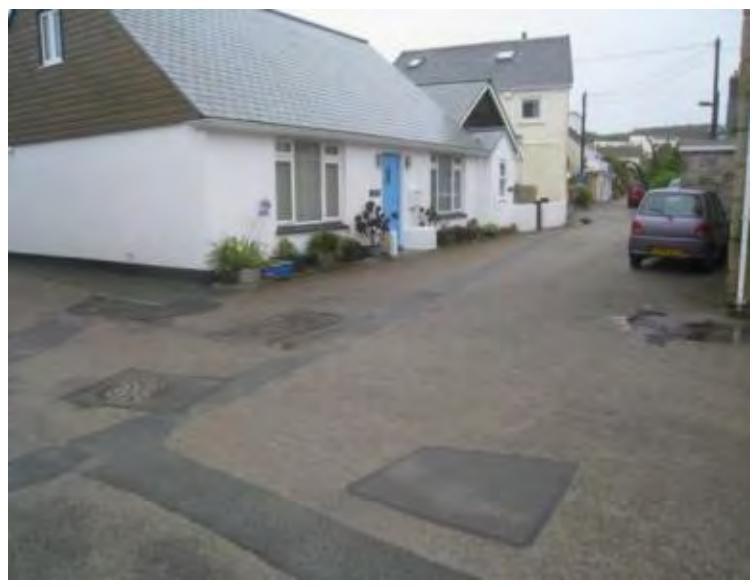
There is no historical evidence of surface water flooding on the islands. If high intensity rainfall events occurred, there used to be a build up of surface water at Rams Valley, behind Porthcressa, where there is a local depression. However, this has reportedly been resolved with the addition of a second, dual surface water pipe to double the discharge capacity. The outfall goes to Porthcressa Beach.

Figure 24: Rams Valley, Porthcressa. Generally the door thresholds are at street level in this locality

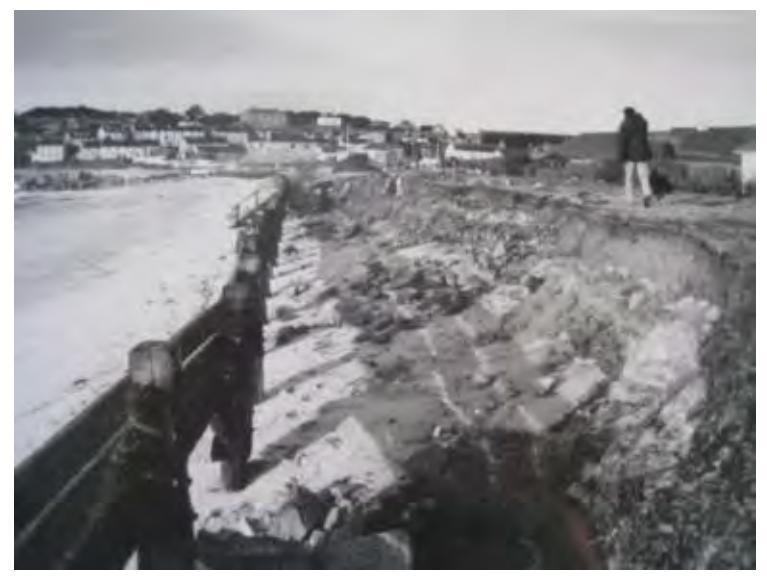
The flood event that took place between 16 and 17 December 1989 would appear to be the most notable. During this event the sea defences at Porthcressa, on the south side of Hugh Town, were damaged and significant erosion took place. At the same time the defences at Old Town and Porthloo were over-topped. It is believed that this event was followed shortly afterwards by two further events of the same magnitude in the early 1990s.

Figure 26: Erosion behind the greenheart timber of the Porthcressa Sea Defences following the December 1989 storm event

The Isles of Scilly Council effected temporary repair using gabion baskets to resist further storms, of significance those in 1990/91

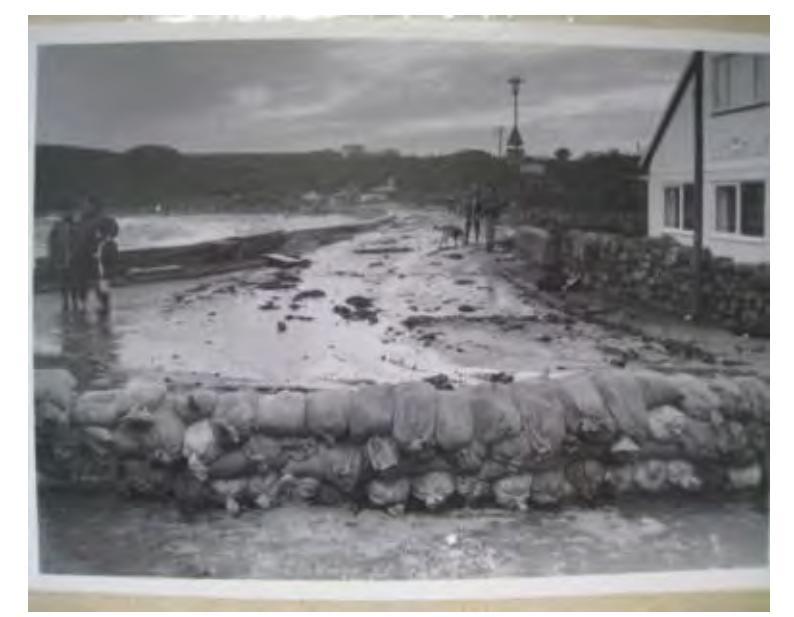
Figure 27: Over-topping of the sea defences at Old Town, St Marys (December 1989). Sand bags were used to help prevent sea water running back to the nearby cottages. Now 1 tonne sandbags are deployed.

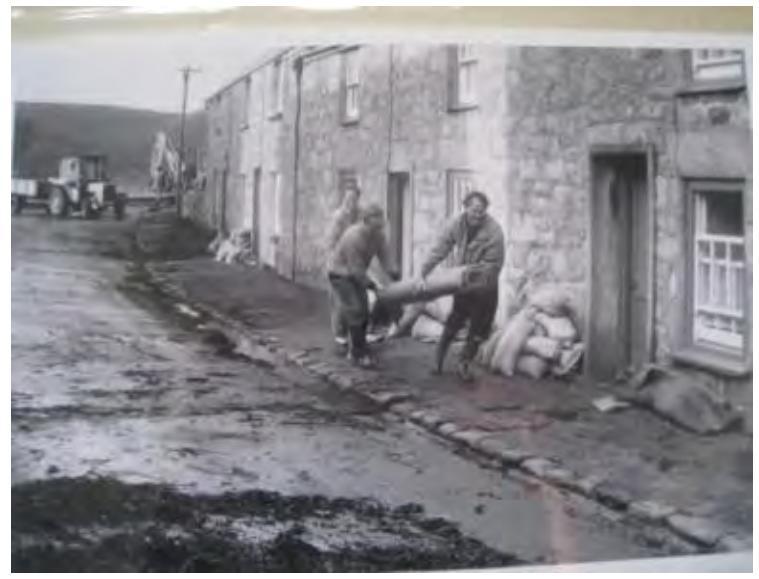
Figure 28: Old Town cottages susceptible to over-topping of the defences. It is understood that 1 or 2 properties were flooded in December 1989. The cottages in this vicinity have now been fitted with flood boards

There would appear to be very few incidents of property flooding. The cottages on the east side of Old Town Bay, shown in Figure 27, are susceptible but are now fitted with flood boards and the 1 tonne sandbags deployed add a further line of defence in the event of a bad weather/high tide warning. These sand bags also help to protect the more recent properties in Trench Lane which sit on lower ground.

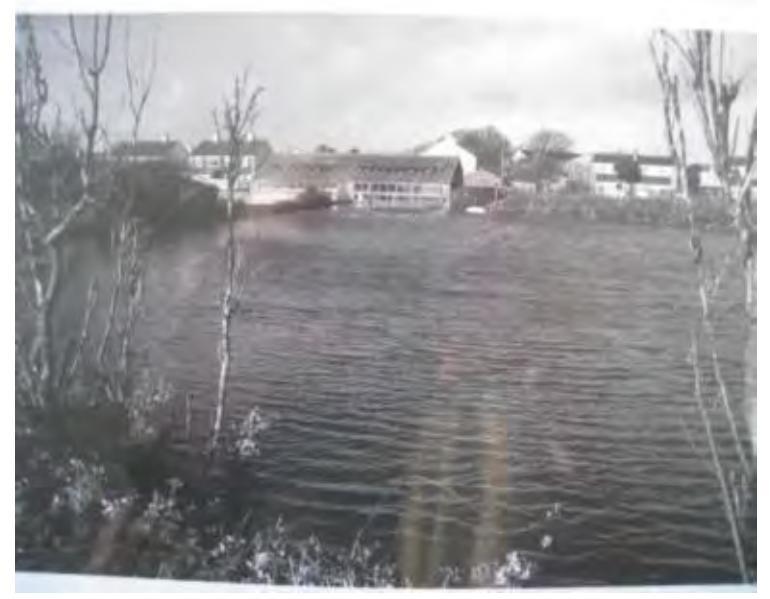
Figure 29: Inundation of the land behind Porth Minick (December 1989)

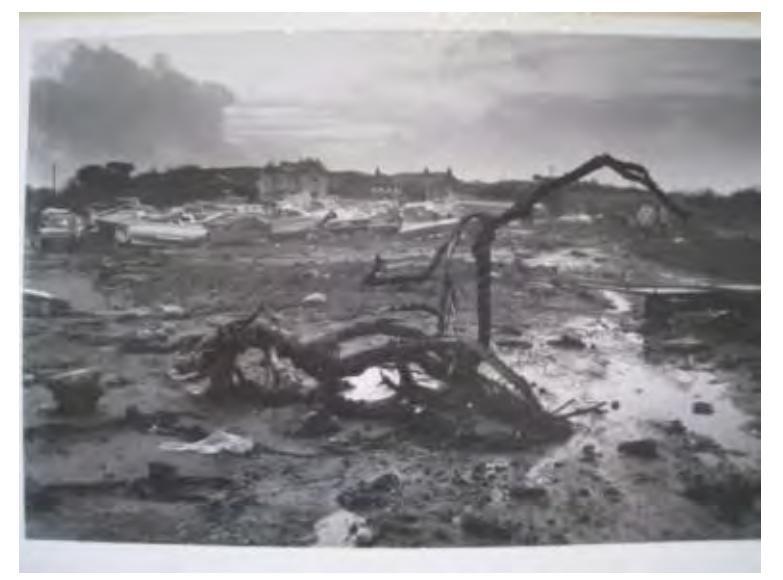
Figure 30: Porthloo following the December 1989 flood event. A terrace of 6 properties was threatened and there was significant erosion of the ram cliff.

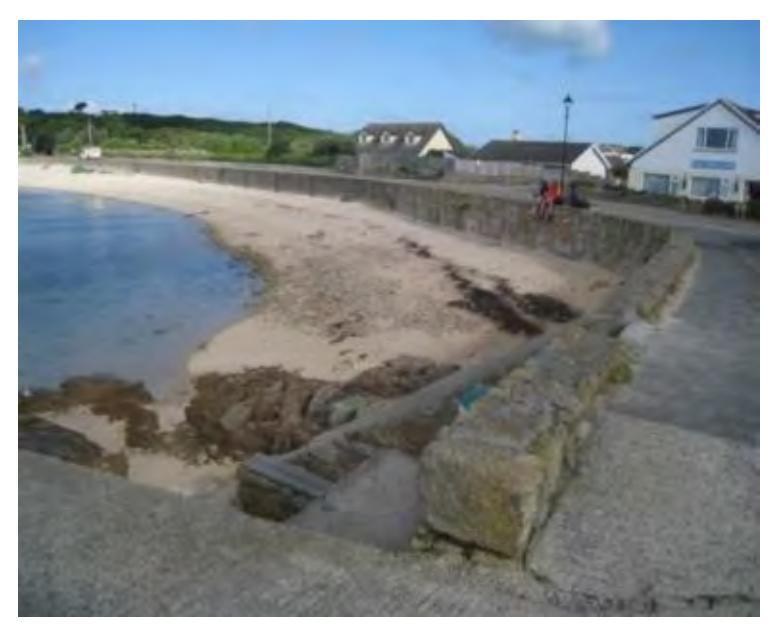
Figure 31: Properties in Trench Lane, Old Town, on lower lying ground behind the sea wall.

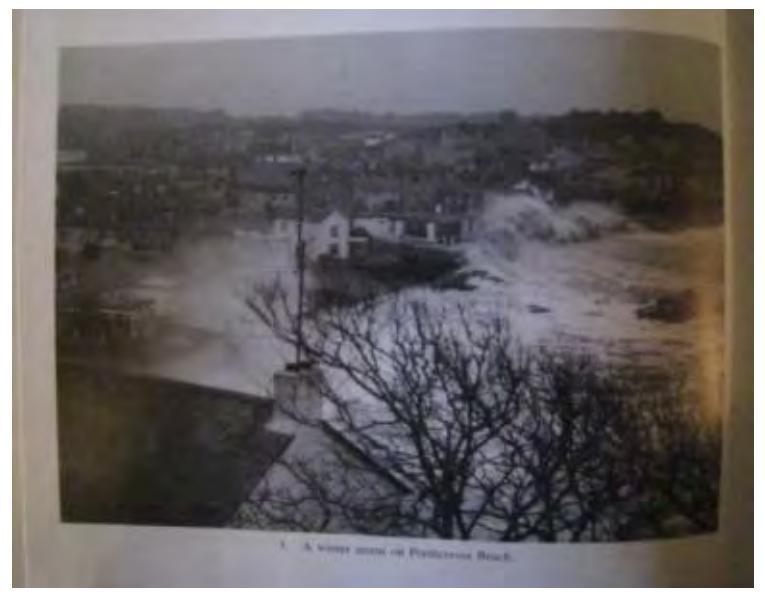
The photographs below show the vulnerability of lower lying properties in Porthcressa during bad weather conditions.

Figure 32: Storm event at Porthcressa with the properties shown below under threat

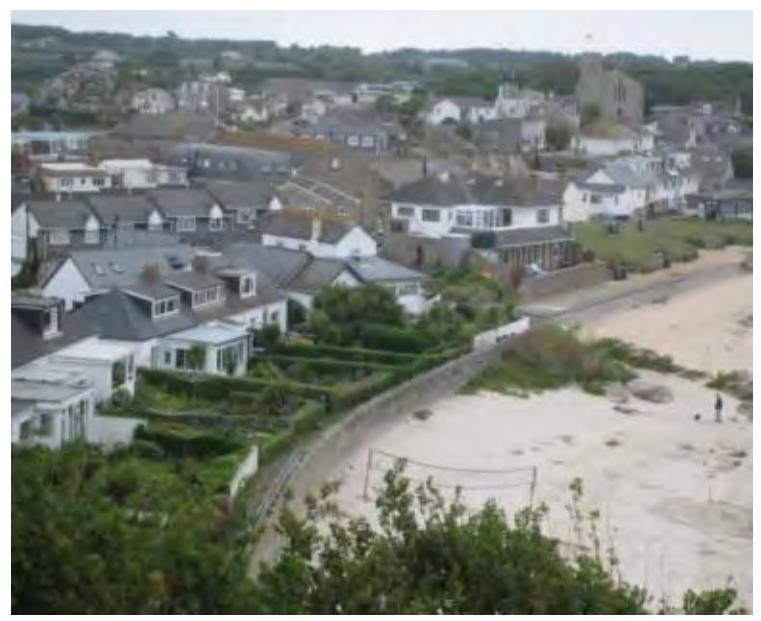
Figure 33: Low lying properties behind the sea defences at Porthcressa

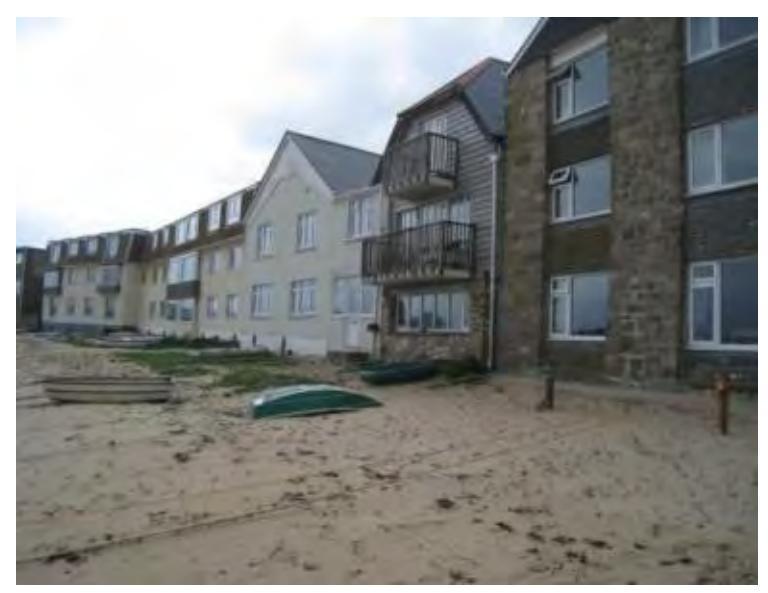
On the north side of Hugh Town, Town Beach is less susceptible to storms battering the coast line. However, given the proximity of the properties to the beach there is a risk of still water flooding if a high tide coincides with a storm surge.

Figure 34: Properties adjoining Town Beach, Hugh Town. The vegetation is indicative that a number of properties are currently outside the tidal zone. However, this may change with rising sea levels.

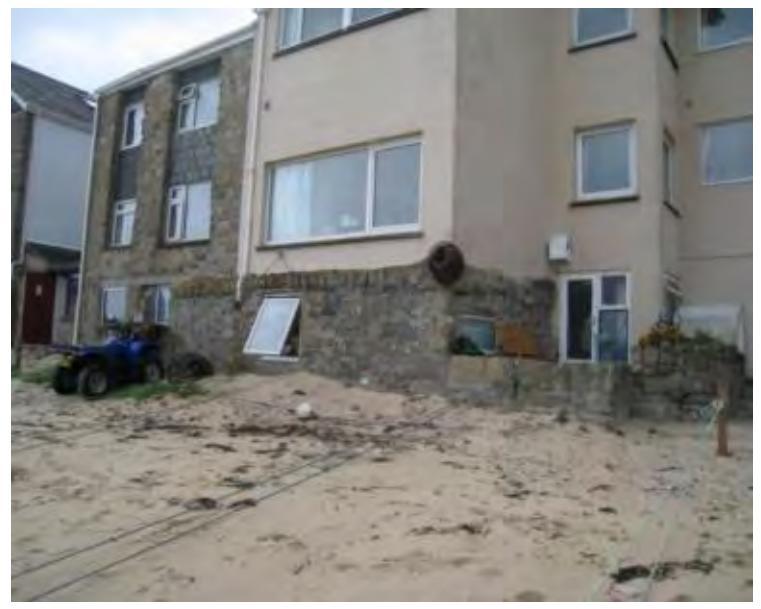
Amazingly there is only one record of property flooding on Town Beach due to the low threshold level of a window installed for a basement.

Figure 35: Town Beach, St Marys. Low window threshold has increased risk of property flooding

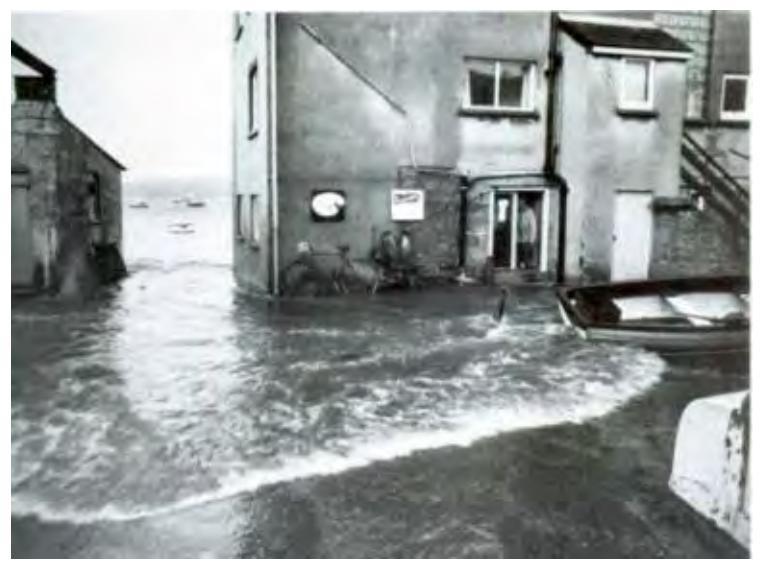
High tides sometimes leave ponding on the Thoroughfare which runs behind these properties backing onto Town Beach and parallel with Hugh Street. However, no properties are believed to have been affected.

Figure 36: High tides inundating the Thoroughfare behind Town Beach

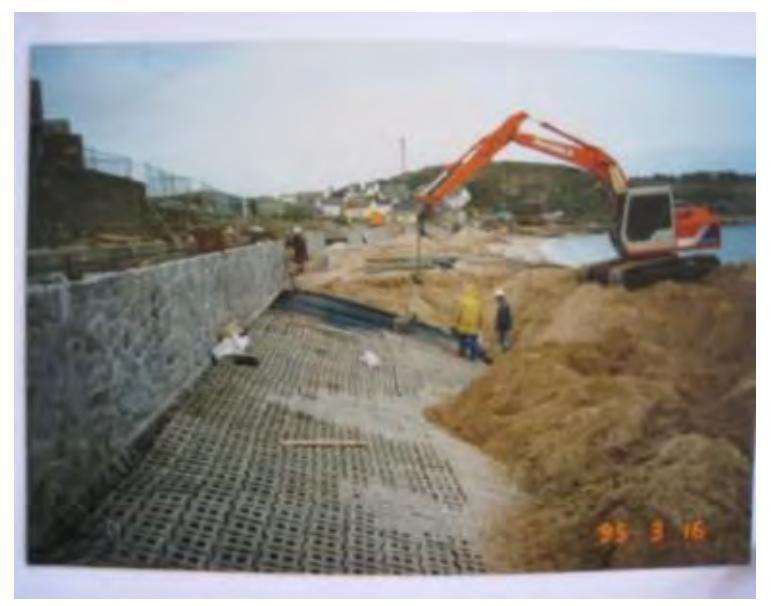
A new defence was constructed in 1995 some 2m in front of the original defences and are as described in Section 16.1. The new defence comprises a stone faced reinforced concrete wall, 225m long and piled at 6m centres. The seawall is 1.6m high with its crest at 6.0m AOD. Toe protection is provided by an Armorflex cable tied concrete block revetment.

Figure 38: Construction of the defence at Portheressa, showing the concrete revetment toe protection

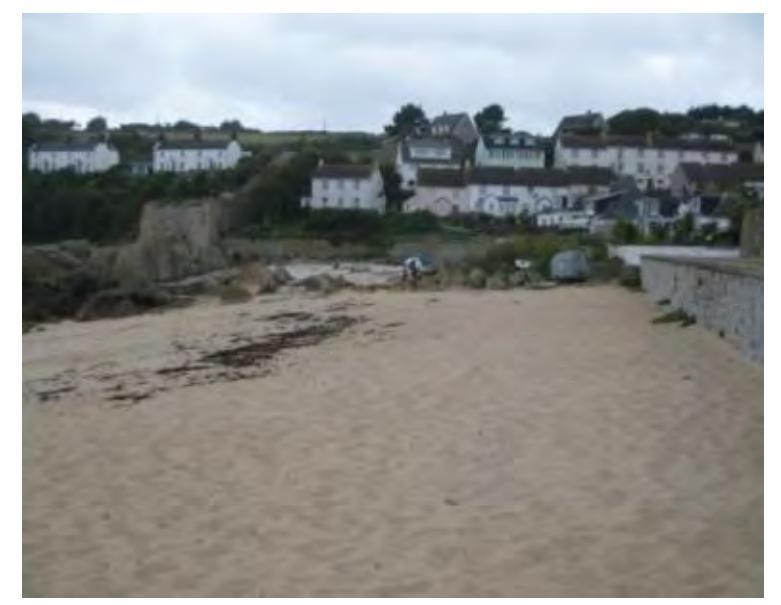
Figure 39: Little Porth, defence ties into Garrison wall

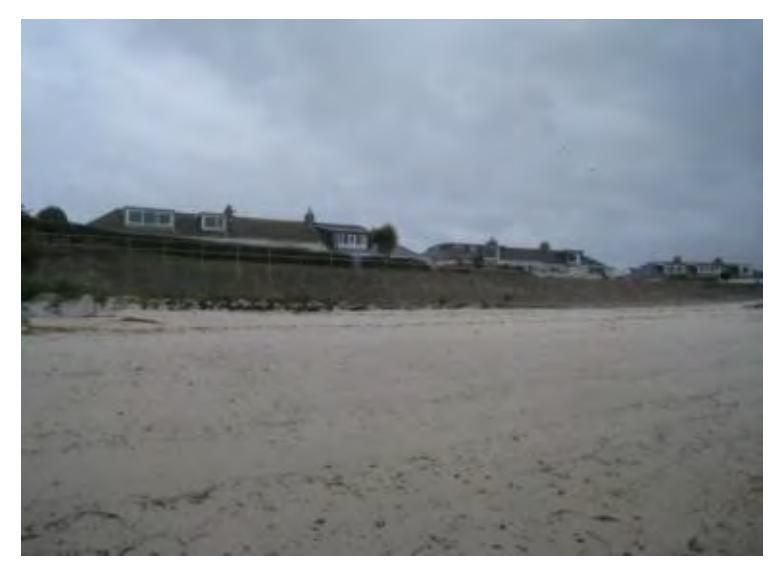
At the eastern end, at Little Carn, the wall starts off as a regular stone wall with mortared joints, the blocks being 410 mm long by 220 mm high and the wall 410mm in depth. The wall is approximately 1.5m to 2.0m high at the eastern end, increasing in height moving towards the Garrsion wall. The measured height will depend on the volume of sand deposited in front of it.

Figure 40: Sea wall at Little Porth

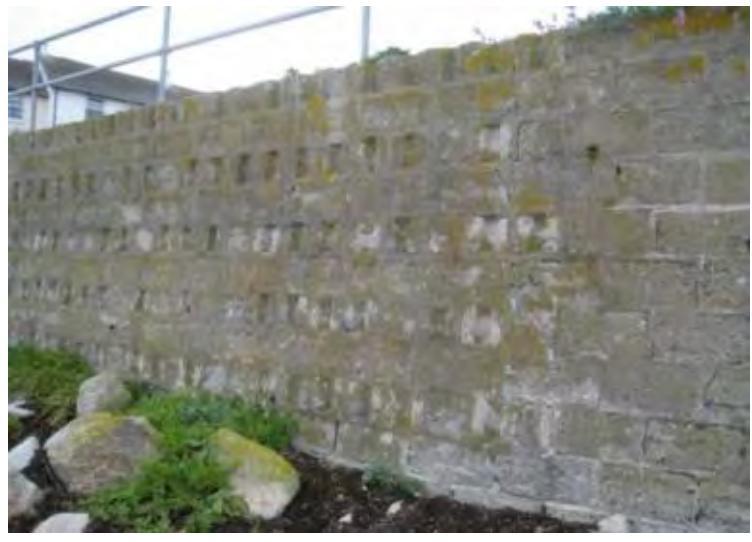
Towards the Garrison wall end the construction changes to what are possibly concrete filled pre-cast concrete blocks.

Figure 45: Change of construction to pre-cast concrete blocks

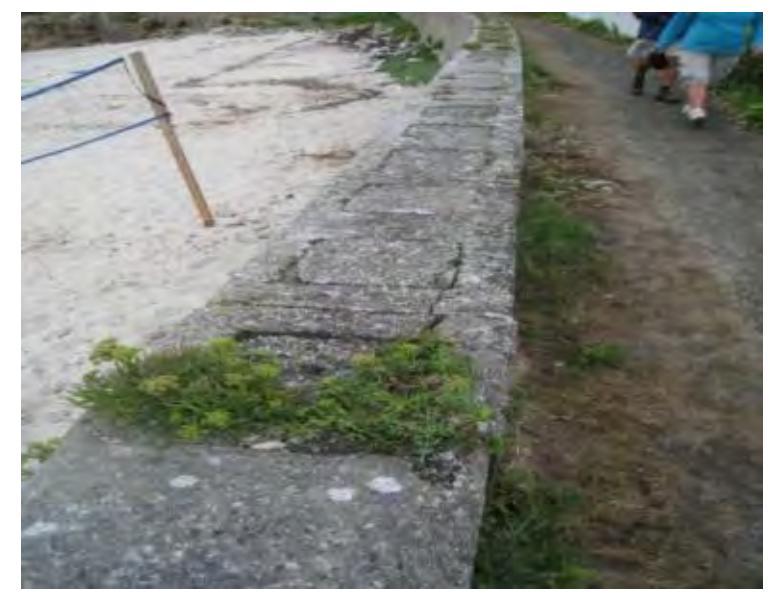
Figure 46: Change of construction from stone to concrete blocks

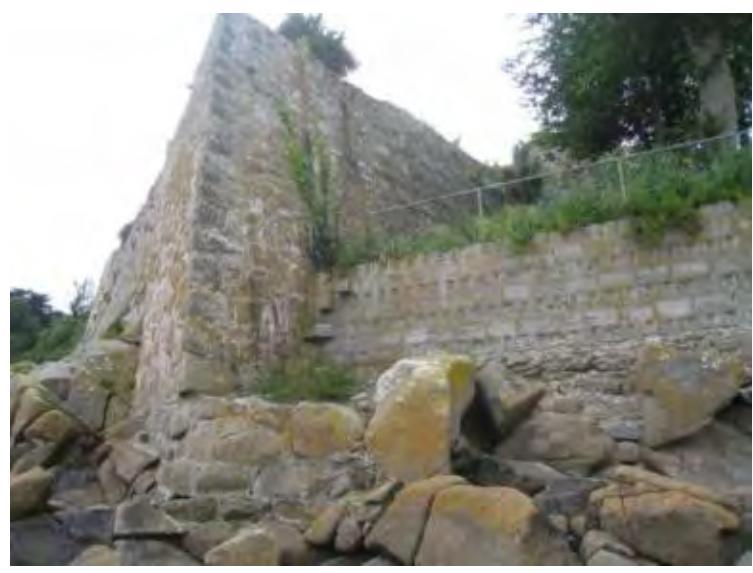
The toe of this section of the wall is visible as mass concrete, poured directly onto the rocky outcrop on which the wall is founded. The toe is further protected by natural rock revetment.

There is some loss of mortar and spalling at the face. Again vegetation is developing where there are small voids. There is evidence of re-pointing of the mortar joints. Very close to where the wall ties into the Garrison wall, the concrete block wall has been built around a rock intrusion and a void has formed beneath it.

Judging by the vegetation at the toe of this section of wall, it would appear that it is outside of the mean high tide level. However, there is potential for this void to open up during storm conditions which could impact on the integrity of the rest of the wall.

Figure 47: Wall ties into Garrison wall and is protected at toe by natural stone revetment. The mass concrete foundation is also visible.

Consequence of failure	High:
	Residential and commercial centre of Hugh Town;
	Foul sewage PS;
	Electricity power transmission cable;
	Quay cut off from rest of St Mary"s
Condition Grade	Little Porth – 3;
(see Table 2)	Portheressa - 1
Short term Intervention	Little Porth:
	Address void at western end;
	Continue to re-point as required.
Cost	Low
SMP2	Narrow inter-tidal zone subject to coastal squeeze effects and long term sustainability of current shoreline position is unlikely.
	Recession mapping indicates up to 20m of erosion.
	Short term:
	Hold the Line;
	Monitor coastal squeeze impacts;
	Long term:
	Managed realignment.
	At this location this may mean widening at some points to protect Porthcressa and Buzza Roads and to avoid the overall narrowing of the isthmus
	Occurrence of a significantly large storm exceeding the design standards of the Porthcressa defences represents the greatest magnitude of immediate risk to Hugh Town.

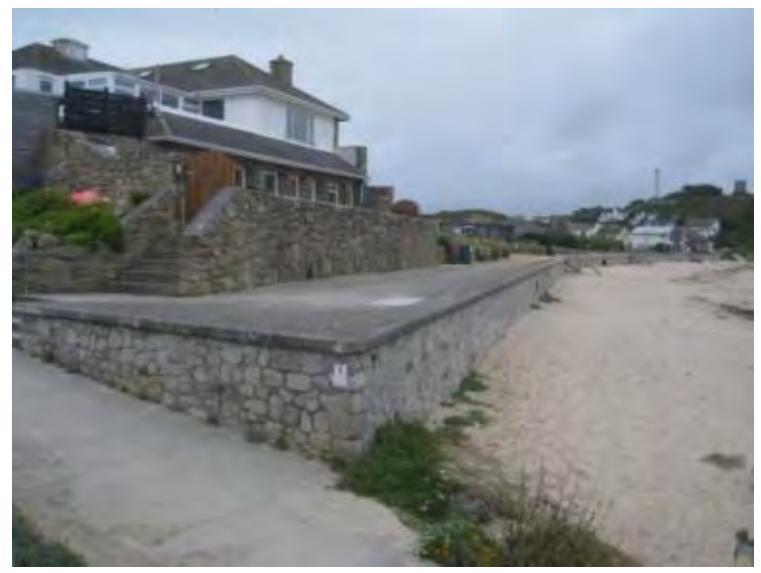
The visible element of this wall is the random block stone wall with mortared joints, topped with 600mm x 150mm deep concrete copings. The wall is jointed at regular intervals, filled with mastic.

Figure 49: The seawall constructed in 1995, some 2m in front of the original defences

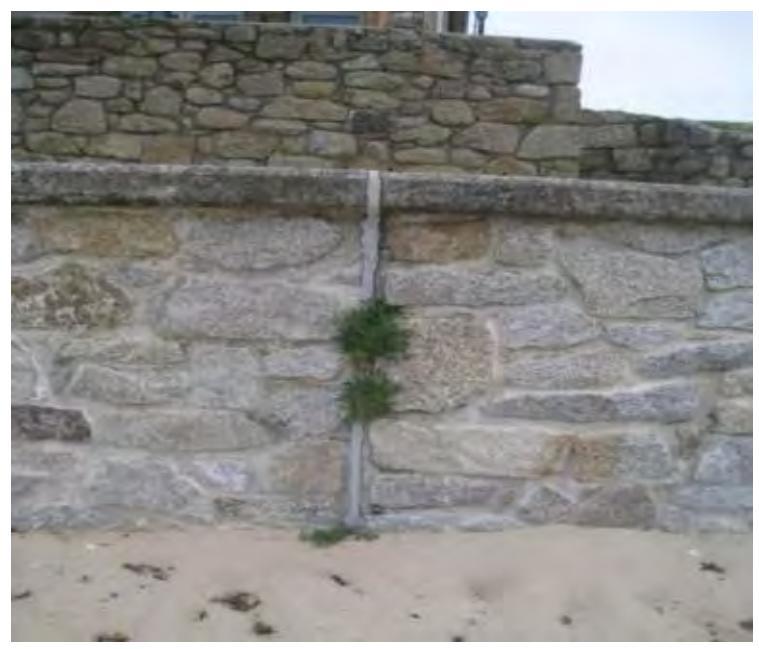
Figure 50: Joints, at approximately 20m spacing, sealed with a mastic filler

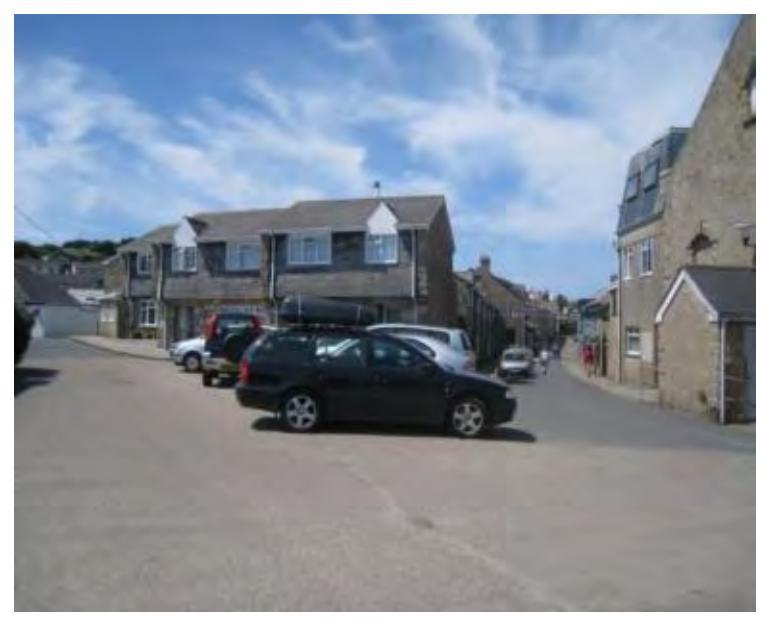
Figure 57: Any over-topping of the wall at Porthcressa will run directly into the centre of Hugh Town

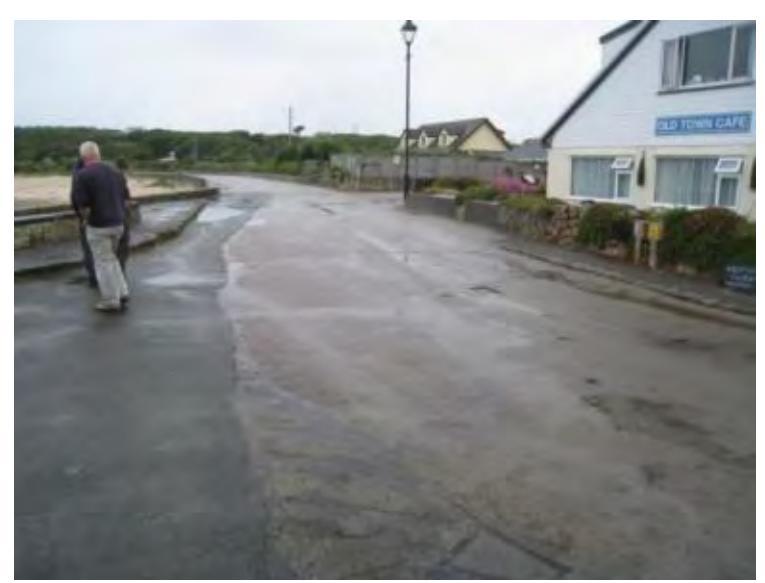
The defences help to protect Old Town and the Lower Moor area. However, wave over-topping is not uncommon and, in the event of a severe storm, 1 tonne sand bags are placed across the road to prevent run-off into the adjacent Trench Lane estate, the Cafe and adjacent cottages.

The leat from Lower Moor outfalls at this location. The outfall pipe discharges some distance down the beach and is protected by stone revetment. Although there is a non-return valve on the pipe network, set back from the outfall in a manhole beneath the road to Trench Lane, seawater is known to flow up into the leat with each high tide. Potentially seawater may also be seeping beneath the wall in to the road foundations, although this needs to be proven.

Figure 59: Location of sand bag defence deployed in preparation of a severe storm. Leat from Lower Moor is culverted and runs beneath Trench Lane and under the road to the Bay. A non-return valve is located on the system in a manhole at the junction with Trench Lane

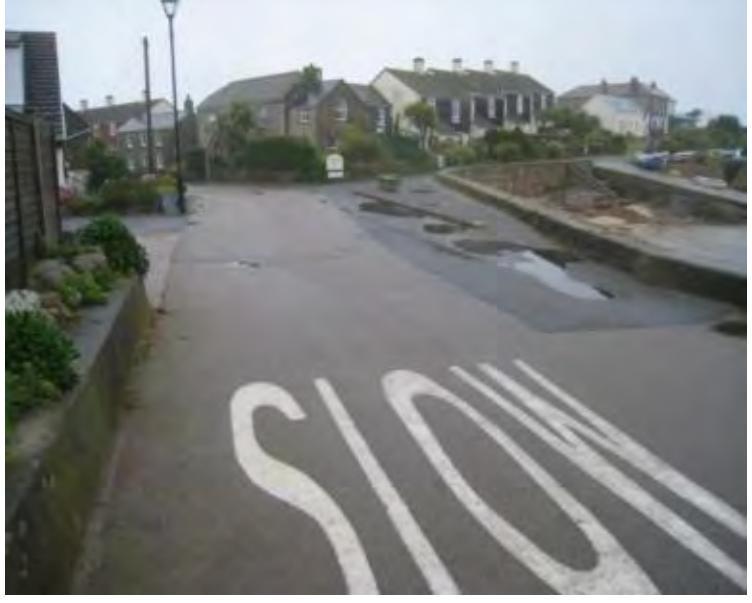
Work was undertaken in 2000 after the existing masonry wall began to settle at the eastern end, closest to Old Town. This caused the wall to start cracking and fines were washed out from behind impacting on the road above.

During the course of the works in 2000, peat was discovered beneath the foundations of the wall. This is likely to have contributed to its settlement.

Figure 61: Ponding behind the wall at location of works in 2000

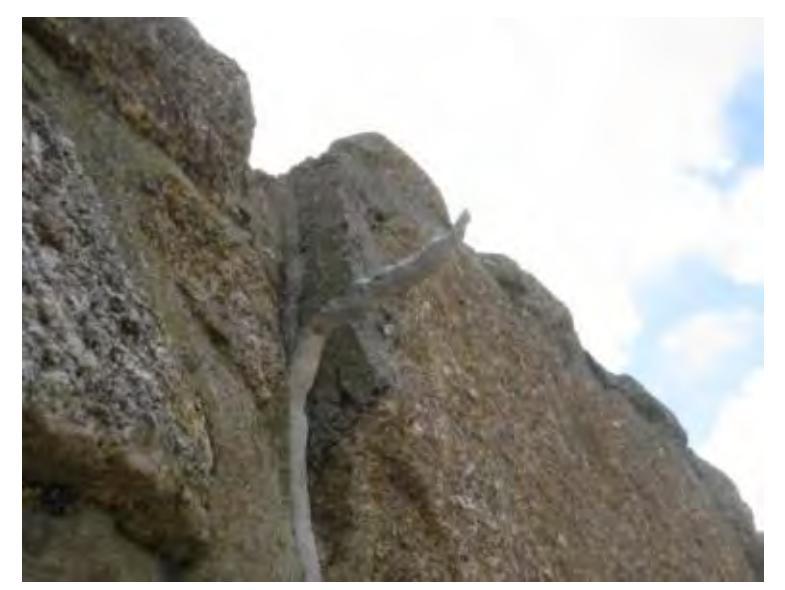
Mastic filler was noted to be missing from the joints and vegetation was becoming established. A number of the stones facing the concrete were displaying fracture lines.

Figure 70: Mastic filler coming away from joints

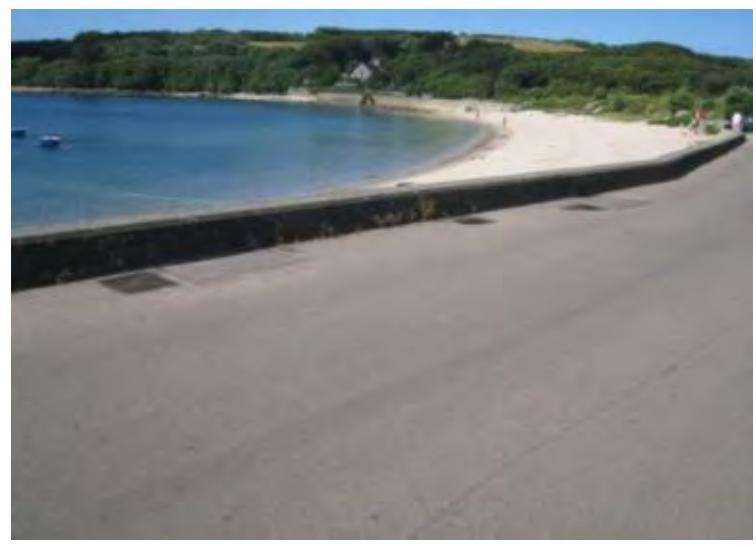
Figure 74: Wall retaining the road which runs between Hugh Town and Old Town. Note repairs to road surface adjacent to the drain outlets

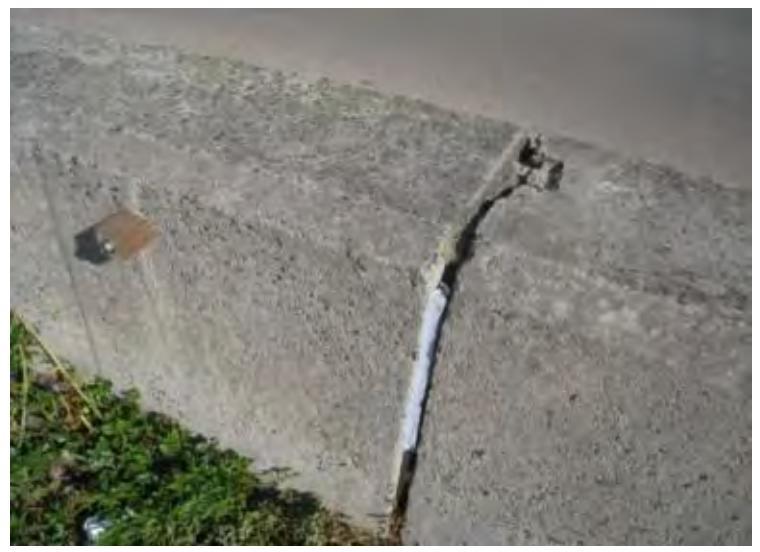
The wall is jointed at regular intervals (approximately 25m) but the mastic filler from most joints is missing. There is minor spalling at some of these joints, and to a lesser extent at the toe of the wall.

Figure 76: Minor spalling at joint

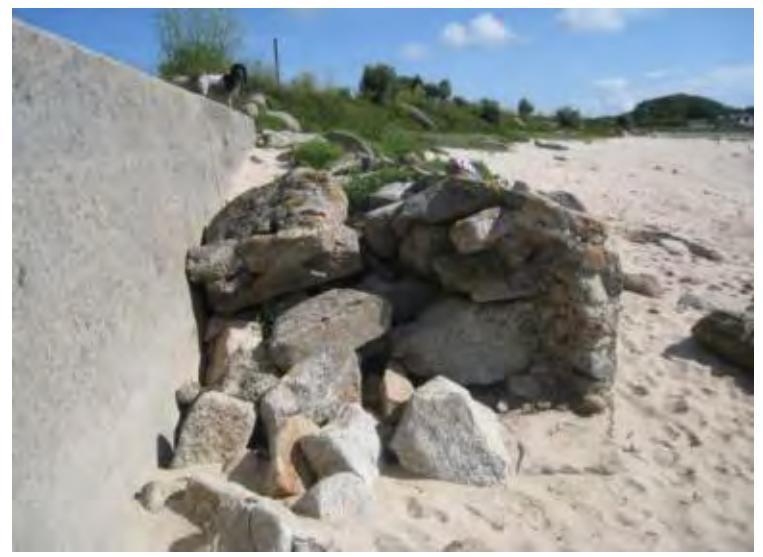
The wall is jointed at regular intervals, the mastic filler is beginning to deteriorate, allowing vegetation to establish.

Figure 80: Previous flood wall, now dilapidated, acts as toe protection. There is a benchmark at this eastern end of the wall.

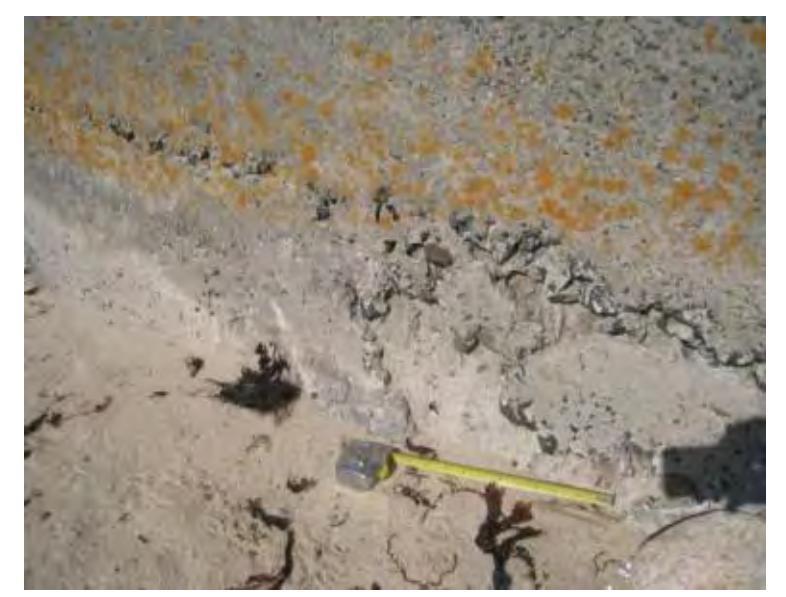
The original concrete pour lines are visible in the face of the wall. There is a concrete toe which is protected by rock armour. The aggregate is exposed at locations along the toe. This may be due to poor vibration of the concrete during the original pour.

Figure 82: Exposed aggregate at toe

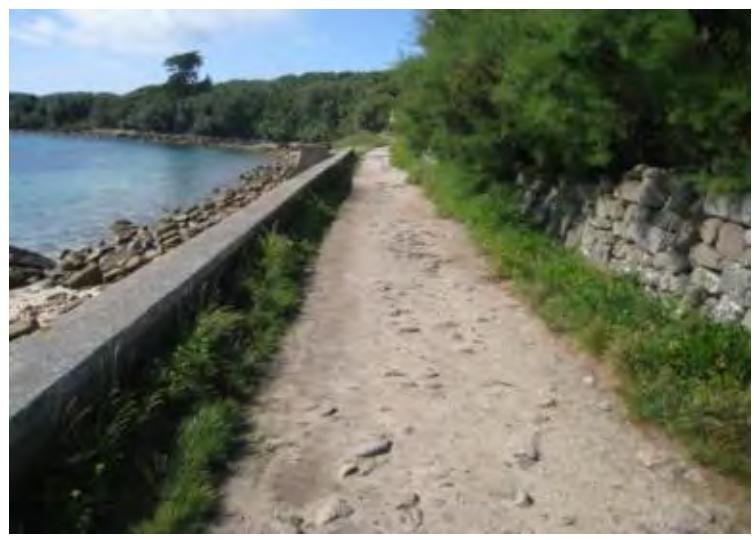
Figure 84: Only one location of spalling was noted, at the western end

There are drainage holes in the wall, to drain the coastal path retained by the wall. However, the holes lie above the path level, so there is likely to be ponding.

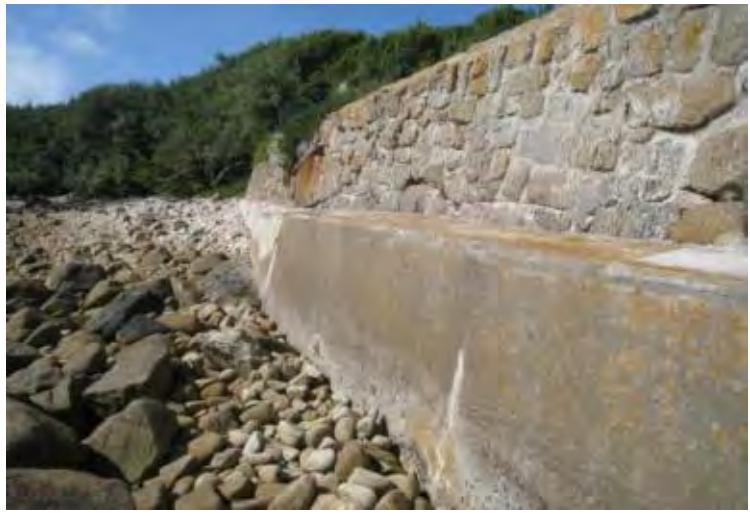
Figure 85: The coastal path runs to the rear of the wall leading to the Church and Peninnis Head

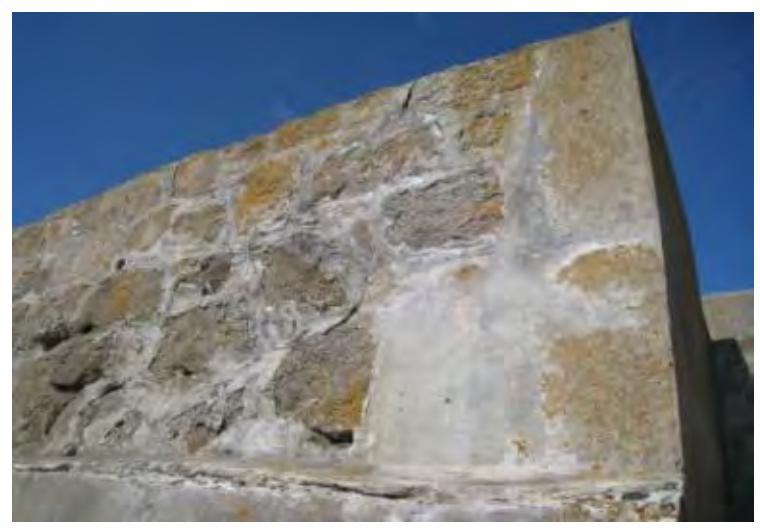
It is likely that the concrete toe for this stone wall was poured when the adjacent concrete wall was built. The height of the concrete toe reduces moving westwards around the bay. The stone work has mortared joints at the end closest to the bay but becomes dry jointed at its far end.

Figure 86: Stone wall with concrete toe

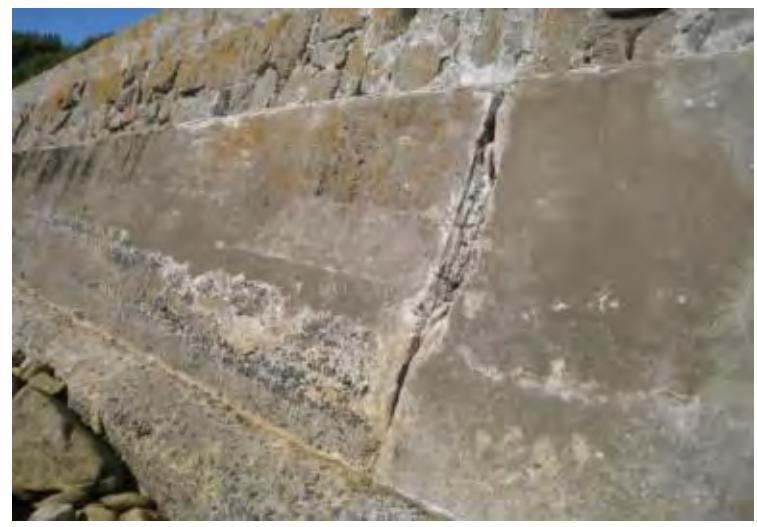
Figure 87: Signs of re-pointing and repair to stone work

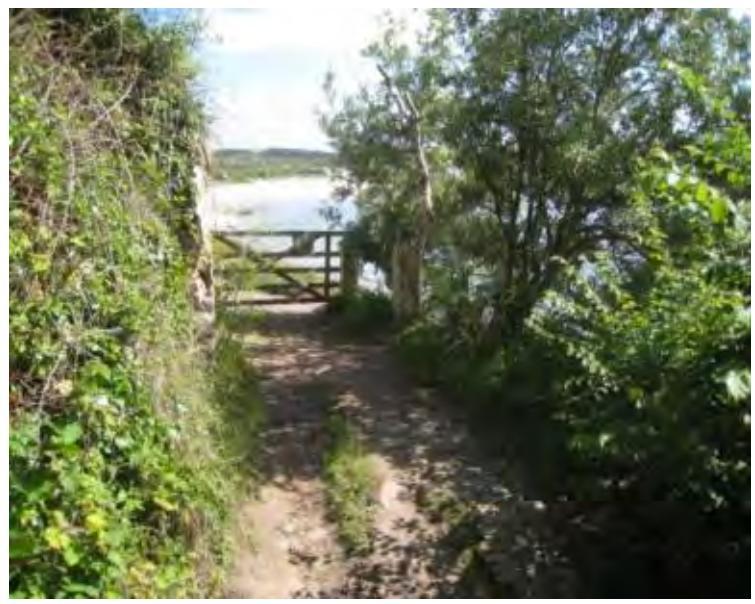
Figure 90: Coastal path, running very close to the top of the dry stone wall

Although not subject to daily high tides, erosion is threatening this end of the wall and the coastal path above.

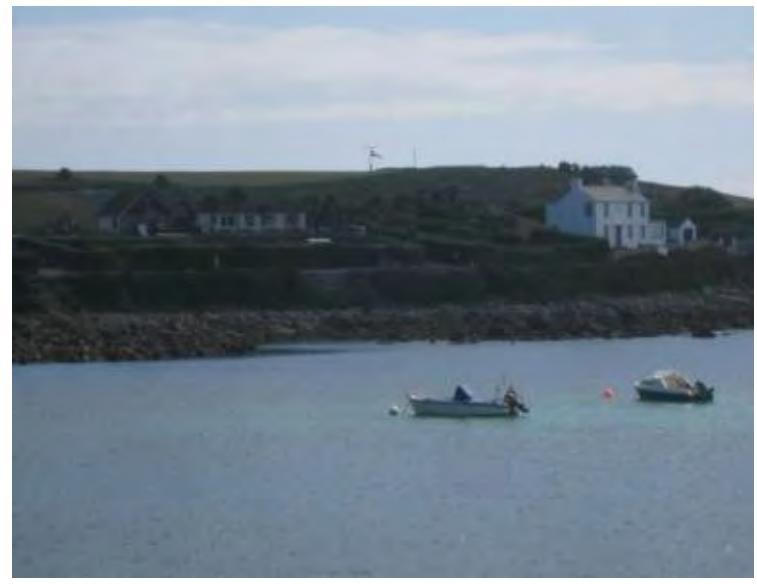
On the east side of Old Town Bay, a repair was noted in the cliff edge supporting the road to Tolman Head. This repair, concrete bagwork, has been undertaken by the Duchy of Cornwall Estate who is responsible for the maintenance of this road.

Figure 93: Coastline around the eastern end of Old Town Bay, with concrete bag repair in the centre of the picture
