#### Isles of Scilly Water Interests Survey

### Report on Flood Defences

11/8185 Issue 1 | August 2011

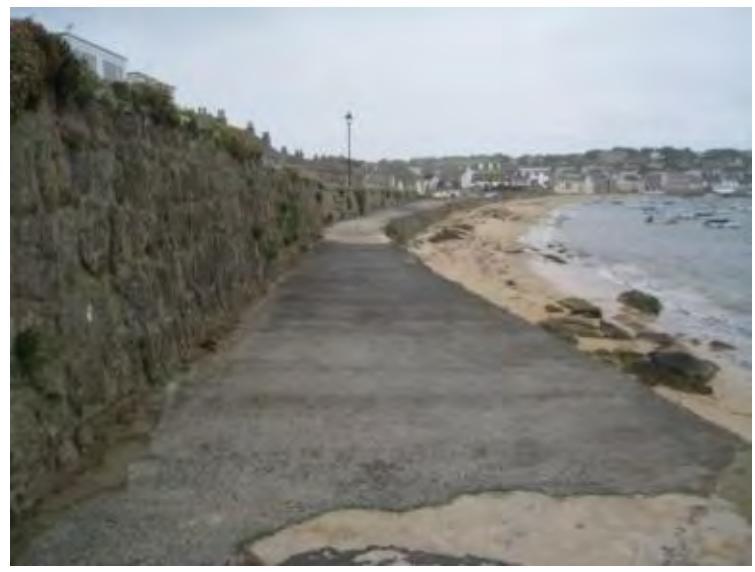
It was noted that the wall has no proper toe to it, so undermining is likely to be a long term problem.

Figure 94: Seawall at Town Beach, St Mary's

Repair works are due to take place this autumn over a 224m length of the wall. The proposed work includes re-pointing and filling of voids that have been formed by the waves pulling out the fines to the rear of the wall. The works are being funded by Defra and a spend of between £60k to £80k is forecast.

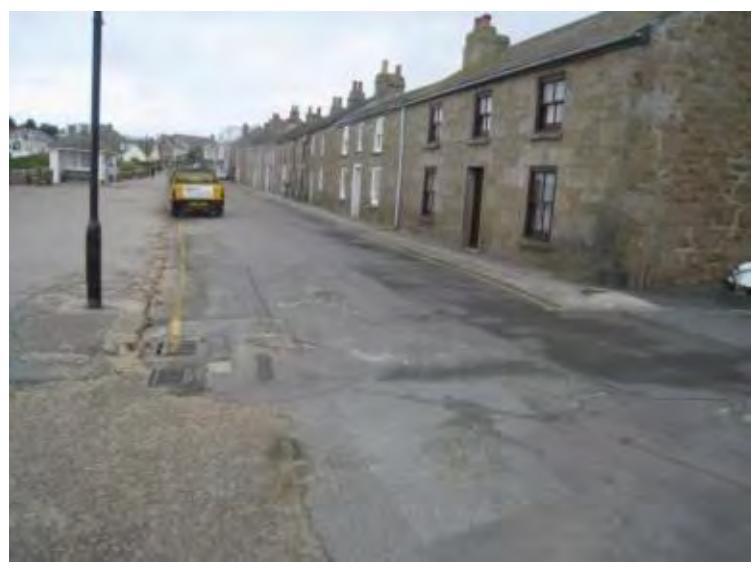
Figure 95: Properties over-looking Town Beach. Door thresholds are set at street level so once over-topping occurs the risk of property flooding is high.

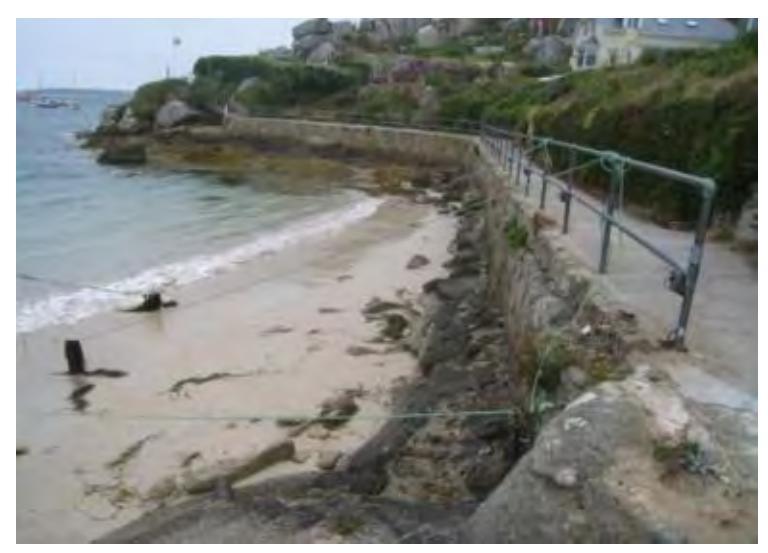
The wall comprises random stone blocks with mortar joints. Between the access steps, at the eastern end of the wall, out to the Lifeboat Station, toe protection has been provided but this is now severely damaged and fractured. Voids have formed at the toe and up to 1.6m above toe level. Some voids are nearly a metre deep.

Figure 96: Stone sea wall running out to Lifeboat Station

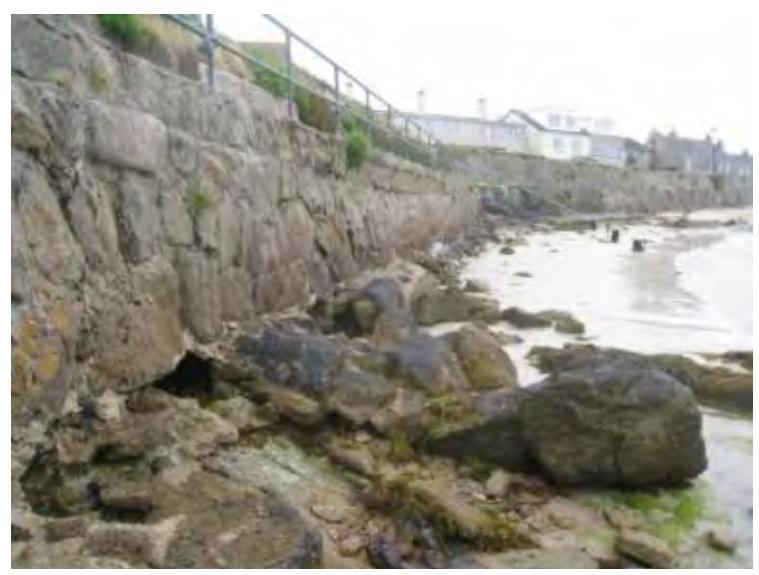
Figure 99: Undermining of toe

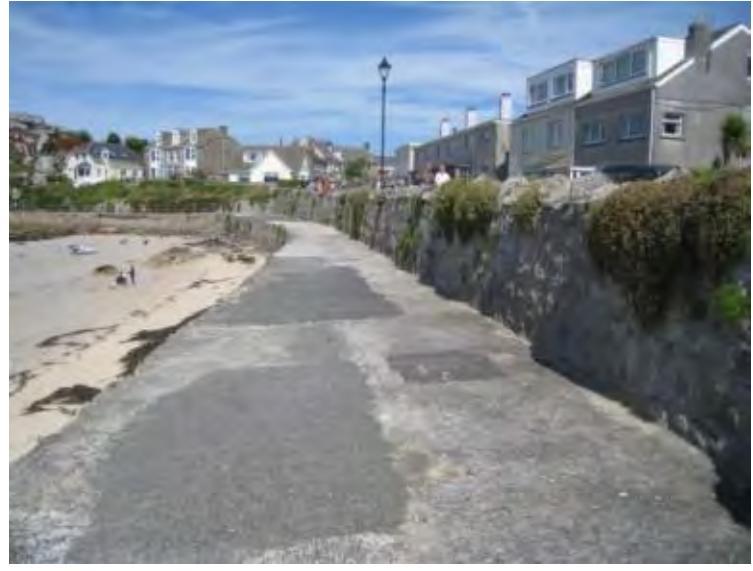
Voids continue to be a problem moving in a westerly direction towards the Rechabite Slip. There is a splash wall above this section of the seawall, which reduces in height from approximately 2.5m to 1.5m towards the Rechabite Slip.

Figure 100: Secondary splash wall

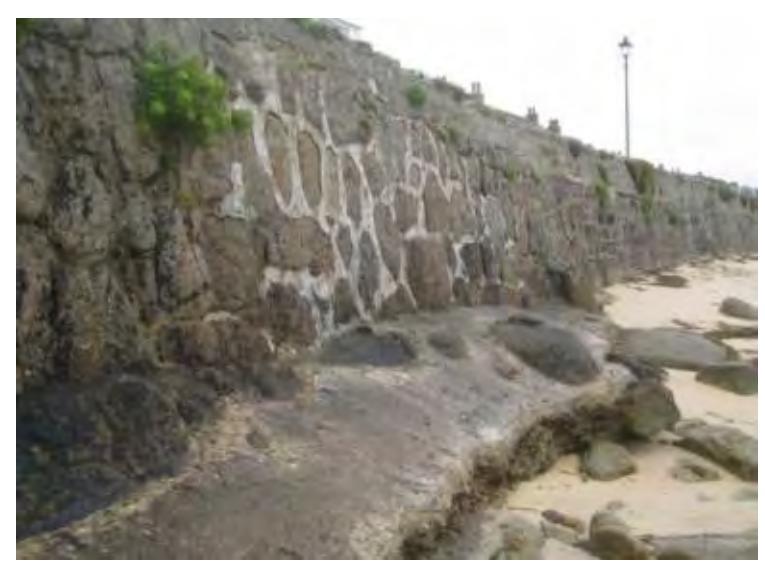
Figure 101: Evidence of previous re-pointing. Protection of the toe of the sea wall appears to stop. The splash wall can be seen above the sea wall.

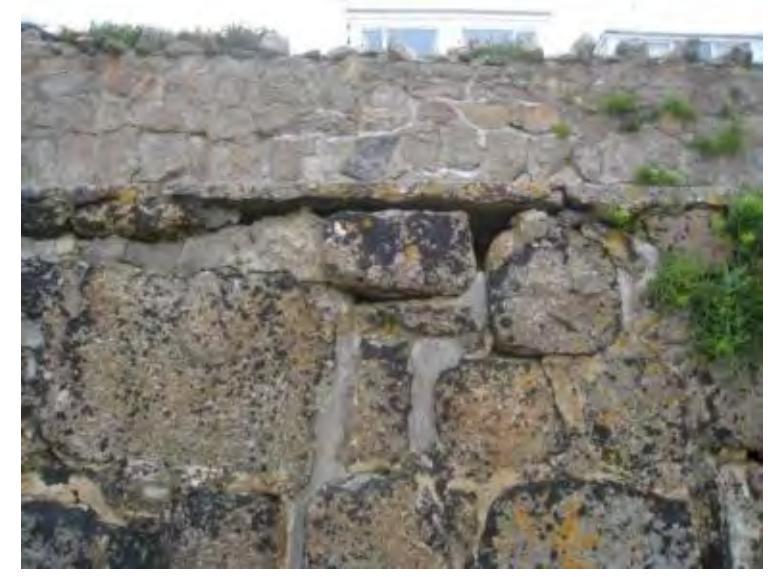
Figure 102: Further voids developing beneath the concrete cap

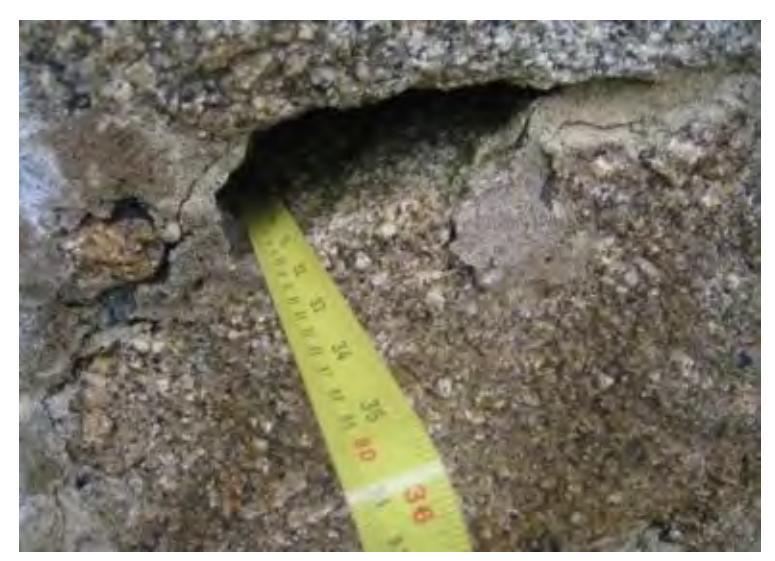
Figure 103: Void measured to be at least 800mm deep

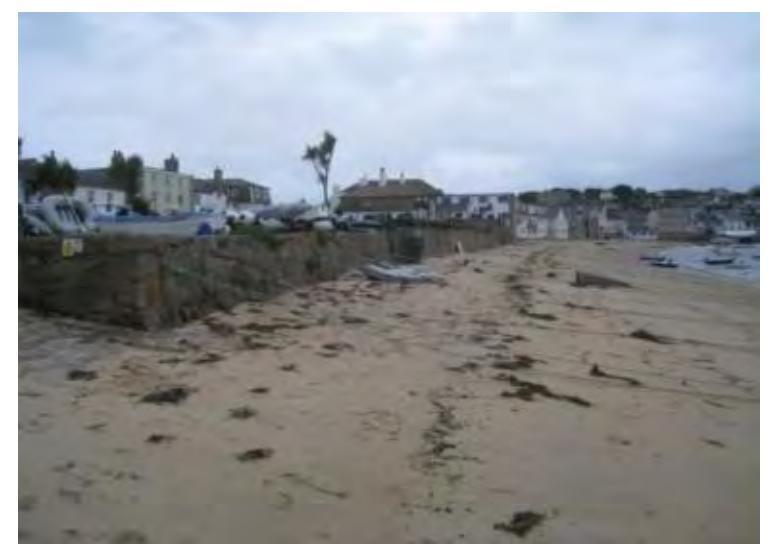
Beyond the Rechabite Slip, the height of the seawall reduces and there is no secondary splash wall. Loss of pointing, voids and some damage to the top of the wall, lowering its defence level, are the main problems.

Figure 105: View towards the west end of Town Beach, with properties backing directly on to the beach beyond the extent of the wall.

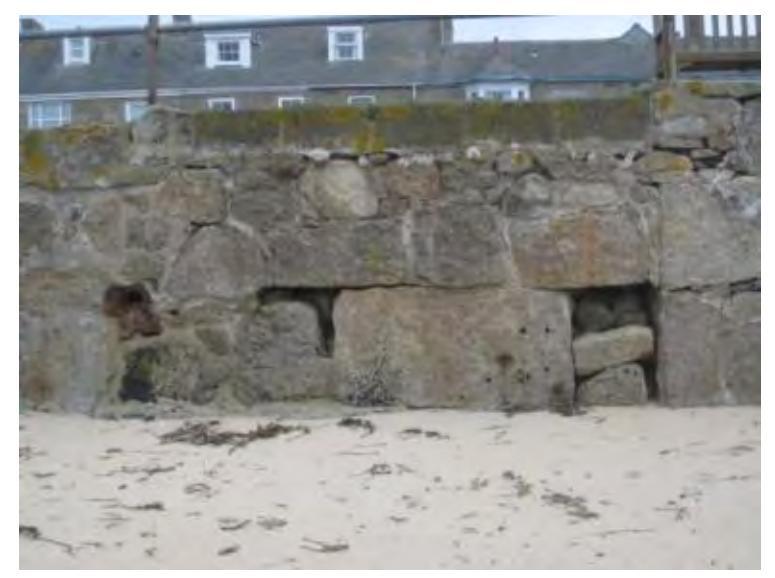
Figure 106: Temporary filling of voids

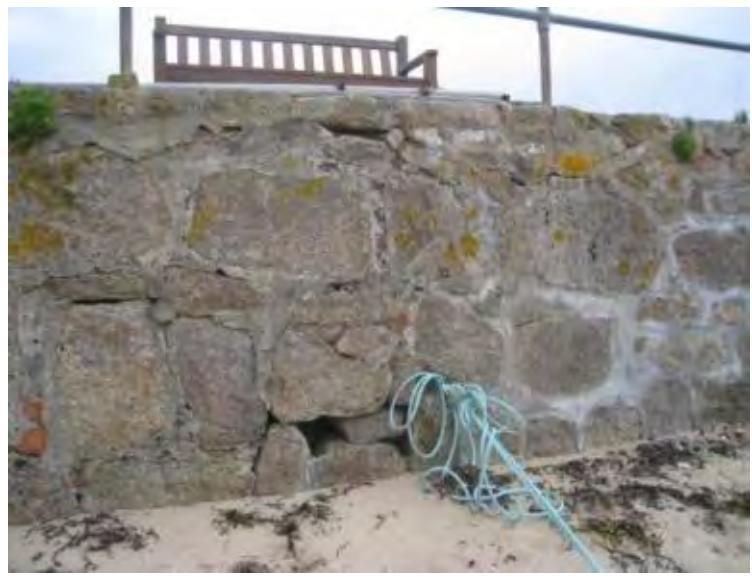
Figure 107: Voids opening up top and bottom of wall

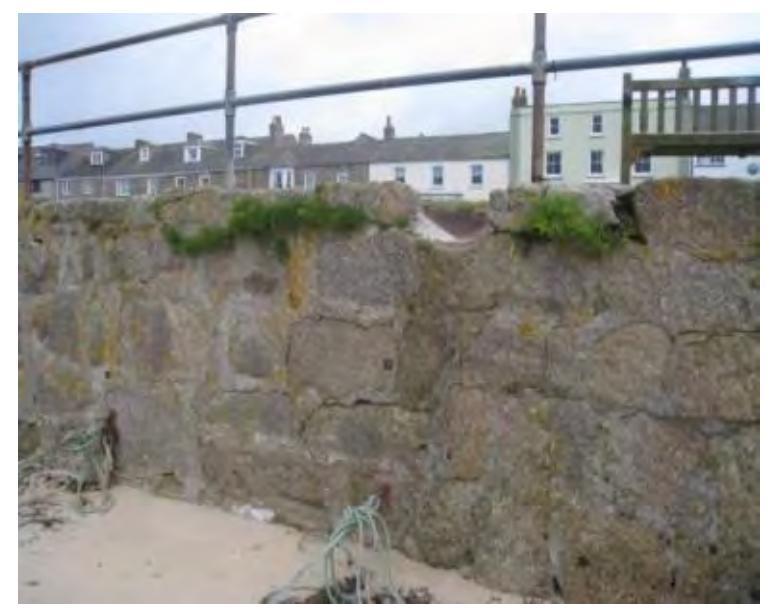
Figure 108: Loss of stone from top of defence

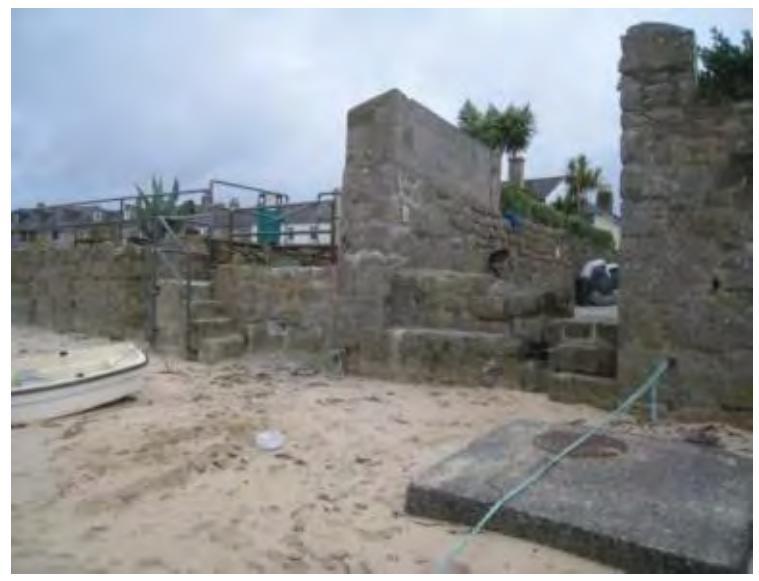
Figure 109: Pedestrian access at western end of Town Beach. Arrangement could compromise defence level. Manhole cover on foul drainage system is shown in foreground.

Consequence of failure	High: Residential and commercial centre of Hugh Town; Damage to road infrastructure Quay cut off from rest of St Mary's
Condition Grade	4
(See Table 2)	
Short term Intervention	Proposed work to re-point and fill voids behind stone wall must be undertaken this autumn, to ensure the integrity of the wall. Undertaking the works this autumn will avoid the wall having to endure another season of winter storms in its current state.
	The need for these works were first identified in 1997, so it is of concern that it has taken over 14 years to implement.
	The use of flood boards at the Rechabite Slip is recommended along with a review of the use of flood boards or raising the defence level at the western end of Holgate's Green where a pedestrian access

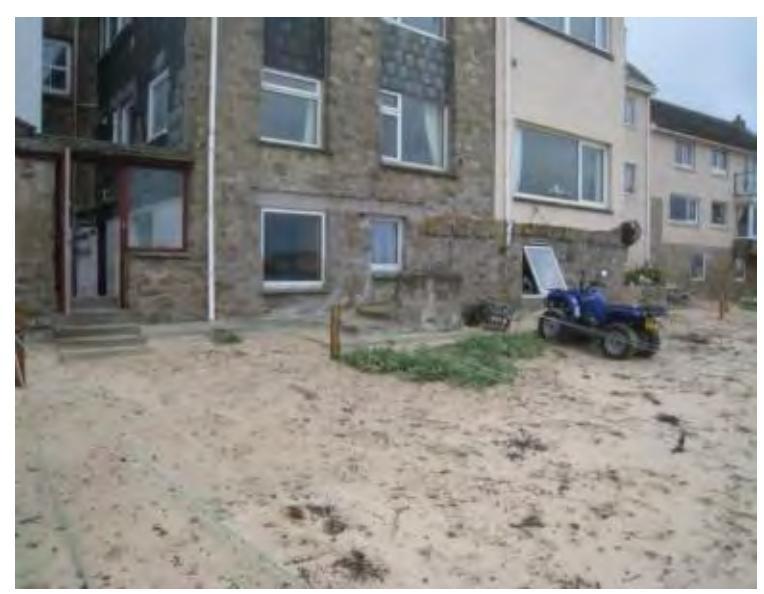
The following photographs illustrate the proximity of residential property to the sea along Town Beach. As yet there has only been one incidence of property flooding but, with sea level rise predicted, the risk of flooding is likely to increase in the future.

Figure 114: Town Beach property. The known flood incident occurred to the property on the right hand side, through the low window

route alongside the Custom House is lower than the defence level
Cost	Low
Medium term intervention	Consider individual flood proofing of property lying at the top of Town Beach.
	Besides sealing the fabric of the building, this would also include sealing the surface water system to try and prevent infiltration by rising tides, resolving any cross-connections with the foul sewer and sealing individual property foul pipes from backing up
Cost	Medium
SMP2	Narrow inter-tidal zone subject to coastal squeeze effects and long term sustainability of current shoreline position is unlikely.
	Recession mapping indicates up to 20m of erosion.
	Short term:
	Hold the Line;
	Long term:
	Managed realignment.
	There is little scope for re-alignment for the Town Beach frontages, but the Town Beach defence could be re-aligned by as much as 25m although this would result in loss of the promenade along the Strande.
	Requirement for a detailed strategy for the Hugh Town area identified. To consider the long term implications of climate change.

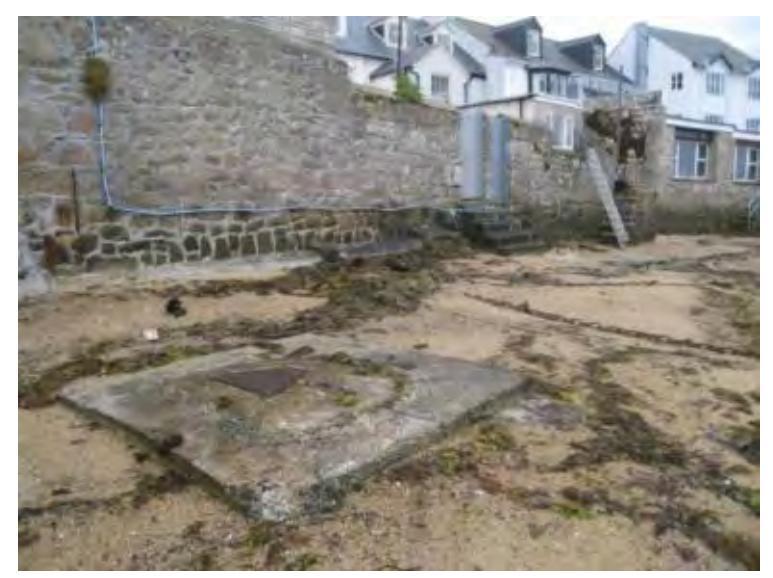
Figure 116: Town Beach Property. Note surface water manhole in foreground. Manholes were reported to be full of sand.

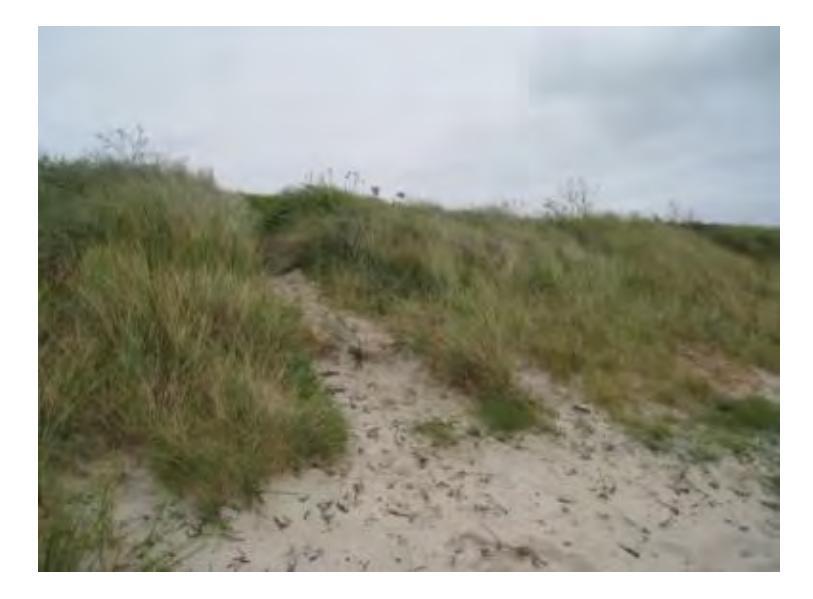
The sand dune has a covering of marram grass. Although this is dense in places the natural defence level offered by the dune has been compromised by informal access routes being established over the dune, probably by the recreational users of the beach. In one location, adjacent to the boat park, there is a clear gap through the dune. High tide would appear to rise one or two metres short of meeting the toe of the dune.

Figure 122: Informal access route causing erosion of dune and reduction in crest level

Consequence of failure	High:
	Commercial Properties and Trading Estate;
	Waste Management Site;
	Water Supply at Lower Moor.
Condition Grade	4
(See Table 2)	
Short term Intervention	It is recommended that access on to the beach is formalised to avoid ad hoc access routes continuing to reduce the defence level and integrity of the natural defence.
	Once access is formalised it is recommended that the areas of erosion and gaps in the dune are filled and vegetated
Cost	Low
Medium/long term intervention	Reinforcement of the sand dune with concrete revetment is recommended, in consideration of future flood design levels. However, SMP2 recommends managed re-alignment in the medium to long term
Cost	Medium
SMP2	Realignment approach is preferred beyond 2025, allowing room for the dune to roll back without reducing its height or width and, at the same time strengthening the natural dune.
	Improving the defensive standard in the south west corner, where the sand dune already backs on to the road, may need to be considered as part of the overall re-alignment.

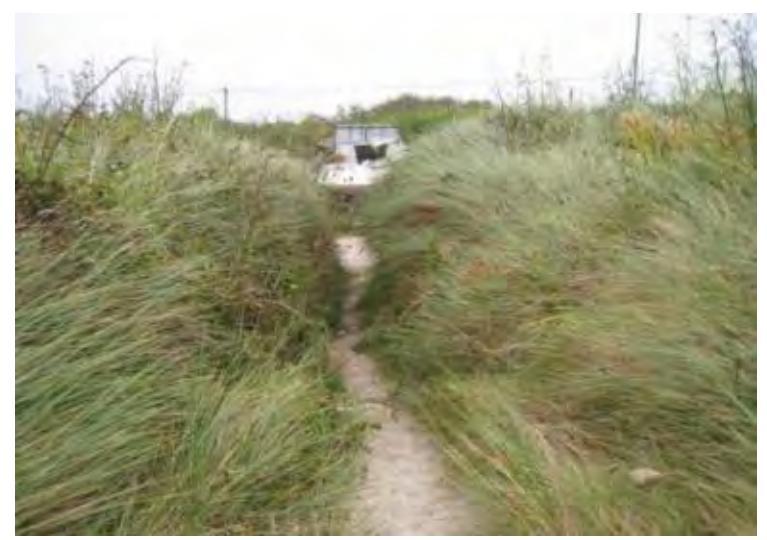
Figure 123: Gap in sand dune, likely to have been created for access. Embankment is over 2m high in this location.

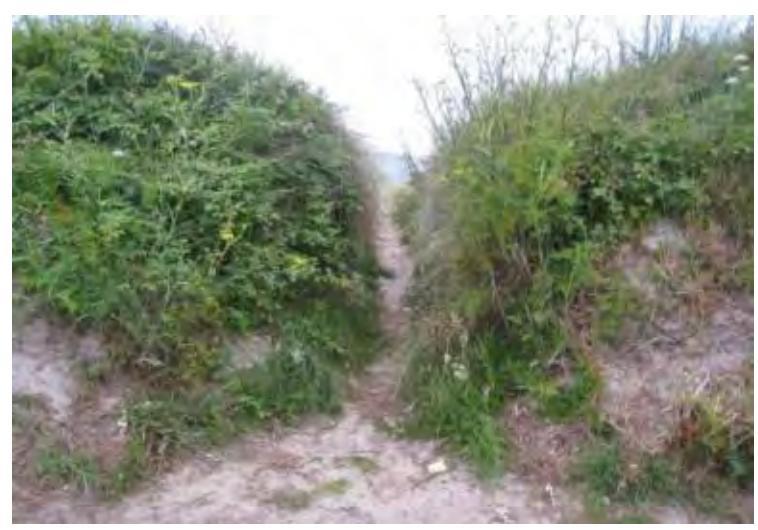
Figure 124: Erosion of the dune as a result of pedestrian access pressures

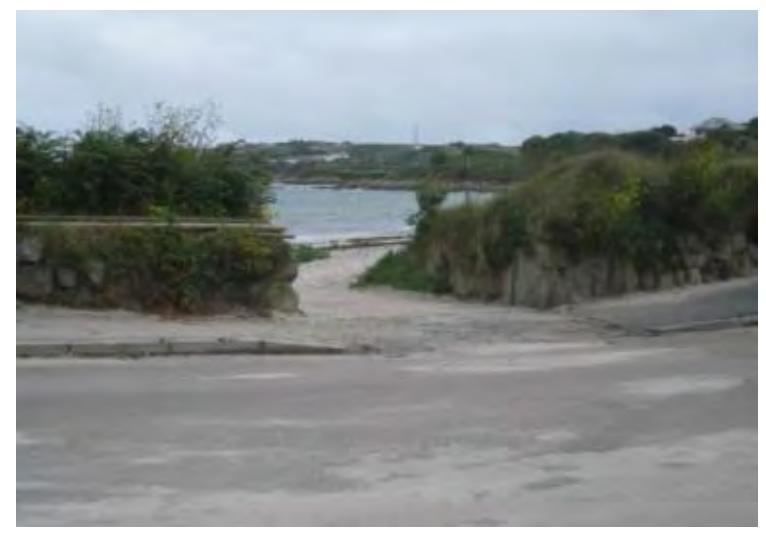
There is a slip through the dune close to the junction with the trading estate. Transportation of sand off the beach and onto the road is a regular problem. The flood boards are often deployed to try and mitigate this. At the time of the inspection a silt trap and highway gulley were being cleared of sand by the DLO.

Figure 126: Slip through dune with flood boards

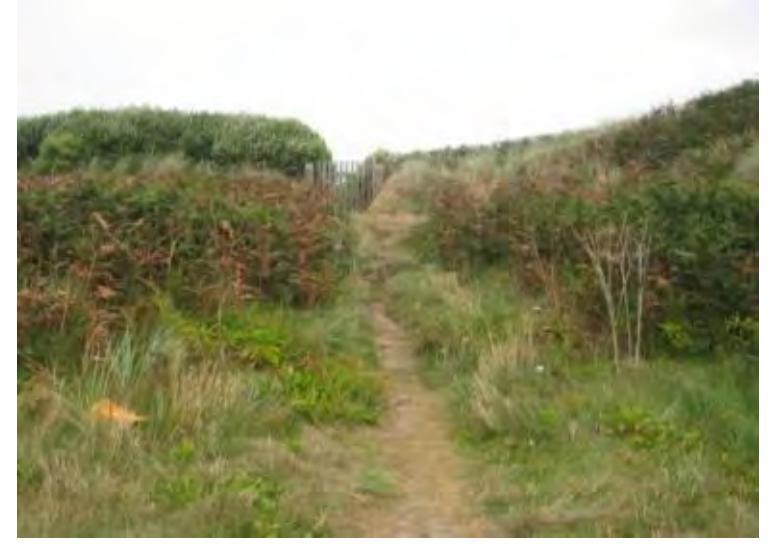
Figure 129: Access route on to beach

Consequence of failure	Low:
	Residential property flooding
Condition Grade (See Table 2)	2
Short term Intervention	It is recommended that access on to the beach is formalised to avoid ad hoc access routes forming and reducing the defence level and integrity of the natural defence in the future
Cost	Low
SMP2	The SMP is predicting up to 15m of landward recession. However, the implications are limited to encroachment onto the coastal path and potentially some property boundaries.
	The preferred plan is to take a "Do Nothing" approach, with no active intervention.

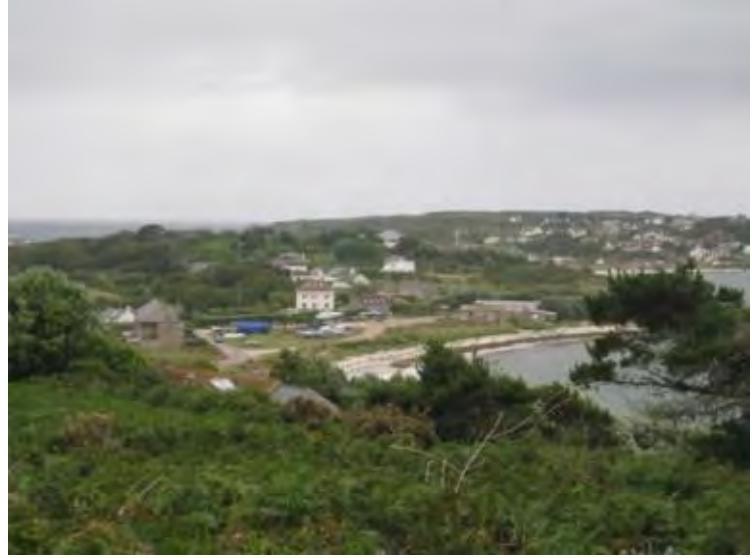
Figure 130: Porthloo

The dune was breached in the 1989 storm and the area behind was inundated.

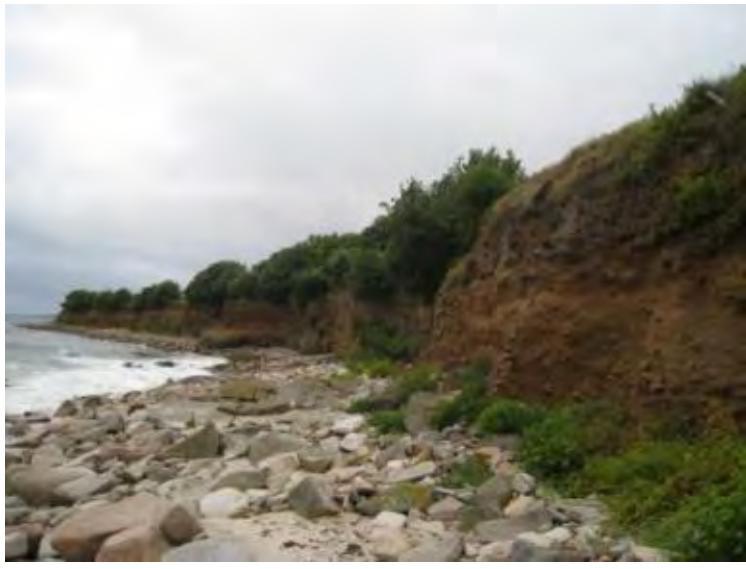
Figure 132: Ram cliff at the north end of Porthloo

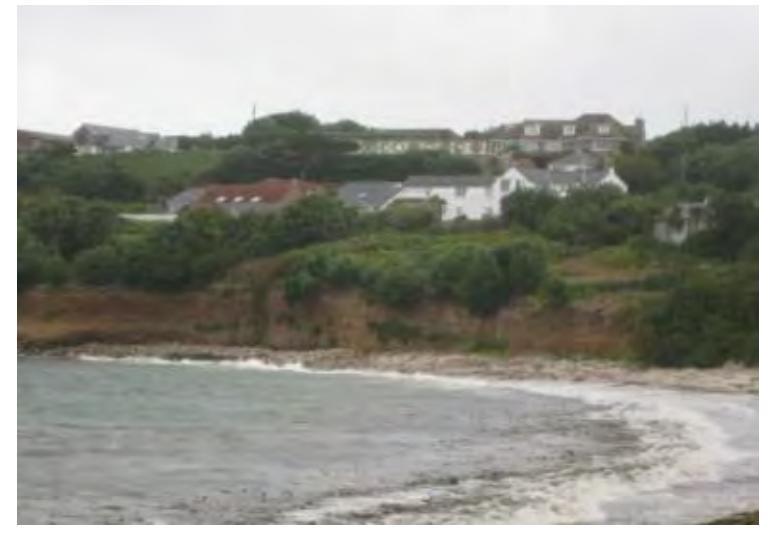
Figure 133: Properties at risk from coastal erosion

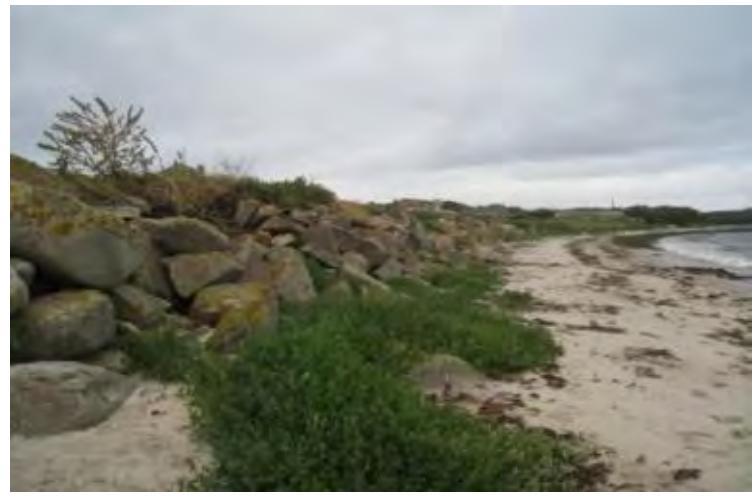
The sand dune is protected by rock revetment on its front face. Some of the revetment comprises old concrete slabs from demolition waste.

Figure 134: Dune is protected by stone revetment, which includes demolition waste in places

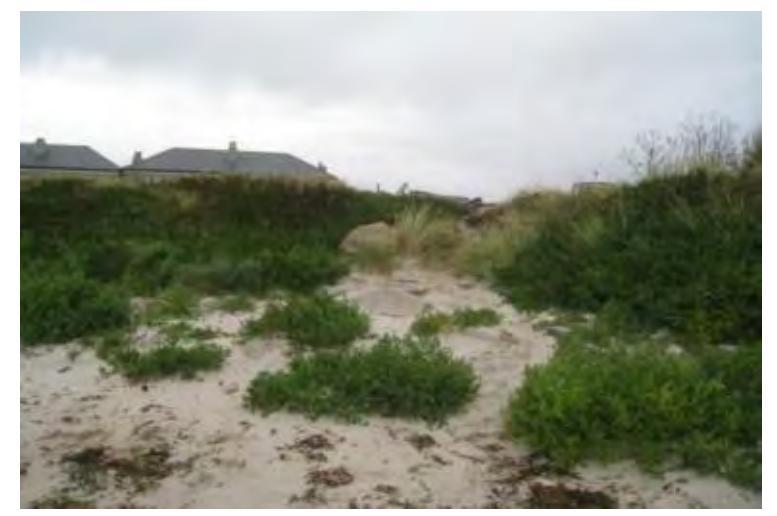
As is common with the other sand dunes, pedestrian access across the top of the dune continues to threaten its defence height and the localised loss of vegetation could create a weak spot in the event of inundation.

Figure 135: Pedestrian access over the top of the dune has locally reduced the vegetation cover and lowered the defence height

Consequence of failure	Medium: Residential Properties; Road infrastructure; Art Gallery; Boat yards; and Potential to contaminate Lower Moor SSSI.
Condition Grade (See Table 2)	3
Short term Intervention	It is recommended that access on to the beach is formalised to avoid ad hoc access routes forming and reducing the defence level and integrity of the natural defence in the future. Maintenance of the flood boards and slots should take place to ensure that they can be deployed during a storm event. Undertake topographic survey and modelling to check over-topping impact on Lower Moor SSSI.
Cost	Low
SMP2	Although Porthloo is more exposed to direct wave action than Porth Thomas and Porth Mellon, the preferred strategy is one of no active intervention (NAI) with managed re-alignment of Porthloo Lane in the medium/longer term. There would be encroachment on property boundaries with possible total loss of one or two properties

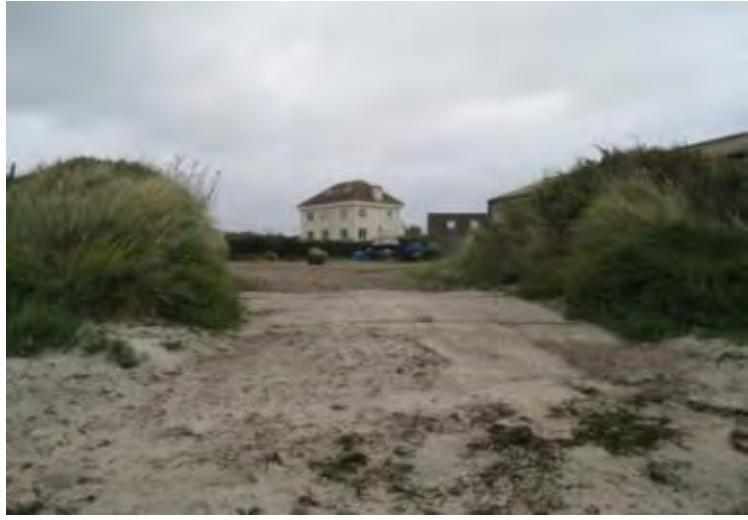
Slots are provided at the slip, close to the boat workshops at the southern end of the bay. However, given the vegetation covering these slots they do not appear to be in active use.

Figure 136: Slip through sand dune with provision for flood boards

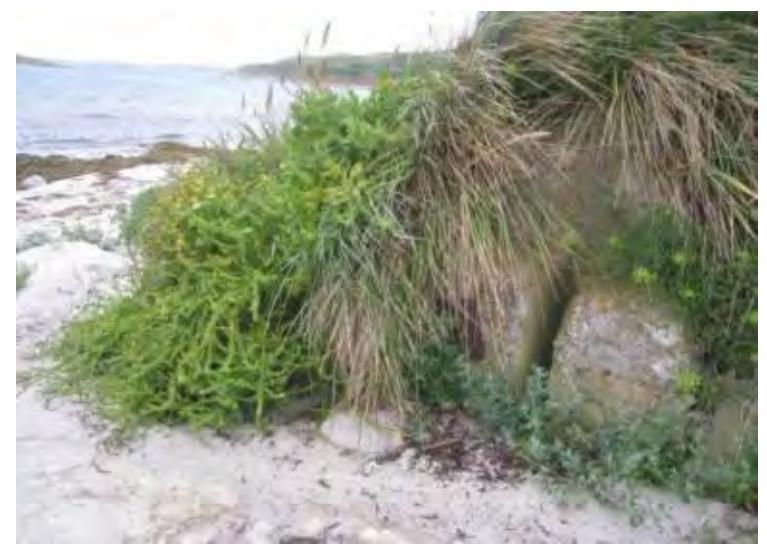
Figure 137: Provision for flood boards

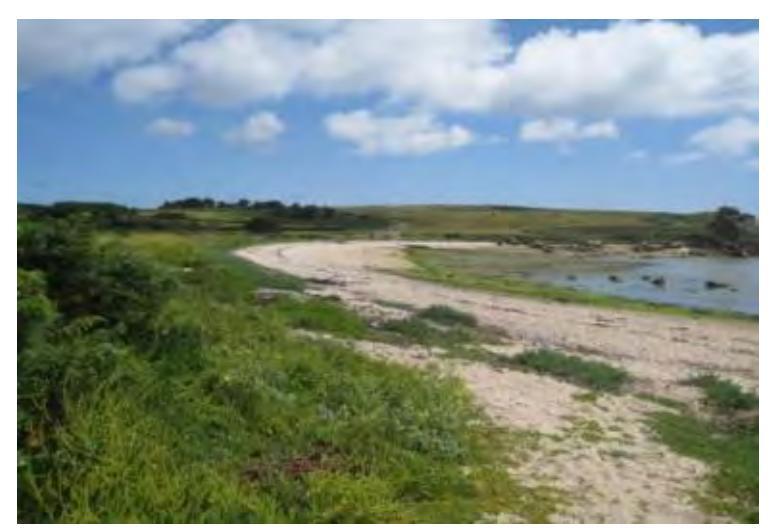
Although this beach is less popular due to its distance from Hugh Town, trampled access routes over the top of it and local loss of vegetation are a problem.

Figure 139: Low embankment at the back of Porth Hellick, helping to protect the Higher Moor SSSI

Consequence of failure	High: Water Supply from Higher Moor affected
Condition Grade (See Table 2)	3
Short term Intervention	It is recommended that access on to the beach is formalised to avoid ad hoc access routes forming and reducing the defence level and integrity of the natural defence in the future.
	Investment towards protecting the outfall and upgrading the flow control system from Higher Moor is also recommended to further enhance the security of the potable water supply.
Cost	Low
SMP2	The SMP proposes managed re-alignment as a means of strengthening the defensive embankment by allowing the beach to roll back in response to sea level rise and to encourage the deposition of sediment so that a more robust defence in the form of natural dunes is established.
	A strategic investigation into the combined risks of over-topping and inundation, percolation and groundwater levels for St Mary's. This should consider:

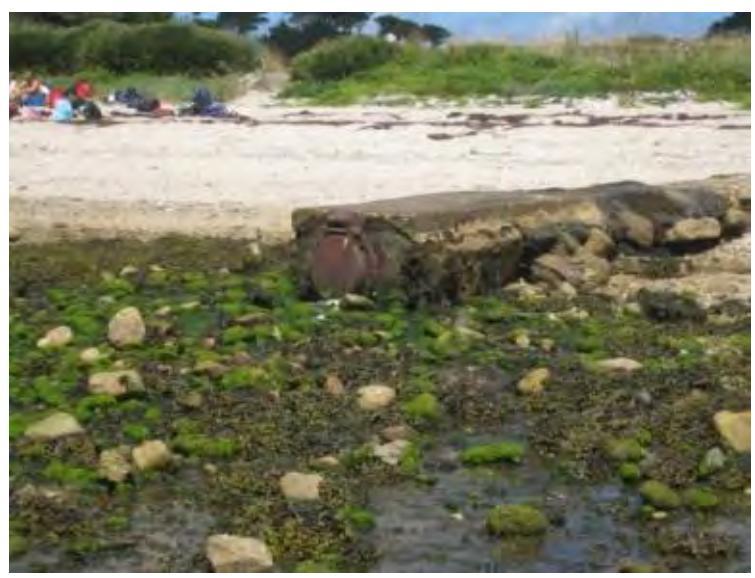
Figure 140: Outfall from Higher Moor, with erosion path formed in the dune behind

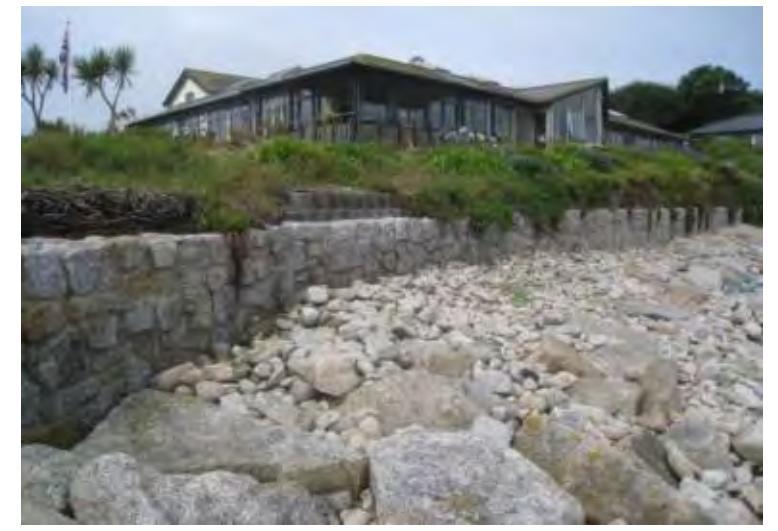
The wall is over 1m deep. The toe is not visible, protected by rock revetment of varying size. The wall is jointed and the mastic filler is still in a reasonable condition.

Figure 144: Granite faced wall with concrete hollow blocks above

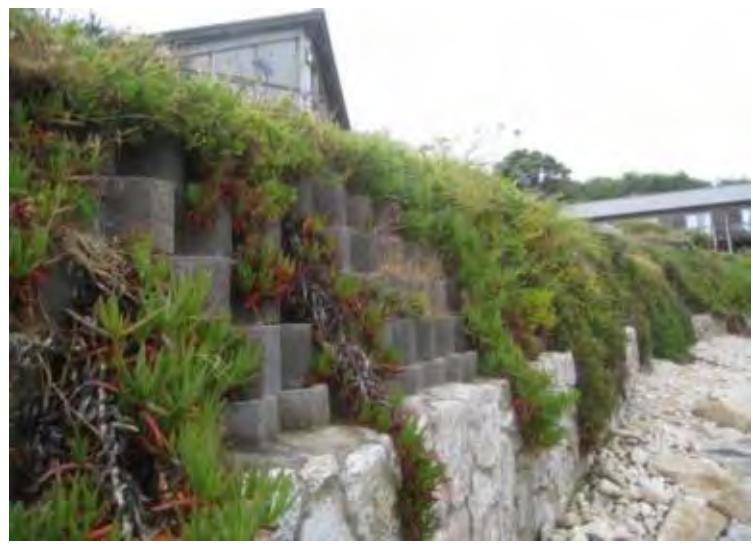
Formal planting has been established at ground level to the rear of the concrete hollow blocks. This planting follows the line of the hotel building and is only a few metres away from the face of the building.

Figure 145: Planting of concrete hollow blocks

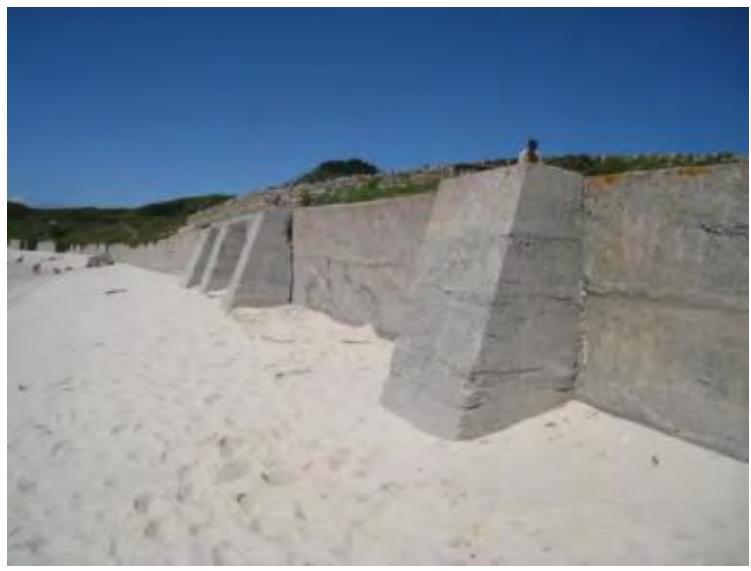
The concrete wall is supported by four buttresses at its southern end. The reinforcement in the buttresses has become exposed and the steel is now corroding.

Figure 148: Southern end of wall is supported by four buttresses

Consequence of failure	Medium:
	Impact to island's water supply from Abbey Pool;
	Heliport;
	Potential loss to island road.
Condition Grade	3
(See Table 2)	
Short term Intervention	It is suggested that patch repairs are undertaken on the wall before the defects become irreparable.
	Long term monitoring of the wall's condition should also be undertaken at least 6 monthly and after each significant storm event.
Cost	Low
SMP2	Erosion of the shoreline may exceed 30m over the next 100 years.
	However, a no active intervention approach is preferred, as it allows natural evolution of the coast and will continue to provide new sediment inputs to the beaches and dunes, helping to maintain their stability and healthy response to sea level rise.
	This approach would satisfy the objectives relating to the AONB and Heritage Coast designations.
Medium/Long term	If a "no active intervention" approach is to be followed the Duchy of Cornwall Estate will need to consider:

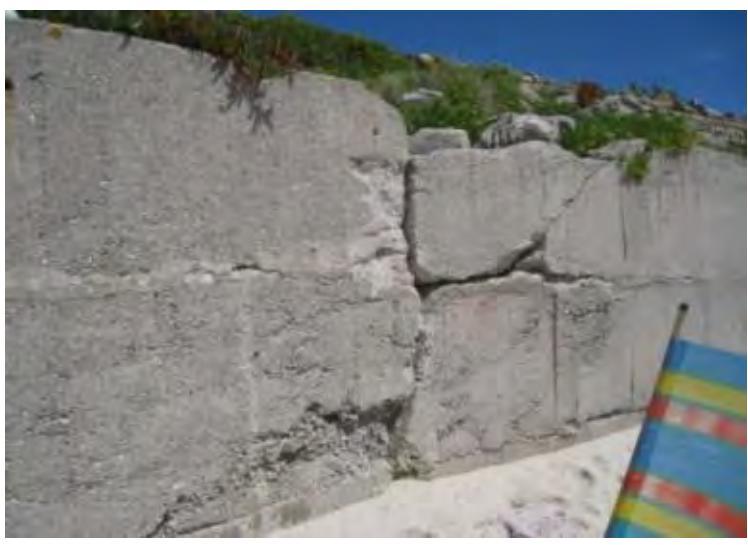
There are numerous areas where the concrete has started to spall. At some joints the wall is displaced from the adjacent section.

Figure 152: Where fracture has occurred these sections are now prone to weathering

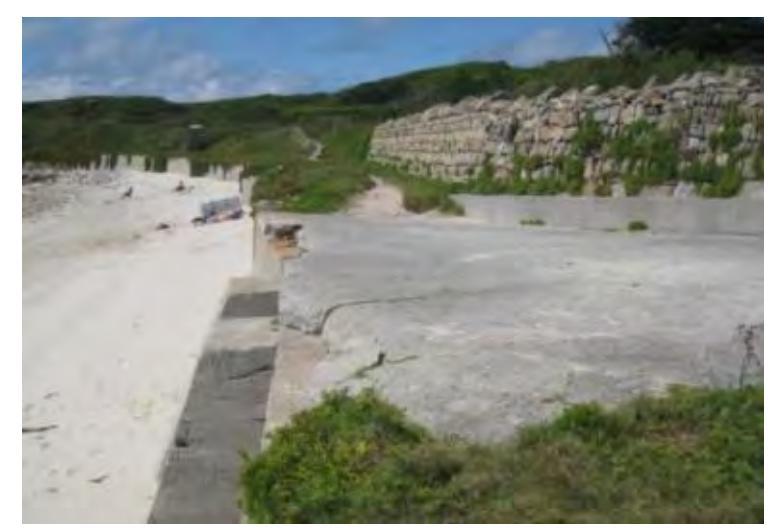
Figure 153: The road from New Grimsby runs to the rear of the stone wall which has been reinforced at its toe

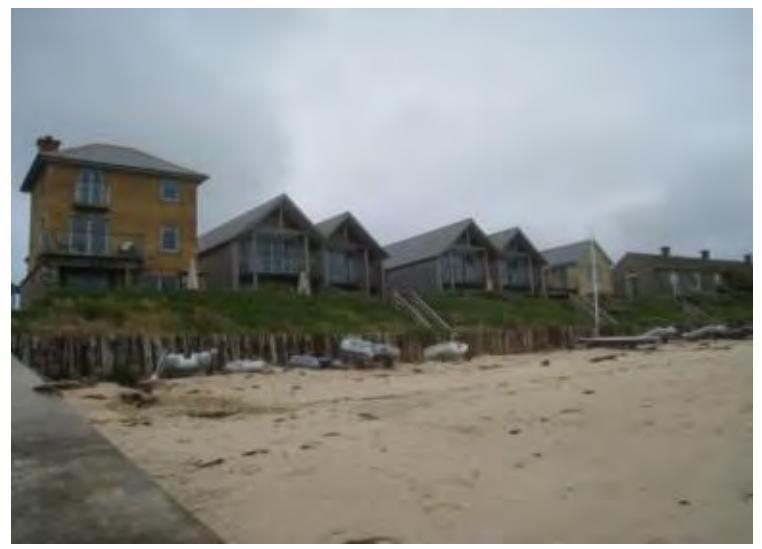
Figure 155: Timber revetment beneath holiday homes near Timothy's Corner

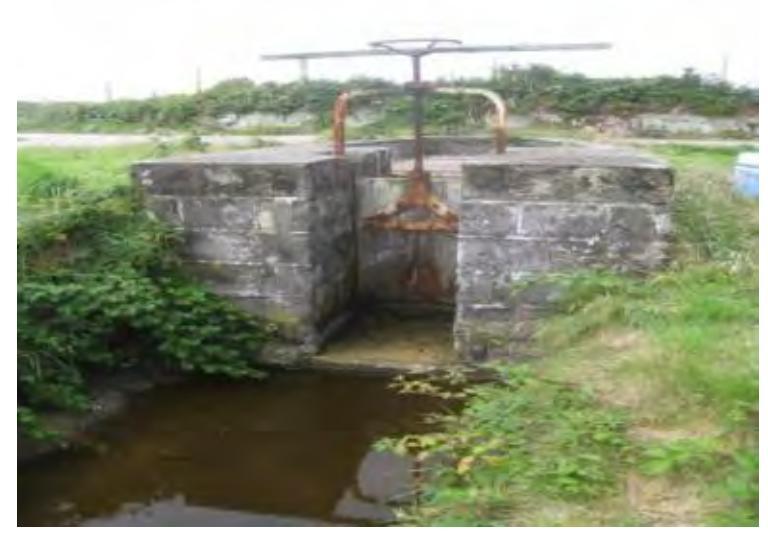
Figure 158: Outlet from Great Pool

There is a control gate on the outlet, adjacent to the road, which helps to prevent saline intrusion.

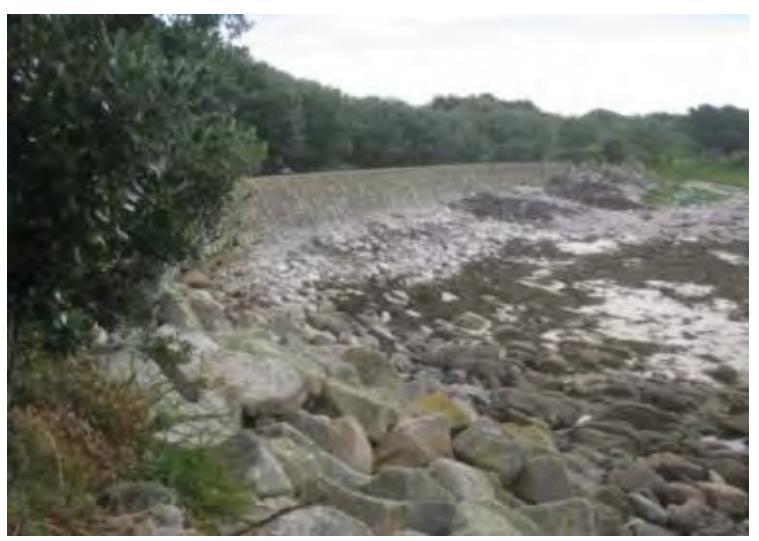
The granite faced mass concrete wall is in a relatively good condition. It is 850mm deep and retains a local track immediately to the rear which gives access to the Big Pool area. However, rutting from farm vehicles would appear to have exposed the reinforcement matting on the back face of the embankment, at the toe. This matting is exposed higher up the back face at one location where footfall has caused erosion.

Figure 159: Granite faced mass concrete wall

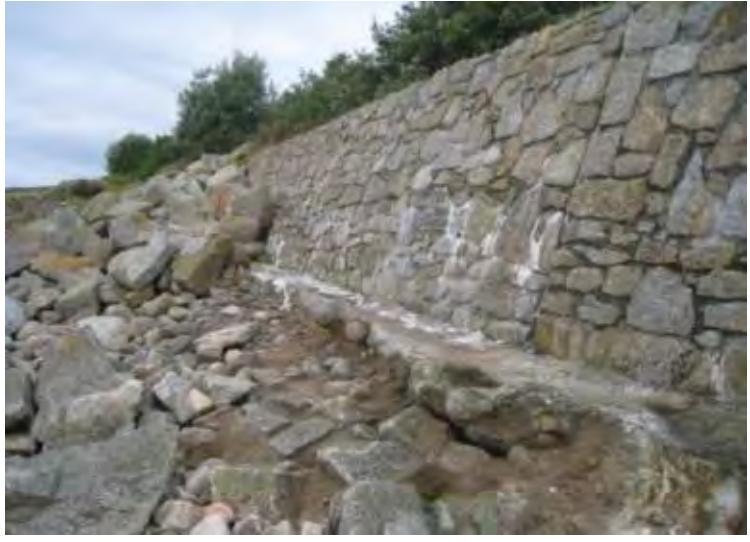
Erosion of the soft ground in front of the toe of the wall has occurred and this could begin to undermine the wall. Without further details on the foundations for the wall the impact of this on the wall's stability is difficult to judge. However, it is important that this in monitored and if necessary voids filled to ensure that long term settlement of the wall is avoided.

Figure 161: Erosion of the soft ground in front of the toe of the wall is taking place. This needs to be monitored and action taken to avoid settlement of the wall in the long term

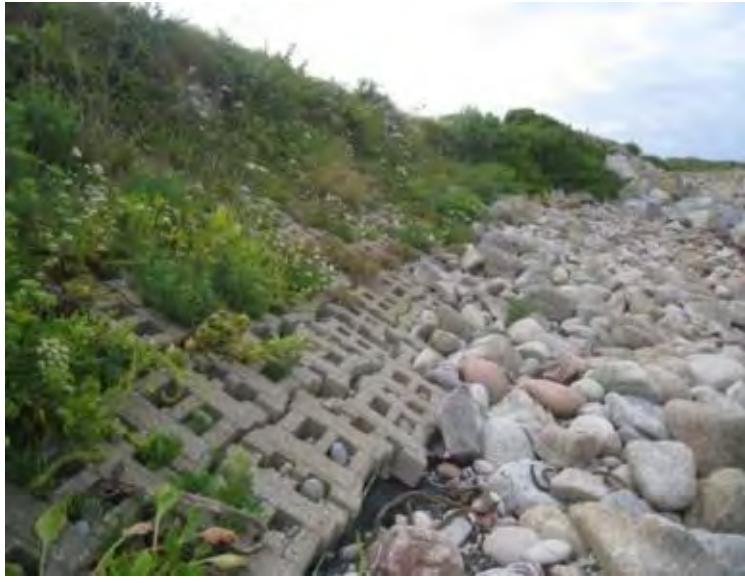
The reinforced embankment is now 15 years old and is showing signs of significant deterioration. The soft material above the revetment has been eroded leaving an unstable and exposed face. At some locations the toe of the revetment is exposed. The weight of the blocks themselves is unlikely to be sufficient to resist uplift during a storm so protection of the toe needs to be resolved.

Figure 164: The toe of the concrete block revetment is exposed and the ties between blocks are visible

Consequence of failure	Medium: Potential impact to island's water supply and ancient archaeology; Impact to arable land
Condition Grade (See Table 2)	Wall: 3 Embankment: 4
Short term Intervention	Currently, there are areas of weakness along the embankment. These need to be repaired to ensure that the potential for a breach is minimised.
	The erosion at the foot of the mass concrete wall needs to be monitored
Cost	Low
Medium term intervention	The embankment would appear to be reaching the end of its design life. Work needs to be undertaken to ensure that the standard of protection is maintained into the future.
Cost	Medium
SMP2	The main issue for St Agnes is the threat from erosion and inundation at the Big Pool, the islands main drinking water supply. Once the design life of the defences around Big Pool is exceeded there would be risks of ground water contamination from seawater during frequent storms. The preferred plan of Hold the Line aims to make provision for the defence of this area, as it is so strategic to the well-being of the local community and the economy of the island.

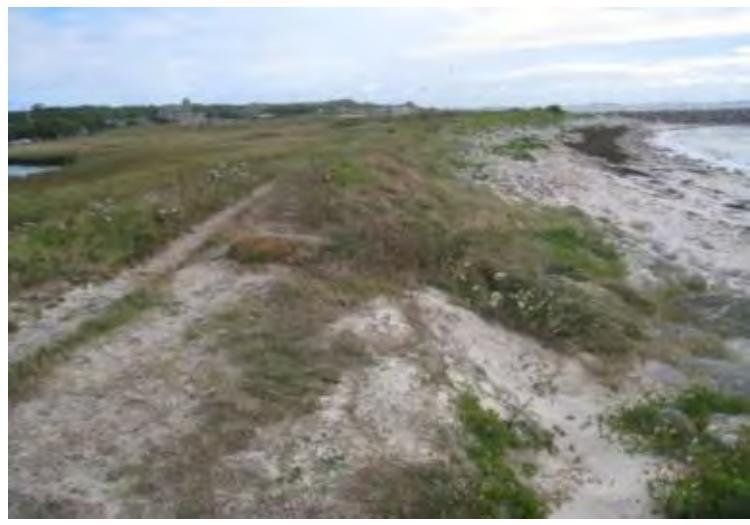
The embankment is showing signs of erosion along the crest. In places the ties to the concrete block revetment are exposed and the reinforcement matting is broken from general wear. The vegetation cover on the front face is sparse in a number of discrete locations. The back face has a good vegetation cover and appears to be satisfactory.

Figure 168: Concrete revetment exposed on front face of embankment

Consequence of failure	Medium – island water supply affected along with grazing land
Condition Grade (See Table 2)	Embankment: 3
Short term Intervention	Currently, there are areas of weakness in the embankment where the revetment and erosion matting are exposed and the matting damaged. These areas need to be monitored and if their condition worsens repairs are to be undertaken. The risk of erosion from foot traffic needs to be reviewed and the coast path potentially diverted off the crest of the embankment.
Cost	Low
SMP2	The main issue for St Agnes is the threat from erosion and inundation at the Big Pool, the islands main drinking water supply. Once the design life of the defences around Big Pool is exceeded there would be risks of ground water contamination from seawater during frequent storms. The preferred plan of Hold the Line aims to make provision for the defence of this area, as it is so strategic to the well-being of the local community and the economy of the island.

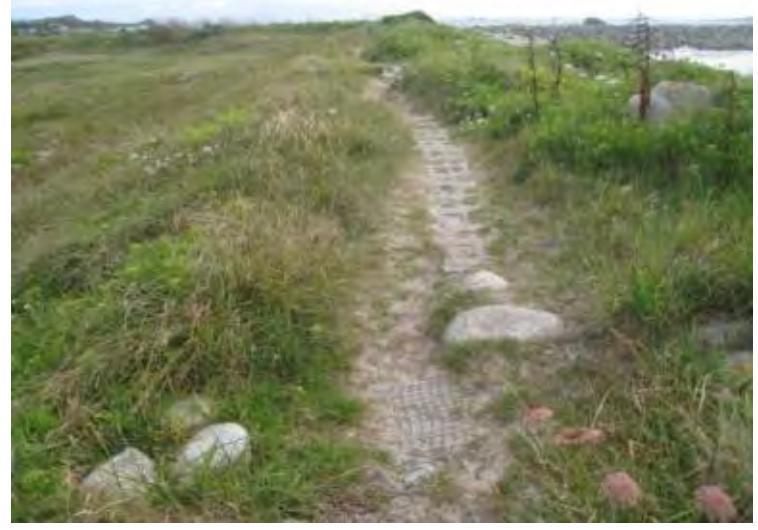
Figure 169: Erosion matting and concrete revetment exposed
