#### Isles of Scilly Water Interests Survey

### Report on Flood Defences

11/8185 Issue 1 | August 2011

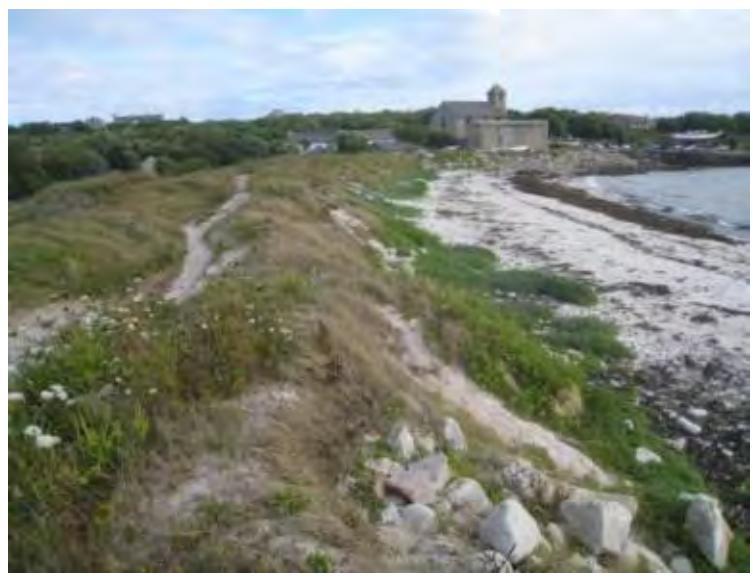
The erosion control matting was not visible and there was a reasonable cover of vegetation which has been supplemented in places by rock revetment. Erosion has occurred along the top of the crest from its use as a coastal path around the bay.

Figure 173: Embankment is protected by a mixture of vegetation and haphazard stone revetment

Consequence of failure	Medium: Potential impact to island's water supply; Impact on Lower Town; Impact to grazing land.
Condition Grade (See Table 2)	3
Short term Intervention	<ul><li>6 monthly inspections of the embankment are recommended to monitor for any developing areas of weakness.</li><li>The risk of erosion from foot traffic needs to be reviewed and the coast path potentially diverted off the crest of the embankment.</li></ul>
Cost	Low
SMP2	The main issue for St Agnes is the threat from erosion and inundation at the Big Pool, the islands main drinking water supply. Once the design life of the defences around Big Pool is exceeded there would be risks of ground water contamination from seawater during frequent storms. The preferred plan of Hold the Line aims to make provision for the defence of this area, as it is so strategic to the well-being of the local community and the economy of the island.

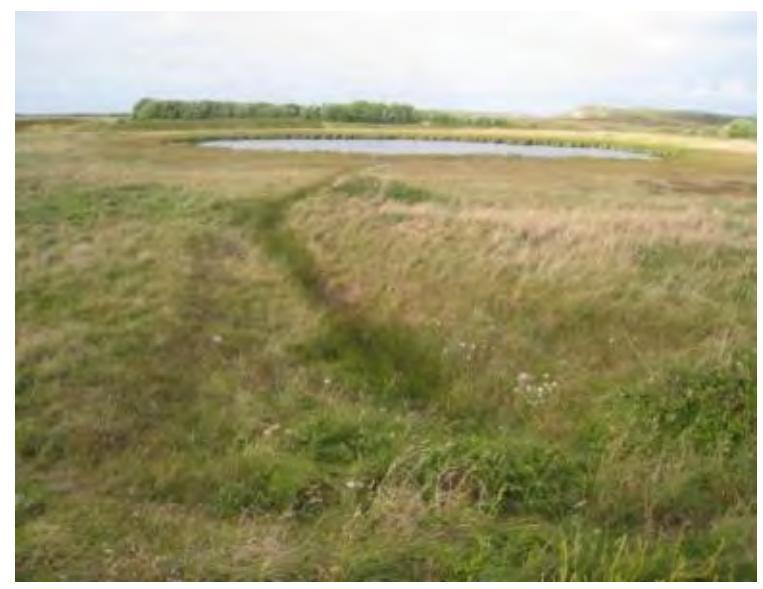
Figure 174: Outfall from Big Pool runs beneath the Periglis Embankment with concrete headwalls on both the front and rear faces

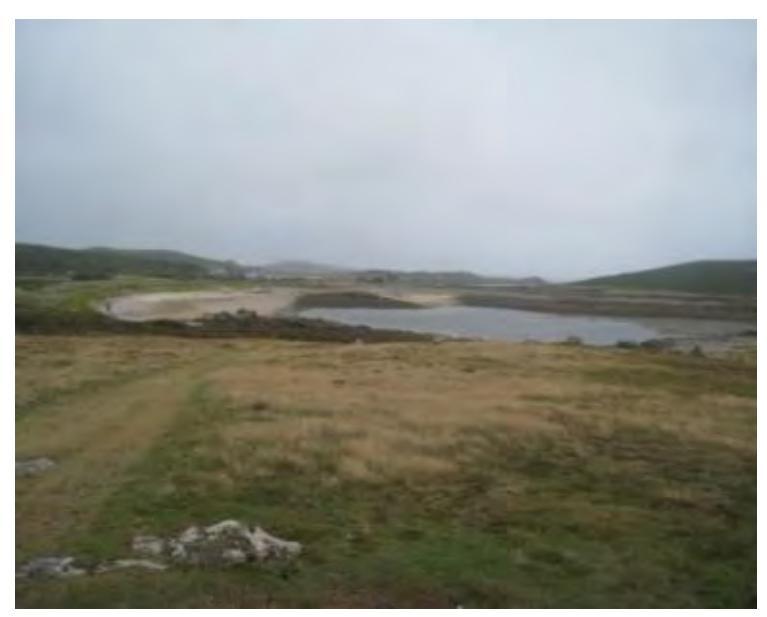
It is clear that the old seawall at Great Popplestone is redundant and the defence is provided by the rock armour placed in front of it. The wall will continue to deteriorate and this needs to be monitored in terms of the impact on the stability of the rock armour.

Figure 177: View over Great Popplestone, from Little Popplestone

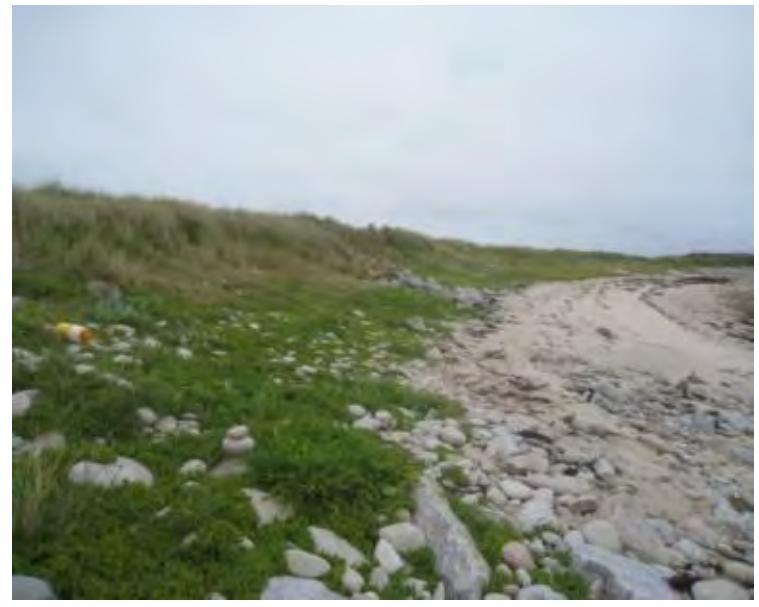
Figure 178: Erosion of ram cliff continues at Little Popplestone

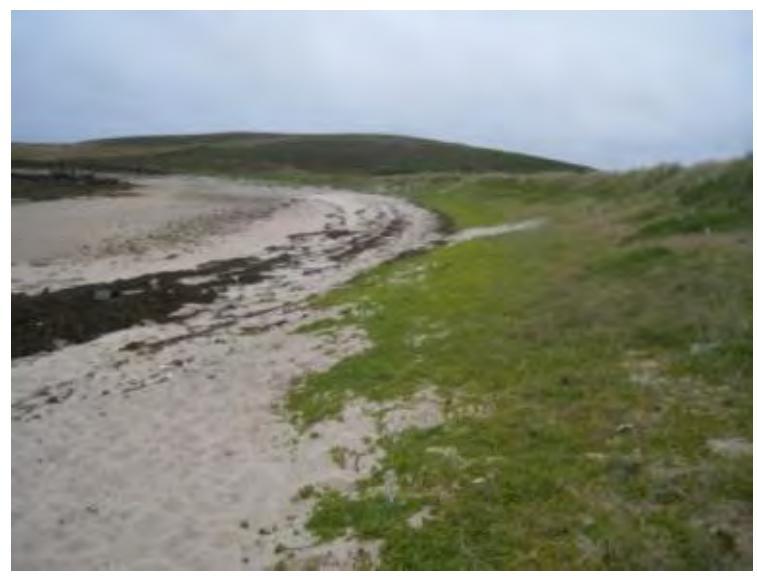
Figure 179: Natural embankment at Great Popplestone supplemented with vegetation cover and stone revetment

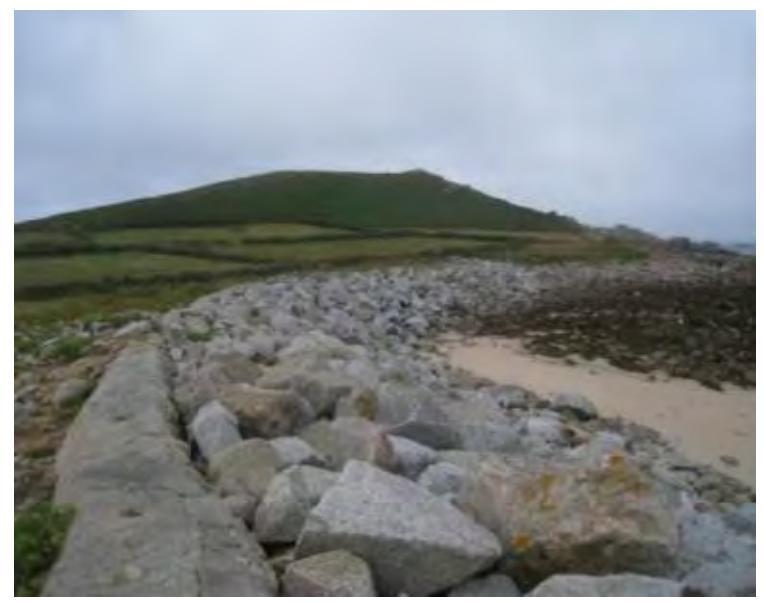
Figure 180: Great Popplestone embankment

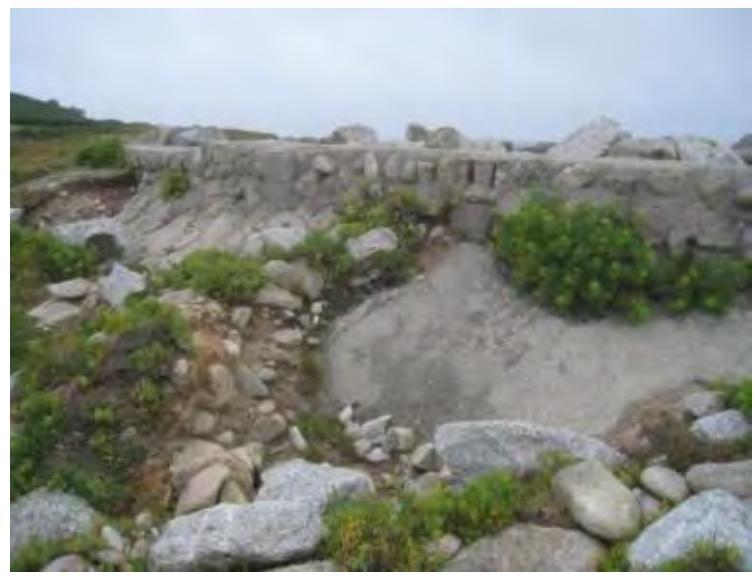
Figure 181: Old seawall at Great Popplestone. Supplemented with rock armour to front face
