## **Cornwall and Isles of Scilly Shoreline Management Plan 2**

Isles of Scilly Mid Term Review Appendix A

Client: Council of the Isles of Scilly

Date: 12 August 2016

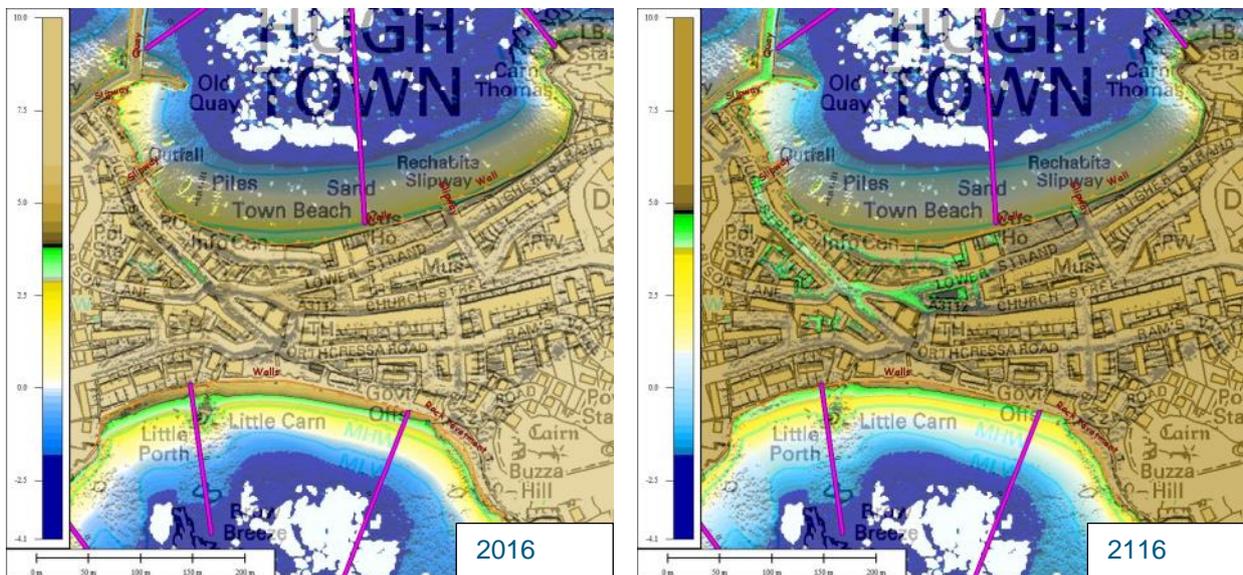
**Comparison of ground levels in relation to water levels for 2016 and 2116.**

This area covers the core of Hugh Town and, therefore, the most critical settlement of the island. At present occasional but serious flooding occurs around the low lying area of the high street linked to the road drainage and sewerage system during heavy rainfall. The images below highlight this area of risk (shaded in green) showing areas at present below the extreme 1 in 100 year sea water level (T100). The images show a comparison of ground levels based on predicted extreme conditions now (2016) and in 100 years' time (2116).

This poses two distinct risks to future management, although it has to be understood that these risks are linked and require a joined up approach.

- Underlying the management of the whole area is the vulnerability of the road drainage and sewerage system. This needs to be considered as part of a wholesale assessment and review of critical infrastructure for the island.

- Furthermore, even with future raising of defences, there may be a risk under more extreme events that overtopping will still occur. The SMP recognises the need to plan for such an eventuality such that overtopping is managed in a manner that impacts are mitigated.

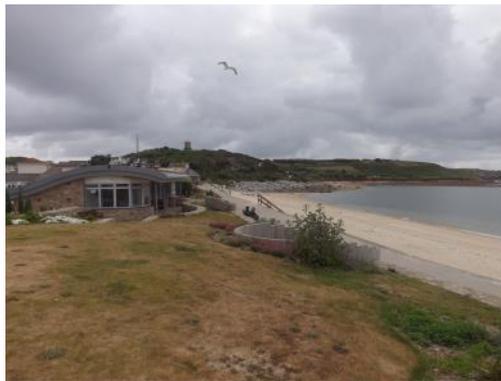
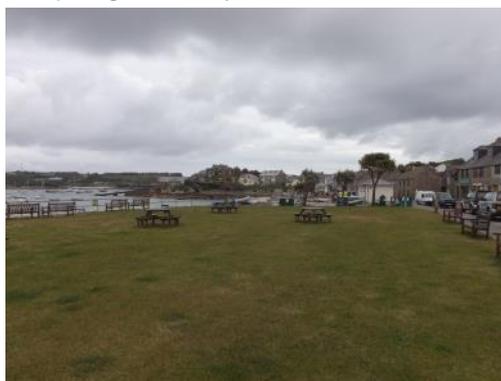
- The SMP recognises that there is little opportunity for adjustment of the alignment of defences over much of the Town Beach frontage in response to sea level rise because of the presence of properties. Locally there will be the need to consider how individual properties may need to be adapted and this is the interpretation that should be placed on the move to a policy of MR in epoch 3, rather than the idea of actually moving the alignment of properties. This needs to be communicated to individual property and business owners such that they are able to make plans for the future in line with managing the risk of sea level rise.

- Potentially greater opportunity exists with respect to the open ground adjacent to the Custom House along the Lower Strand. This is already discussed in the SMP but is further highlighted in the review. Recent works have been undertaken to improve the sea wall in front of the green and further works may be required here and further to the north. In the future, this defence will come under increased pressure. The area provides one of the few sections of actual beach use and access to the foreshore. In considering future management and, therefore the attitude to more immediate works, consideration should be given as to how this area might be adapted and possibly realigned. Essentially it will be important to maintain the upper crest width such that flood defence may be

landscaped into the frontage while also considering the possible need to set back the existing front-face defence line to mitigate the impact of beach loss. This needs to be discussed within a broader consideration of adaption of the sea front.

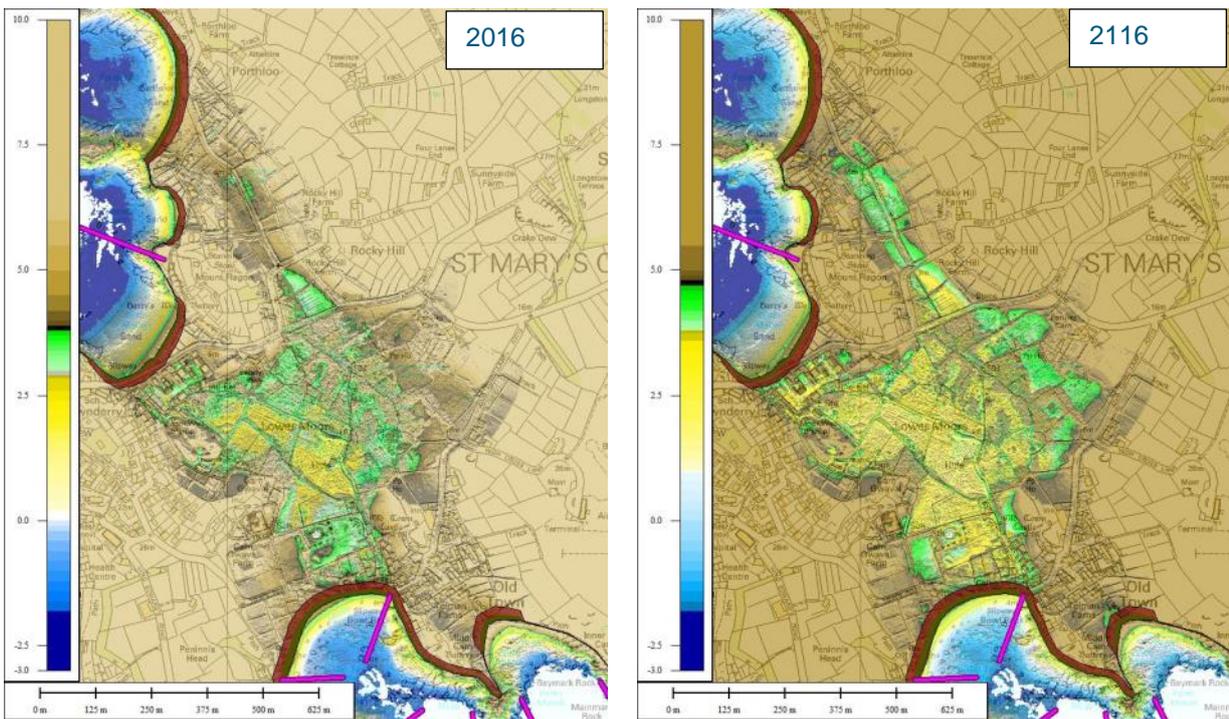
**Comparison of ground levels in relation to water levels for 2016 and 2116.**

The area as a whole contains important infrastructure such as the island’s waste management site and is one of the principle sources of freshwater for the island. In addition the area is important for its ecological value and management of the influence on freshwater and saline or brackish habitats. More specific to each coastal frontage is the need to maintain the landscape and ecological quality of the dunes and foreshores, alongside aspects of coastal use and the transport network.

road runs along this ridge with property and industrial units lying just to the south of the road. It may be seen from the above images that potential future erosion threatens to take out the road and expose the area behind to regular still water level flooding to the Lower Moor in general. Even at present the area of the industrial estate suffers flooding during heavy rainfall, exacerbated by tidal locking.

The SMP highlights the difficulty and tension in management between allowing the development of the natural dune system, and thereby encouraging the development of a more naturally robust system of defence and the need to ensure that breach or excessive overtopping of the coastal ridge does not occur affecting the road, the local industry and the broader scale interests of Lower Moor. The SMP policy moves from initially holding the line to a policy of managed realignment. Key points coming from this review are:

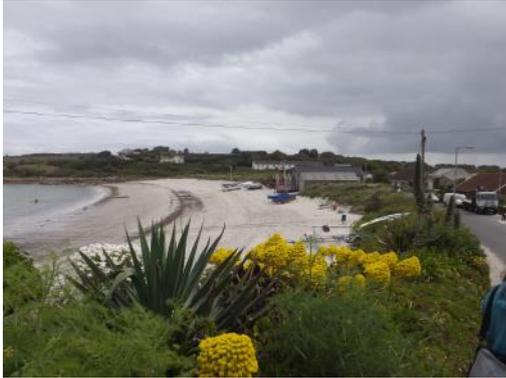
- over much of the frontage the aim should be to maintain the width of the dune area so that the dune system has room to adapt. Critically this will require careful agreement over any future proposed defence of the boat house, recognising that the backshore will retreat further back. In addition as the dune

line retreats there may be conflict with the trackway set within the dunes. The aim would be not to attempt to manage the dunes along this line but to look at alternative access routes. In addition, as the dunes retreat it will be important to maintain the open area behind the dunes to allow development of the natural defence system.

- At the southern end, the SMP recognises that there may be the need for further intervention to protect the road. Direct protection along this section may be required but alternative options for management such as controlling the developing alignment may be more appropriate.
- The aim is to continue to provide a sustainable level of protection to the hinterland but even so it has to be recognised that under more extreme conditions there is increased flood risk. This approach needs to be planned for looking at how use of the area in the future may need to adapt and how the impact of flooding may be mitigated.

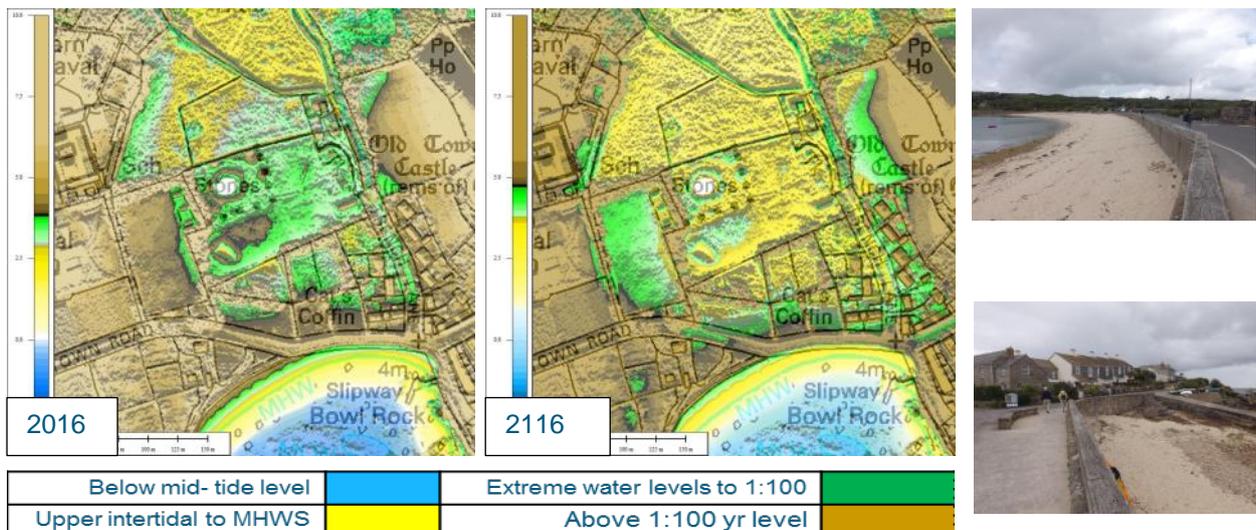
**Comparison of ground levels in relation to water levels for 2016 and 2116 with respect to Old Town Bay**

To the south, the defence of Lower Moor is provided by the sea wall to the road at the back of Old Town Bay. The SMP identifies this as one of the most vulnerable sections of defence around the island, with extreme pressure on the frontage with sea level rise.

At present, as shown below, there is a reasonable width or ridge along which runs the main road through the village, linking between the airport and Hugh Town. The area of Lower Moor, immediately behind the ridge is generally at a level less than of the T100 extreme water level, with some properties at risk along Trench Lane under this typical return period event. Indeed, during severe overtopping events these properties are now at risk from flooding. In the future (in 100 years), the immediate area of Lower Moor is below the level of normal spring tides, increasing the area of the Moor potentially at risk from saline seepage and potential inundation in the event of a breach of the coastal ridge.

This poses major issues with respect to long term management, with the SMP questioning the viability and sustainability of maintaining defences along this frontage in the future:

- Attempting to hold the existing defence would require major increase in the height of the defences and increased strengthening of the wall, increasing the likelihood of significant beach lowering, significant impact on amenity and landscape and running an increasing risk of sudden and catastrophic failure of defences should design standards be exceeded with little subsequent opportunity for adaptation.

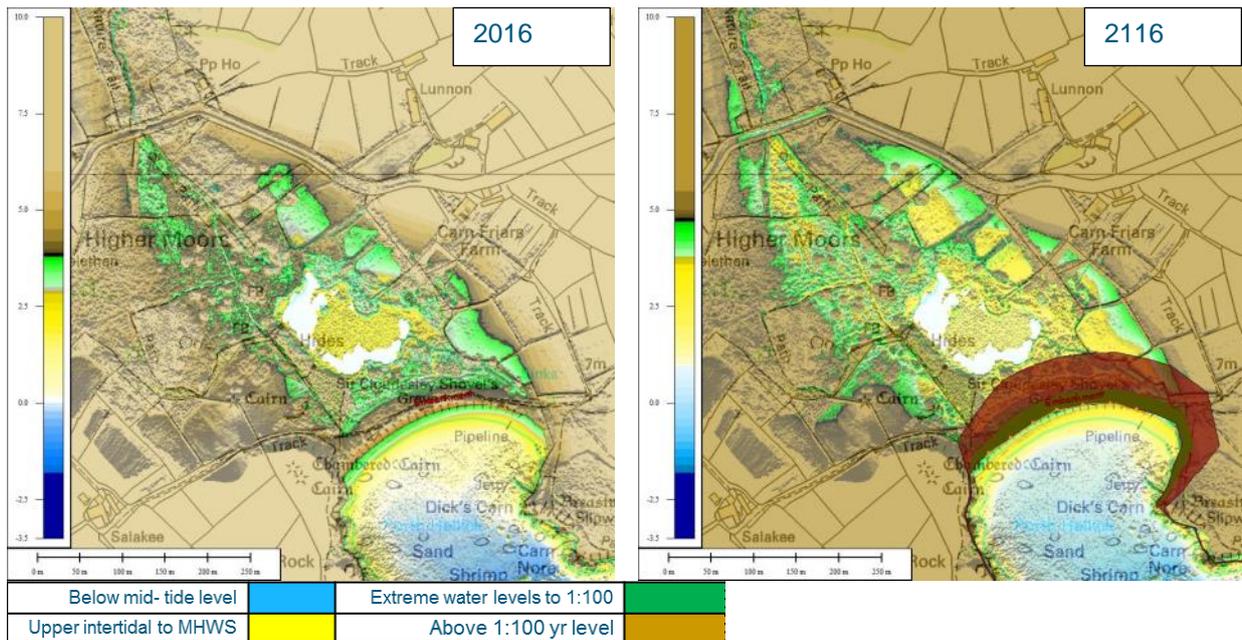
**Comparison of ground levels in relation to water levels for 2016 and 2116**

The image above shows the ground levels within the valley for both present day and 2116. The back shore of Porth Hellick comprises a natural sand/ grit ridge that appears to function in part in a similar manner to a more normal shingle backshore storm ridge. The back face of the ridge appears to have benefited from past over-wash of sediment, providing a good volume of sediment and reliance to back face wash out potentially allowing further natural adaptation.

At present and as a general principle, management should attempt to work with the natural process of change in the beach and profile. It is recommended that a more detailed assessment is made of the present day stability of the ridge and that a better assessment is made of the standard of protection this ridge provides.

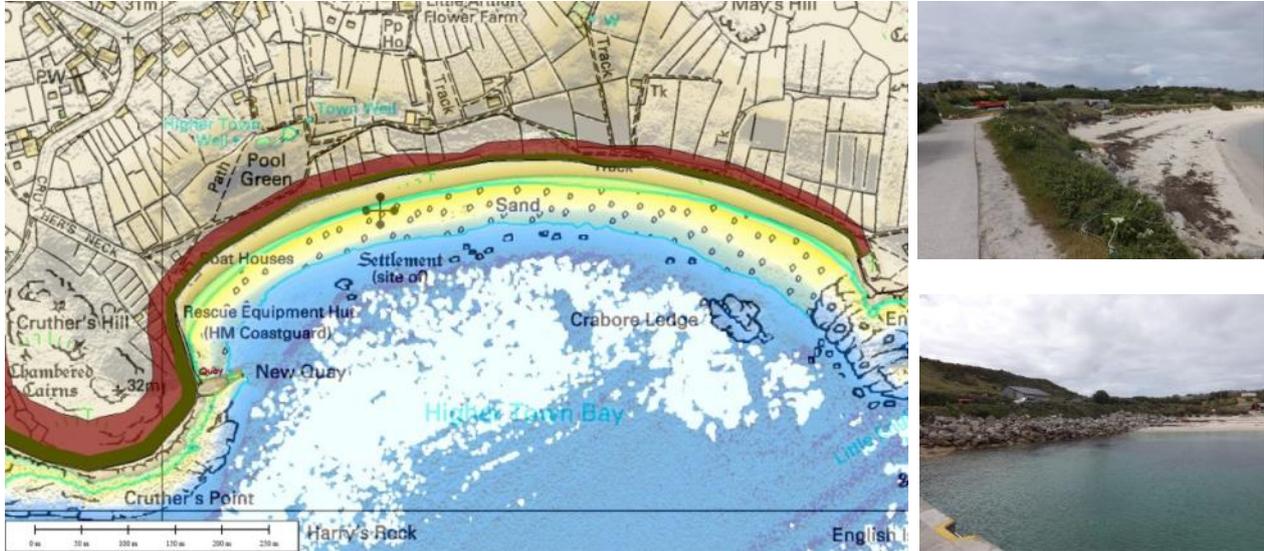
Local Plan and Images of the western corner of PU43.3

the Quay as well as protecting some limited number of properties. The crest of the bank behind the rock has suffered minor erosion, presumably due to overtopping.

Slightly beyond the revetment there is some local defence to a beach access and slipway.

At the eastern end of the revetment, however, there may be pressure to extend the length of revetment to prevent outflanking. This starts to impose more upon the natural processes and runs the risk of establishing a principle of acceptance that the revetment might continue to be extended further in the future. This then becomes a creeping incursion gradually taking more and more resource and impinging to an ever increasing extent on the landscape. The pressure for this becomes particularly acute following severe storm damage and this needs to be planned for in advance.

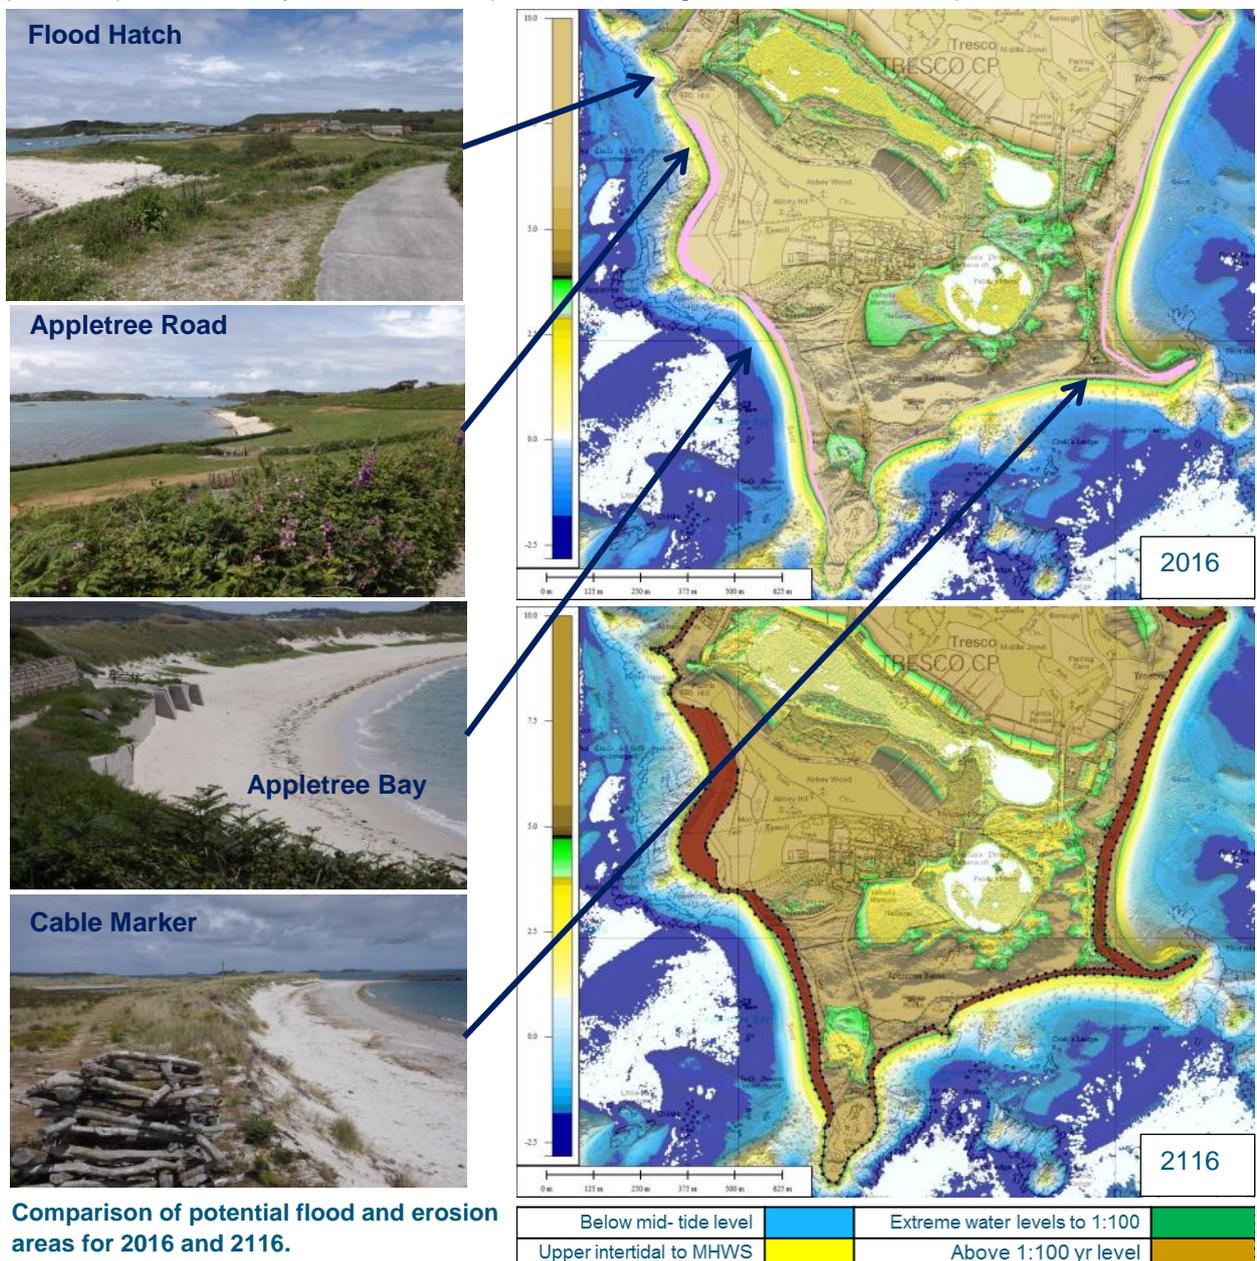
Comparison of potential flood and erosion areas for 2016 and 2116.

Key areas subject to this review are shown on the above image and these are discussed below.

- There is concern that NAI may result in overtopping or breach through to the Great Pool from the Flood Hatch beach, potentially affecting the larger area. While this area is relatively narrow, there is not considered to be an immediate risk and the SMP projections of erosion would suggest no substantial risk in the future. It is noted that there is a sluice to the Great Pool at this location, although it is uncertain where this exits at the coast. It would be sensible to investigate this and assess any risk to any outfall for the future.

- To the northern end of Appletree Bay there is a section of sea wall protecting the road. The wall is in generally poor condition and repair work has been undertaken. Under the SMP policy no further action would be taken to sustain this defence. The Lidar data would suggest that there is no substantial flood route. However, it was noted during the inspection that this area has particularly dense tree cover and this may distort the data, particularly at the eastern end of the obvious valley, linking through to the Abby Pool. This should be investigated further.

- Following the storms in 2014 the area, around the cable marker at the eastern end of Bathinghouse Porth, was subject to erosion; as was much of the cliffed dune frontage. While it is understood that the cable being marked is well beneath the surface there is concern that erosion in this area might open up flooding to the valley behind. Some minor works were undertaken to locally defend the marker. During the inspection, it was noted that some recovery of the dunes has occurred, with evidence of embryo dune development at the toe. Hardening the shoreline, even over a short distance in this area, is likely to impose a significant disruption to the naturally developing line of the dunes and cliffs, always with the risk that further works would be undertaken in the future, extending the need for defences to prevent outflanking.

At present, the condition of the wall does not appear to pose an immediate risk to the road. The agreed SMP policy would support the relocation of the road rather than works being undertaken to substantially reinforce this structure. It is however, suggested that minor works if seen as being advisable in the short term would not counter to the SMP policy if these works were undertaken in a manner compatible with the nature of the existing defence. The intent of the SMP is to ensure the continuing natural function of the shoreline. At present there is no significant evidence that the wall has a broader influence on the shoreline. In the future the wall will be in advance of the natural shoreline and the intent would certainly be that this should not result in incremental extension of the defence to the south.
