HOLY VALE TREE SURVEY

For works under Natural England Higher
Level Stewardship AG00596391

Written by Matthew Rogers B.A. (Hons.), NPTC
City and Guilds Level 3 Arboriculture

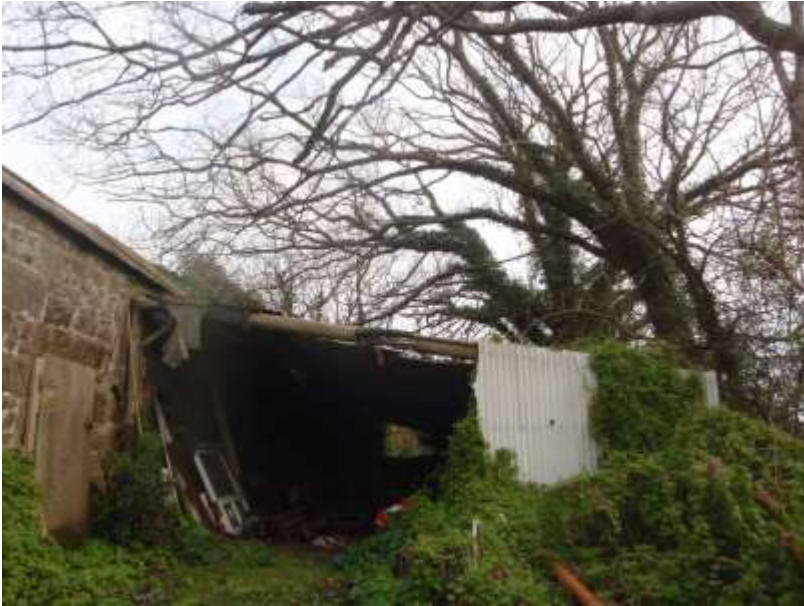
Fig 1.4 Large over-mature unbalanced Elms growing over building (not on Holy Vale site)

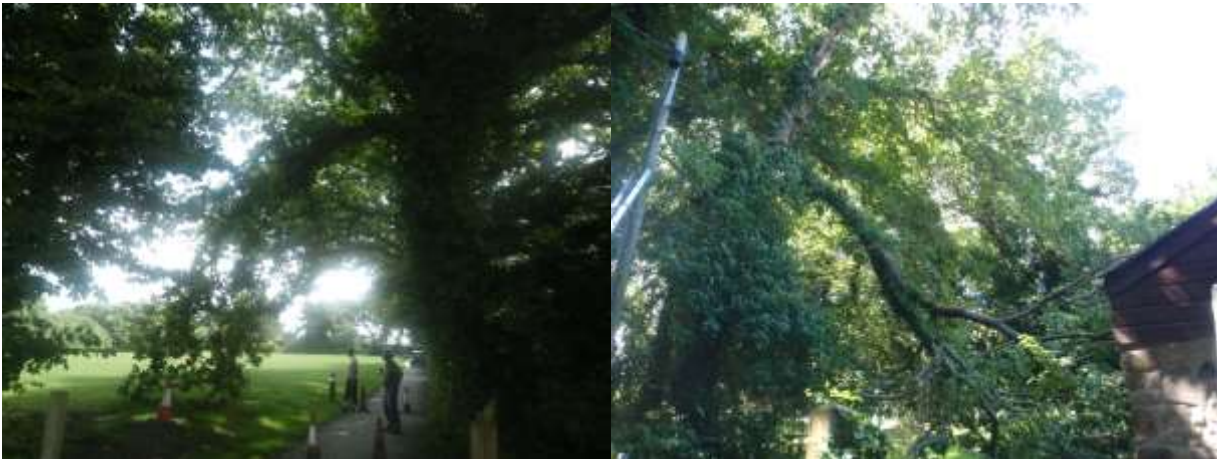
Fig 1.5 Two examples of large Elm limbs splitting out during summer months (not on Holy Vale site)

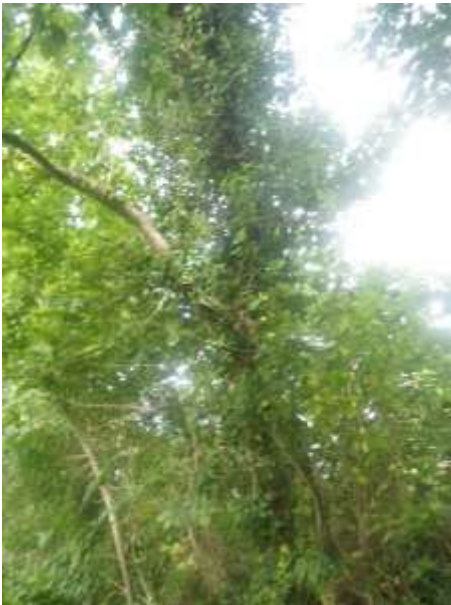
Tree 3A:

1. **Unique ref no:** 3A
2. **Grid Ref:**
3. **Measurements:** Diameter of stem 1.50m (measured); Height 12m (est.); Spread 5m(est.)
4. **Species:** Probably *Ulmus Procera*

5. **Estimated Age:** 60 years
6. **Tree Form and Vigour:** Appears to be maiden tree, slight lean to south west probably to seek light, made more acute by large low branch to south west, active live growth, some epicormics growth, nil veteran features noted

12. **Potential threats:** Nil biological observed other than general points noted in main text. Lean probably caused by large lower limbs seeking light to south and west in dense canopy. Potential "sail" problem caused by ivy during strong winds.

13. **Management Recommendations:** Minimal crown lift to approx. 5 metres, taking into consideration the recommendations for mitigating the risk to any potential bat roost

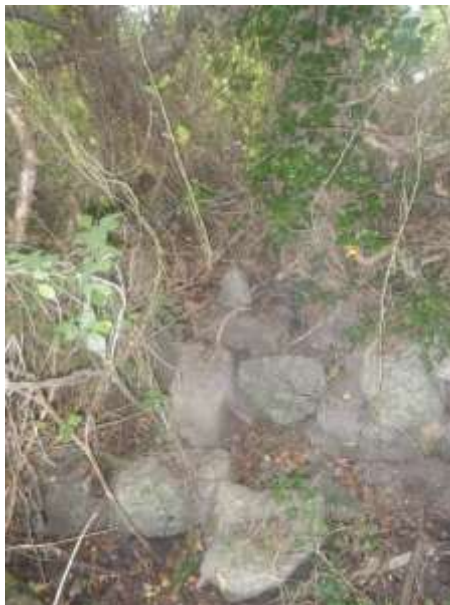
Tree 5A:

1. **Unique ref no:** 5A
2. **Grid Ref:**
3. **Measurements:** Diameter of stem 1.35m (measured); Height 14m (est.); Spread 8m(est.)
4. **Species:** Probably *Ulmus Procera*

5. **Estimated Age:** 60 years
6. **Tree Form and Vigour:** Appears to be maiden tree, slight lean to west probably to seek light, active live growth, large lower limb to south west, some epicormics growth, nil veteran features noted

7. **Tree associates:** Ivy growing freely over tree; some evidence of historic bird nesting within ivy.
8. **Relationship to landscape features:** hedgerow tree, some damage caused from windblow to granite wall (see picture)

12. **Potential threats:** Nil biological observed other than general points noted in main text. Lean probably caused by large lower limbs seeking light to south and west in dense canopy. Potential "sail" problem caused by ivy during strong winds.

13. **Management Recommendations:** Crown lift to approx. 5 metres.

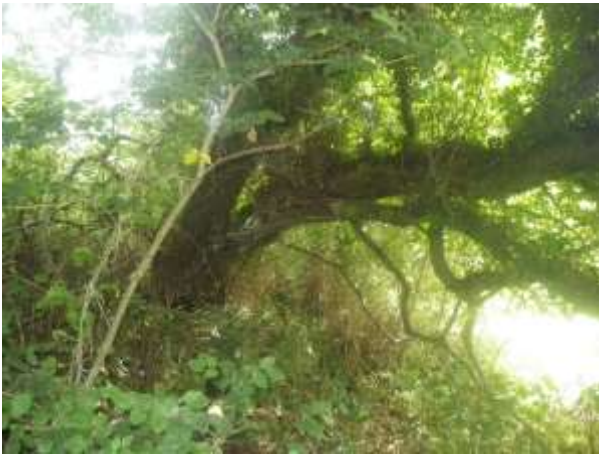
Tree 6A:

1. **Unique ref no:** 6A
2. **Grid Ref:**
3. **Measurements:** Diameter of stem 3.4m (measured); Height 18m (est.); Spread 20m(est.)
4. **Species:** Probably *Ulmus Procera*

5. **Estimated Age:** 100 years
6. **Tree Form and Vigour:** Tree is windblown and resting on ground having fallen to south west, root ball still not showing but area has lifted around stone hedge, probably been in this position for several years, appears to be maiden tree, active live growth, some epicormics growth, nil veteran features noted

12. **Potential threats:** Nil biological observed other than general points noted in main text. Tree has succumbed to windblow damage. Currently tree not in safe position as may fall further causing additional uprooting and damage to wall. Also hindering use of agricultural field and allowing prolific growth of new suckers where area not cultivated.

13. **Management Recommendations:** Lop stem to approx. 1.5 metres above root ball to encourage new more vertical growth

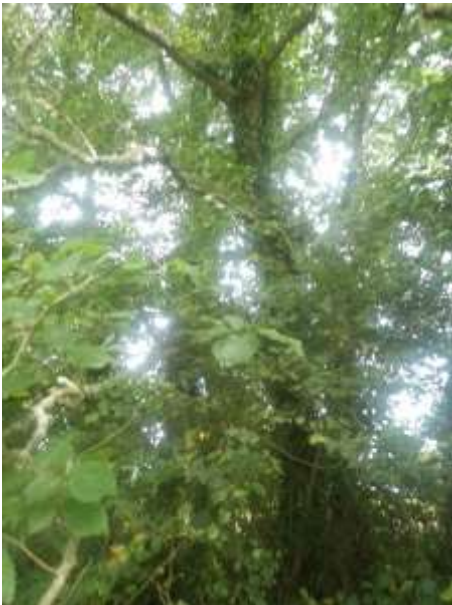
Tree 7A:

1. **Unique ref no:** 7A
2. **Grid Ref:**
3. **Measurements:** Diameter of stem 1.50m (measured); Height 15m (est.); Spread 14m(est.)
4. **Species:** Probably *Ulmus Procera*

5. **Estimated Age:** 60 years
6. **Tree Form and Vigour:** Appears to be maiden tree, slight lean to south west probably to seek light, active live growth, some epicormics growth, nil veteran features noted

12. **Potential threats:** Nil biological observed other than general points noted in main text. Potential "sail" problem caused by ivy during strong winds.

13. **Management Recommendations:** Crown lift to approx. 5 metres.

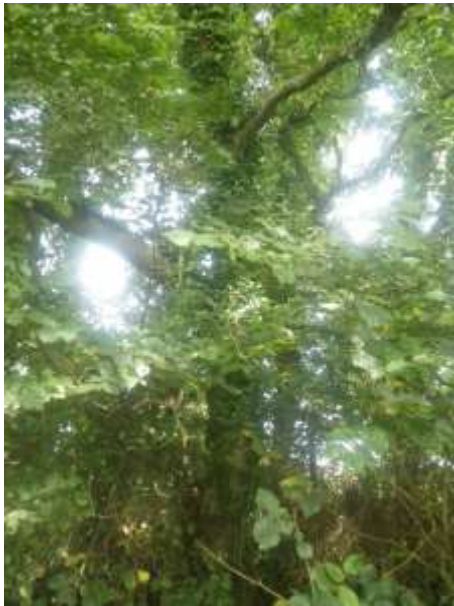
Tree 8A:

Medium potential for bat roost

1. **Unique ref no:** 8A
2. **Grid Ref:**
3. **Measurements:** Diameter of stem 1.50m (measured); Height 15m (est.); Spread 12m(est.)
4. **Species:** Probably *Ulmus Procera*

5. **Estimated Age:** 60 years
6. **Tree Form and Vigour:** Appears to be maiden tree, slight lean to south west probably to seek light, large lower limb also growing in south west direction, active live growth, possible hollow stem identified by bat survey

12. **Potential threats:** Nil biological observed other than general points noted in main text. Lean probably caused by large lower limbs seeking light to south and west in dense canopy. Potential "sail" problem caused by ivy during strong winds.

13. **Management Recommendations:** Minimal crown lift to approx. 5 metres, taking into consideration the recommendations for mitigating the risk to any potential bat roost.

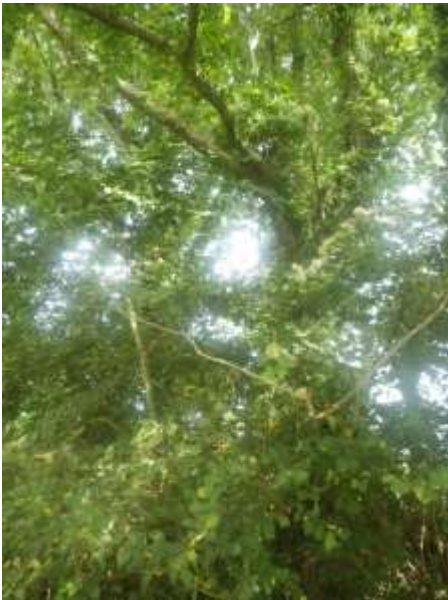
Tree 9A:

1. **Unique ref no:** 9A
2. **Grid Ref:**
3. **Measurements:** Diameter of stem 1.5m (measured); Height 15m (est.); Spread 12m(est.)
4. **Species:** Probably *Ulmus Procera*

5. **Estimated Age:** 60 years
6. **Tree Form and Vigour:** Appears to be maiden tree, slight lean to south west probably to seek light, large lower limb also growing in south west direction, active live growth

12. **Potential threats:** Nil biological observed other than general points noted in main text. Lean probably caused by large lower limbs seeking light to south and west in dense canopy. Potential "sail" problem caused by ivy during strong winds.

13. **Management Recommendations:** Crown lift to approx. 5 metres.

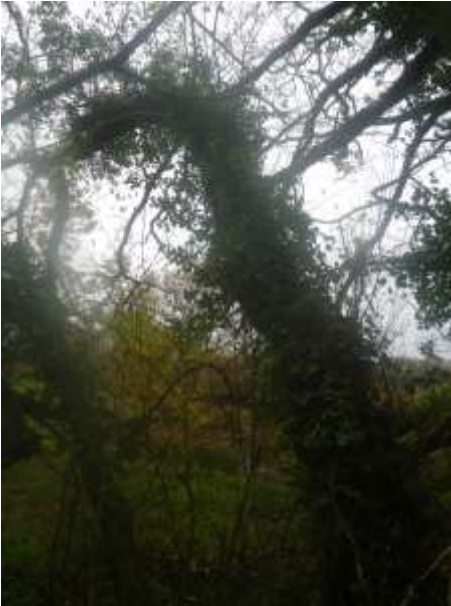
Tree 2B:

1. **Unique ref no:** 2B
2. **Grid Ref:**
3. **Measurements:** Diameter of stem 1.3m (measured); Height 8m (est.); Spread 15m(est.)
4. **Species:** Probably *Ulmus Procera*

5. **Estimated Age:** 60 years
6. **Tree Form and Vigour:** Appears to be maiden tree, very significant lean to east probably to seek light, active live growth in almost horizontal direction.

12. **Potential threats:** Nil biological observed other than general points noted in main text. Lean probably caused by large lower limbs seeking light to east in dense canopy. Potential “sail” problem caused by ivy during strong winds. Likely tree will fall to East in near future if left.

13. **Management Recommendations:** Lop to approx. 3 metres.

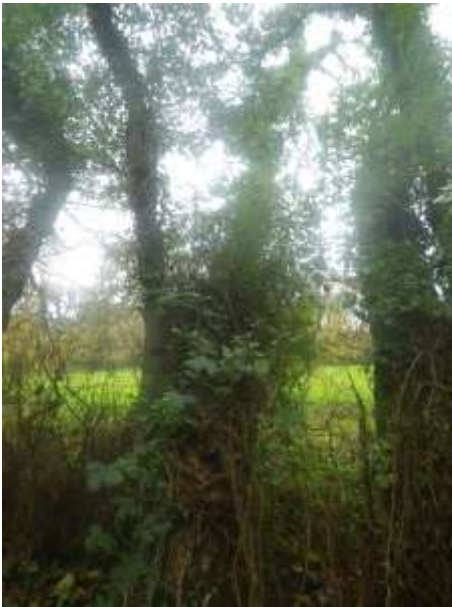
Tree 5B:

1. **Unique ref no:** 5B
2. **Grid Ref:**
3. **Measurements:** Diameter of stem 1.6m (measured); Height 6m (est.); Spread 14m(est.)
4. **Species:** Probably *Ulmus Procera*

5. **Estimated Age:** 70 years
6. **Tree Form and Vigour:** Appears to be maiden tree, very significant lean to east probably to seek light, active live growth

12. **Potential threats:** Nil biological observed other than general points noted in main text. Lean probably caused by main trunk seeking light to east in dense canopy. Potential "sail" problem caused by ivy during strong winds. Likely tree will shortly fall to east.

13. **Management Recommendations:** Lop at approx. 3 metres.

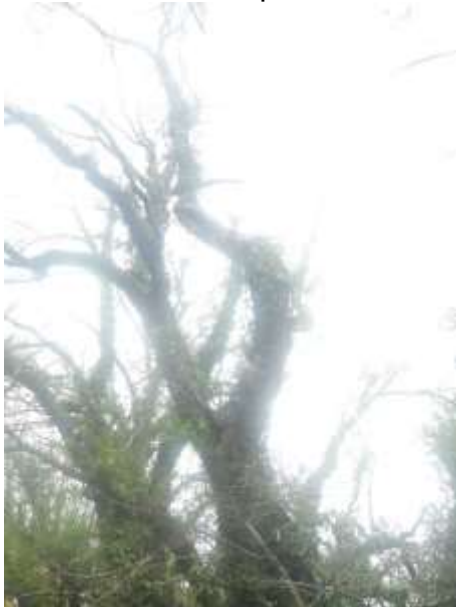
Tree 6B:

Medium bat roost potential

1. **Unique ref no:** 6B
2. **Grid Ref:**
3. **Measurements:** Diameter of stem 1.6m (measured); Height 17m (est.); Spread 14m(est.)
4. **Species:** Probably *Ulmus Procera*

5. **Estimated Age:** 70 years
6. **Tree Form and Vigour:** Appears to be maiden tree, slight lean to west probably to seek light, active live growth, old poorly healed wound evident approx. 6 metres up forming slight cavity, identified in bat survey

12. **Potential threats:** Nil biological observed other than general points noted in main text. Lean probably caused by main trunk seeking light to west in dense canopy. Potential "sail" problem caused by ivy during strong winds.

13. **Management Recommendations:** Minimal crown lift to approx. 5 metres, taking into consideration the recommendations for mitigating the risk to any potential bat roost.

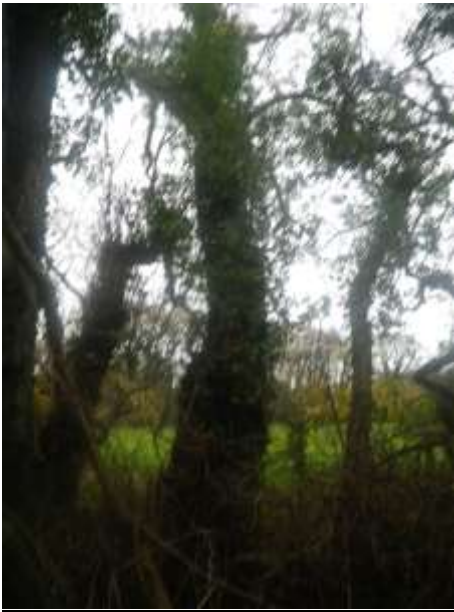
Tree 7B:

1. **Unique ref no:** 7B
2. **Grid Ref:**
3. **Measurements:** Diameter of stem 1.7m (measured); Height 17m (est.); Spread 12m(est.)
4. **Species:** Probably *Ulmus Procera*

5. **Estimated Age:** 80 years
6. **Tree Form and Vigour:** Appears to be maiden tree, lean to east probably to seek light, active live growth, significantly unbalanced towards east

13. **Management Recommendations:** Crown lift to approx. 5 metres.

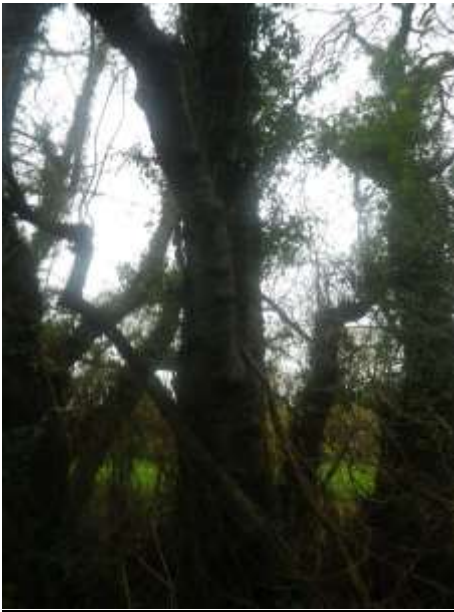
Tree 8B:

1. **Unique ref no:** 8B
2. **Grid Ref:**
3. **Measurements:** Diameter of stem 1.8m (measured); Height 18m (est.); Spread 14m(est.)
4. **Species:** Probably *Ulmus Procera*

5. **Estimated Age:** 80 years
6. **Tree Form and Vigour:** Appears to be maiden tree, good form, slight lean to west active live growth, some lower deadwood

13. **Management Recommendations:** Crown lift to approx. 5 metres, deadwood lower limbs

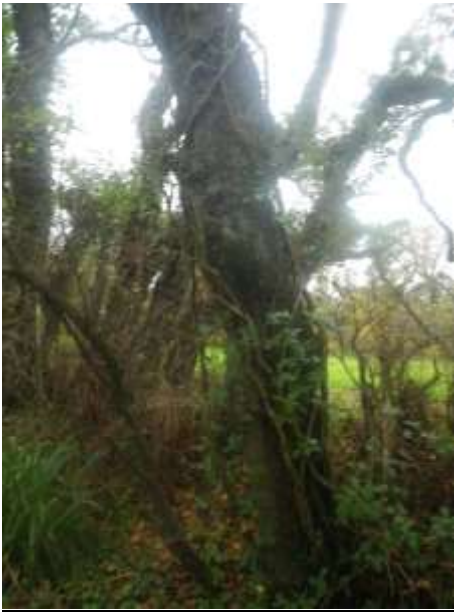
Tree 9B:

Bacidia incompta present

1. **Unique ref no:** 9B
2. **Grid Ref:**
3. **Measurements:** Diameter of stem 1.8m (measured); Height 18m (est.); Spread 14m(est.)
4. **Species:** Probably *Ulmus Procera*

5. **Estimated Age:** 80 years
6. **Tree Form and Vigour:** Appears to be maiden tree but possibly historic pollard at 3.5 metres, good form, slight lean to west probably to seek light, active live growth, some lower deadwood

13. **Management Recommendations:** Crown lift to approx. 5 metres, deadwood lower limbs, carefully remove ivy to encourage spread of *Bacidia incompta*

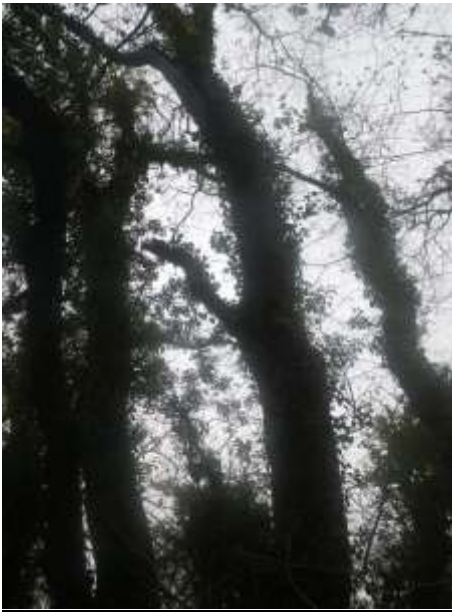
Tree 10B:

1. **Unique ref no:** 10B
2. **Grid Ref:**
3. **Measurements:** Diameter of stem 1.7m (measured); Height 18m (est.); Spread 14m(est.)
4. **Species:** Probably *Ulmus Procera*

5. **Estimated Age:** 80 years
6. **Tree Form and Vigour:** Appears to be maiden tree, slight lean to west probably to seek light, active live growth, old poorly healed wound evident approx. 6 metres up forming cavity, some lower deadwood

13. **Management Recommendations:** Crown lift to approx. 5 metres., deadwood lower branches

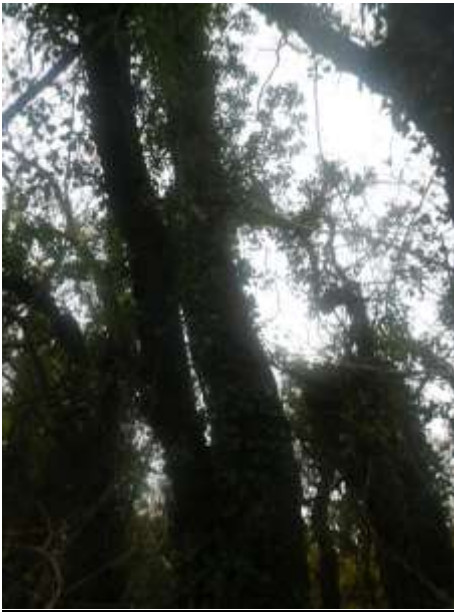
Tree 11B:

1. **Unique ref no:** 11B
2. **Grid Ref:**
3. **Measurements:** Diameter of stem 1.7m (measured); Height 18m (est.); Spread 14m(est.)
4. **Species:** Probably *Ulmus Procera*

5. **Estimated Age:** 80 years
6. **Tree Form and Vigour:** Appears to be maiden tree, slight lean to west probably to seek light, active live growth, old poorly healed wound evident approx. 6 metres up forming cavity, some lower deadwood

13. **Management Recommendations:** Crown lift to approx. 5 metres., deadwood lower branches

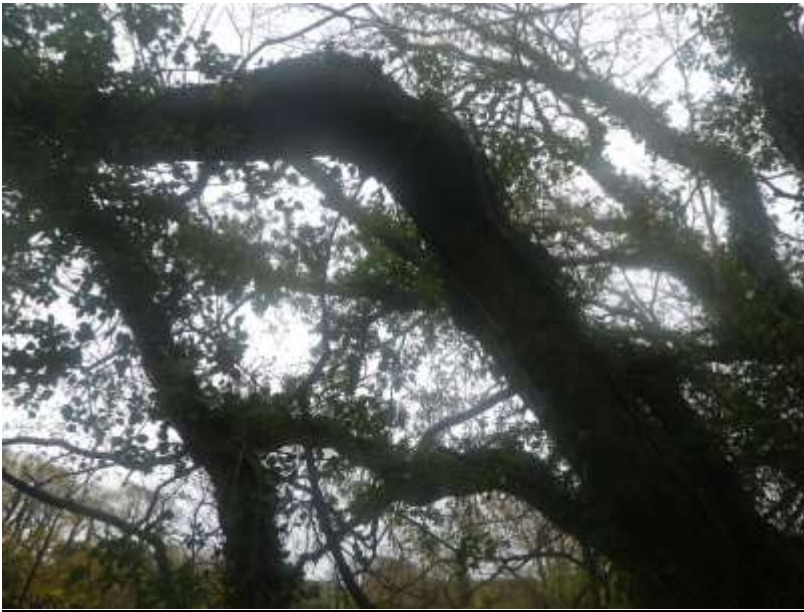
Tree 12B:

1. **Unique ref no:** 12B
2. **Grid Ref:**
3. **Measurements:** Diameter of stem 1.3m (measured); Height 3m (est.); Spread 14m(est.)
4. **Species:** Probably *Ulmus Procera*

5. **Estimated Age:** 50 years
6. **Tree Form and Vigour:** Appears to be maiden tree, very significant lean to west probably to seek light, active live growth, some lower deadwood

13. **Management Recommendations:** Crown lift to approx. 5 metres., deadwood lower branches

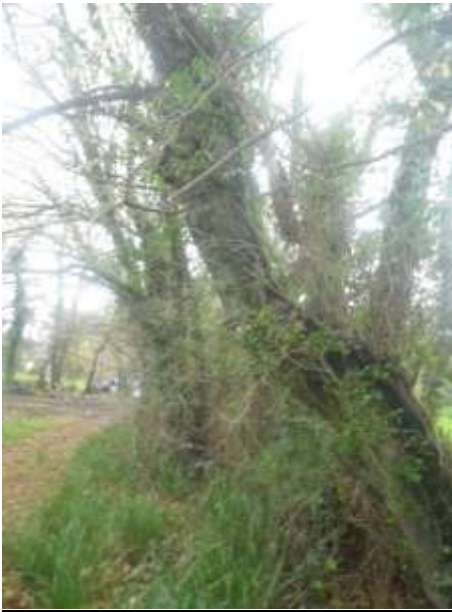
Tree 13B:

1. **Unique ref no:** 13B
2. **Grid Ref:**
3. **Measurements:** Diameter of stem 1.6m (measured); Height 18m (est.); Spread 14m(est.)
4. **Species:** Probably *Ulmus Procera*

5. **Estimated Age:** 70 years
6. **Tree Form and Vigour:** Appears to be maiden tree, significant lean to west probably to seek light, active live growth, some lower deadwood

13. **Management Recommendations:** Crown lift to approx. 5 metres., deadwood lower branches

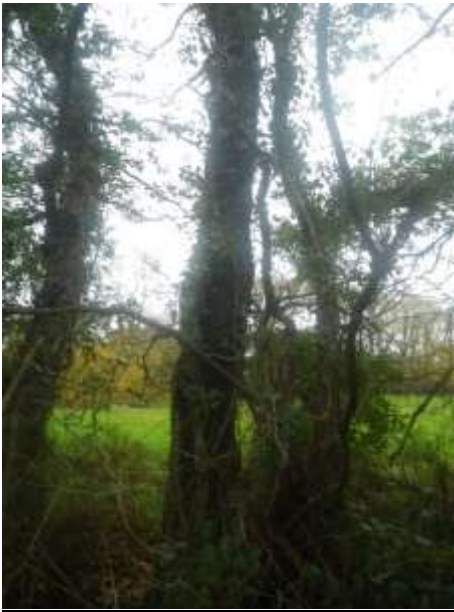
Tree 14B:

1. **Unique ref no:** 14B
2. **Grid Ref:**
3. **Measurements:** Diameter of stem 1.4m (measured); Height 18m (est.); Spread 14m(est.)
4. **Species:** Probably *Ulmus Procera*

5. **Estimated Age:** 50 years
6. **Tree Form and Vigour:** Appears to be maiden tree, lean to east probably to seek light, active live growth, some lower deadwood

13. **Management Recommendations:** Crown lift to approx. 5 metres., deadwood lower branches

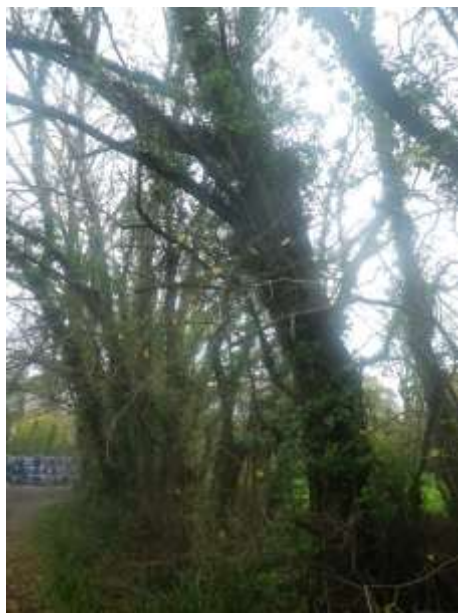
Tree 15B:

Bacidia incompta present

1. **Unique ref no:** 15B
2. **Grid Ref:**
3. **Measurements:** Diameter of stem 1.7m (measured); Height 16m (est.); Spread 14m(est.)
4. **Species:** Probably *Ulmus Procera*

5. **Estimated Age:** 80 years
6. **Tree Form and Vigour:** Possibly historic pollard, knuckle now well formed, slight lean to west probably to seek light, active live growth, old poorly healed wound evident approx. 3 metres up forming cavity, some lower deadwood

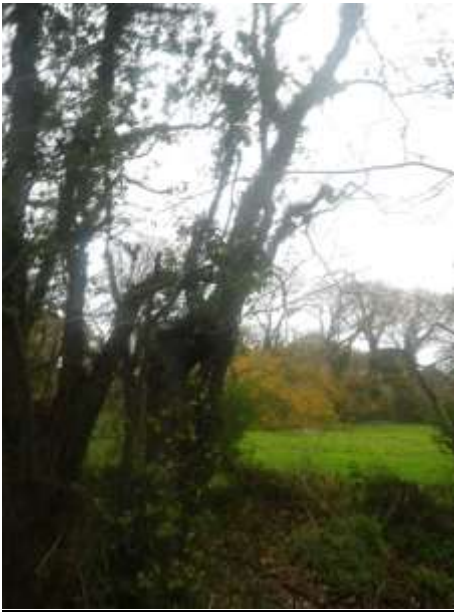
Tree 16B:

1. **Unique ref no:** 16B
2. **Grid Ref:**
3. **Measurements:** Diameter of stem 1.0m (measured); Height 5m (est.); Spread 14m(est.)
4. **Species:** Probably *Ulmus Procera*

5. **Estimated Age:** 30 years
6. **Tree Form and Vigour:** Appears to be maiden tree, significant lean to east probably to seek light, active live growth, some lower deadwood, showing lack vigour

12. **Potential threats:** Nil biological observed other than general points noted in main text. Lean probably caused by main trunk seeking light to east in dense canopy. Potential "sail" problem caused by ivy during strong winds.

13. **Management Recommendations:** Lop to approx. 3 metres

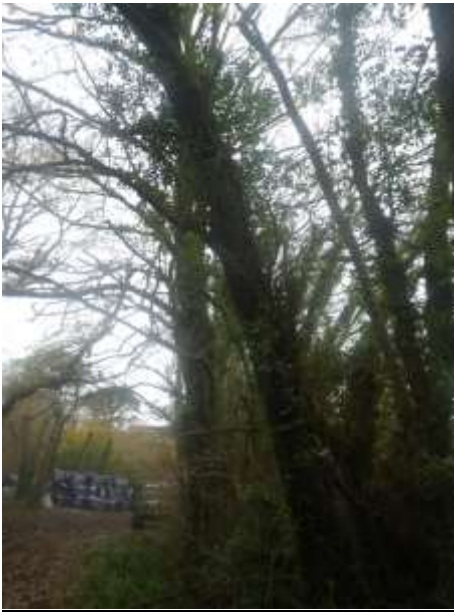
Tree 17B:

1. **Unique ref no:** 17B
2. **Grid Ref:**
3. **Measurements:** Diameter of stem 1.3m (measured); Height 13m (est.); Spread 10m(est.)
4. **Species:** Probably *Ulmus Procera*

5. **Estimated Age:** 60 years
6. **Tree Form and Vigour:** Appears to be maiden tree, slight lean to west probably to seek light, active live growth, some lower deadwood

12. **Potential threats:** Nil biological observed other than general points noted in main text. Lean probably caused by main trunk seeking light to west in dense canopy. Potential "sail" problem caused by ivy during strong winds.

13. **Management Recommendations:** Crown lift to approx. 5 metres., deadwood lower branches

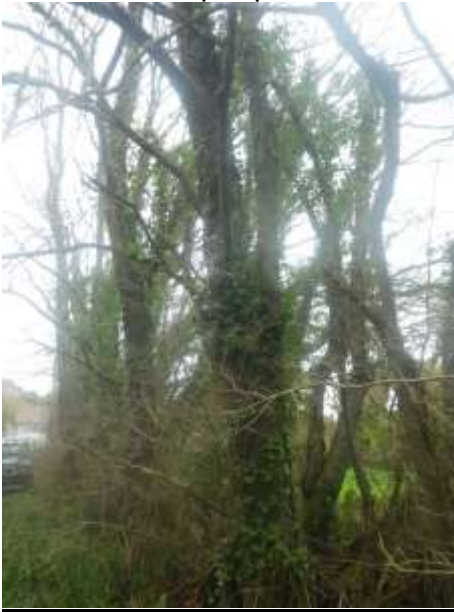
Tree 18B:

Bacidia incompta present

1. **Unique ref no:** 18B
2. **Grid Ref:**
3. **Measurements:** Diameter of stem 1.6m (measured); Height 18m (est.); Spread 14m(est.)
4. **Species:** Probably *Ulmus Procera*

5. **Estimated Age:** 70 years
6. **Tree Form and Vigour:** Appears to be maiden tree, slight lean to west probably to seek light, active live growth, significant deadwood to west

7. **Tree associates:** Ivy growing freely over tree; some evidence of historic bird nesting within ivy. *Bacidia incompta* noted by lichen survey.
8. **Relationship to landscape features:** hedgerow tree

12. **Potential threats:** Nil biological observed other than general points noted in main text. Lean probably caused by main trunk seeking light to west in dense canopy. Potential "sail" problem caused by ivy during strong winds.

13. **Management Recommendations:** Crown lift to approx. 5 metres, deadwood lower branches, carefully remove ivy to encourage spread of *Bacidia incompta*.

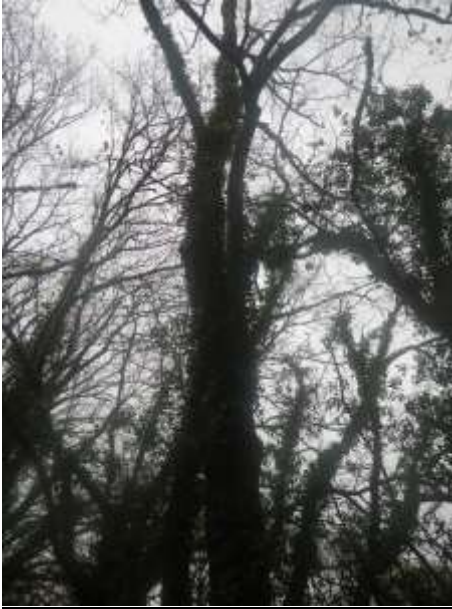
Tree 19B:

1. **Unique ref no:** 19B
2. **Grid Ref:**
3. **Measurements:** Diameter of stem 1.6m (measured); Height 18m (est.); Spread 14m(est.)
4. **Species:** Probably *Ulmus Procera*

5. **Estimated Age:** 70 years
6. **Tree Form and Vigour:** Appears to be maiden tree, slight lean to west probably to seek light, active live growth, some lower deadwood, large lateral limb growing to south west

12. **Potential threats:** Nil biological observed other than general points noted in main text. Lean probably caused by main trunk seeking light to west in dense canopy and exacerbated by large lateral limb growing to south west. Potential "sail" problem caused by ivy during strong winds.

13. **Management Recommendations:** Crown lift to approx. 5 metres., deadwood lower branches

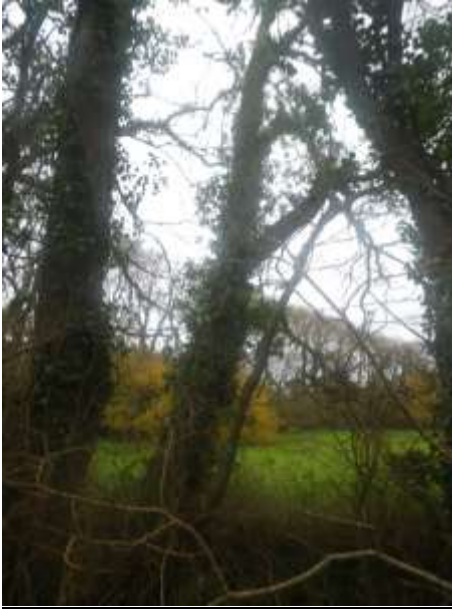
Tree 20B:

1. **Unique ref no:** 20B
2. **Grid Ref:**
3. **Measurements:** Diameter of stem 1.3m (measured); Height 16m (est.); Spread 12m(est.)
4. **Species:** Probably *Ulmus Procera*

5. **Estimated Age:** 40 years
6. **Tree Form and Vigour:** Appears to be maiden tree, significant lean to east probably to seek light, active live growth, some lower deadwood

12. **Potential threats:** Nil biological observed other than general points noted in main text. Lean probably caused by main trunk seeking light to east in dense canopy. Significant lateral branches exacerbating lean to east. Potential "sail" problem caused by ivy during strong winds.

13. **Management Recommendations:** Crown lift to approx. 5 metres., deadwood lower branches

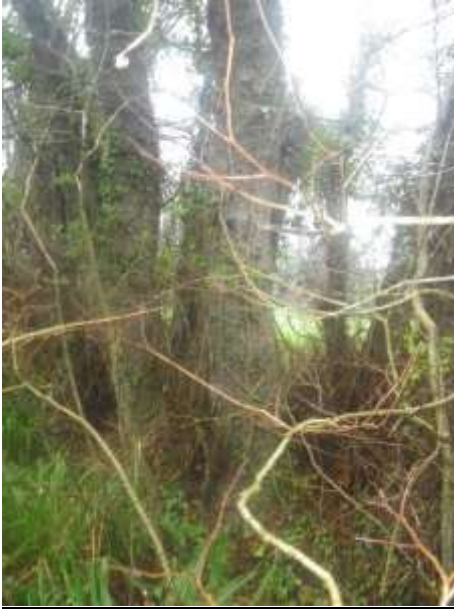
Tree 21B:

1. **Unique ref no:** 21B
2. **Grid Ref:**
3. **Measurements:** Diameter of stem 1.2m (measured); Height 16m (est.); Spread 14m(est.)
4. **Species:** Probably *Ulmus Procera*
5. **Estimated Age:** 40 years
6. **Tree Form and Vigour:** Appears to be maiden tree, upright and nice form, active live growth, some lower deadwood
7. **Tree associates:** Some ivy growth over tree
8. **Relationship to landscape features:** hedgerow tree
9. **Photographic record above.**
10. **Evidence of previous management works:** None evident
11. **Nil additional historic/ cultural value associated with tree.**
12. **Potential threats:** Nil biological observed other than general points noted in main text. Potential "sail" problem caused by ivy during strong winds.
13. **Management Recommendations:** Crown lift to approx. 5 metres., deadwood lower branches

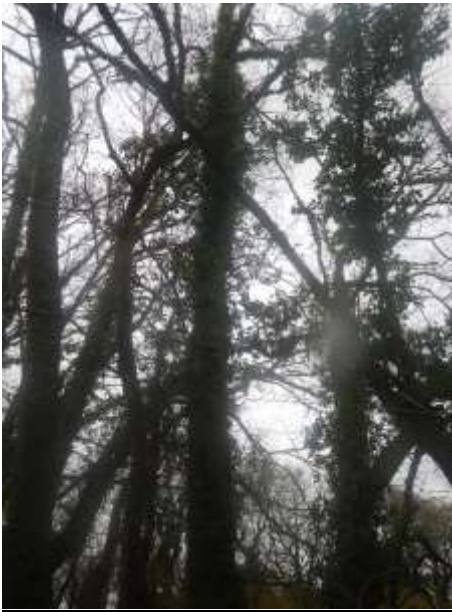
Tree 22B:

1. **Unique ref no:** 22B
2. **Grid Ref:**
3. **Measurements:** Diameter of stem 1.2m (measured); Height 18m (est.); Spread 14m(est.)
4. **Species:** Probably *Ulmus Procera*
5. **Estimated Age:** 40 years
6. **Tree Form and Vigour:** Appears to be maiden tree, upright growth, some lower deadwood especially to west
7. **Tree associates:** Ivy growing freely over tree; some evidence of historic bird nesting within ivy.
8. **Relationship to landscape features:** hedgerow tree
9. **Photographic record above.**
10. **Evidence of previous management works:** None evident
11. **Nil additional historic/ cultural value associated with tree.**
12. **Potential threats:** Nil biological observed other than general points noted in main text. Potential "sail" problem caused by ivy during strong winds.
13. **Management Recommendations:** Crown lift to approx. 5 metres., deadwood lower branches

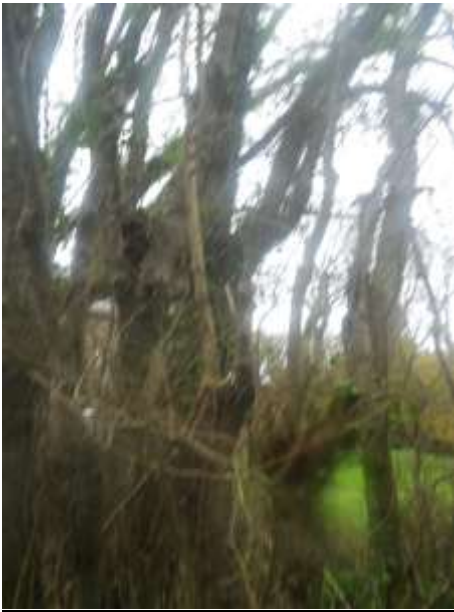
Tree 23B:

1. **Unique ref no:** 23B
2. **Grid Ref:**
3. **Measurements:** Diameter of stem 1.4m (measured); Height 16m (est.); Spread 10m(est.)
4. **Species:** Probably *Ulmus Procera*

5. **Estimated Age:** 40 years
6. **Tree Form and Vigour:** Appears to have been historically lopped, significant multi co-dominant regrowth, active growth, lean to east

12. **Potential threats:** Nil biological observed other than general points noted in main text. Potential "sail" problem caused by ivy during strong winds. Large cavity around old lop may cause additional rotting

13. **Management Recommendations:** Crown lift to approx. 5 metres., deadwood lower branches especially to east

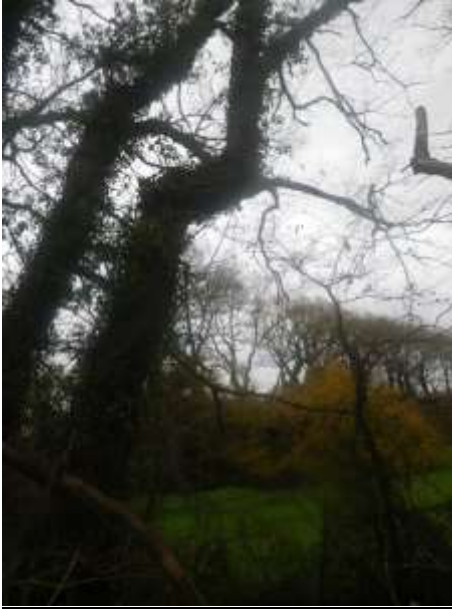
Tree 24B:

1. **Unique ref no:** 24B
2. **Grid Ref:**
3. **Measurements:** Diameter of stem 1.2m (measured); Height 18m (est.); Spread 14m(est.)
4. **Species:** Probably *Ulmus Procera*

5. **Estimated Age:** 40 years
6. **Tree Form and Vigour:** Appears to be maiden tree, significant lean to east probably to seek light, active live growth, some lower deadwood, two significant lateral limbs growing to east

12. **Potential threats:** Nil biological observed other than general points noted in main text. Lean probably caused by main trunk seeking light to east in dense canopy. Potential "sail" problem caused by ivy during strong winds.

13. **Management Recommendations:** Crown lift to approx. 5 metres., deadwood lower branches, remove large limbs to east

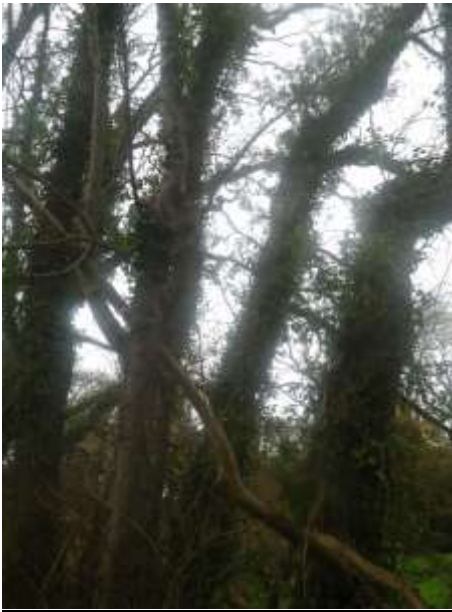
Tree 25B:

1. **Unique ref no:** 25B
2. **Grid Ref:**
3. **Measurements:** Diameter of stem 1.2m (measured); Height 16m (est.); Spread 12m(est.)
4. **Species:** Probably *Ulmus Procera*

5. **Estimated Age:** 40 years
6. **Tree Form and Vigour:** Appears to be maiden tree, slight lean to east probably to seek light, active live growth, some lower deadwood

12. **Potential threats:** Nil biological observed other than general points noted in main text. Lean probably caused by main trunk seeking light to east in dense canopy. Potential "sail" problem caused by ivy during strong winds.

13. **Management Recommendations:** Crown lift to approx. 5 metres., deadwood lower branches

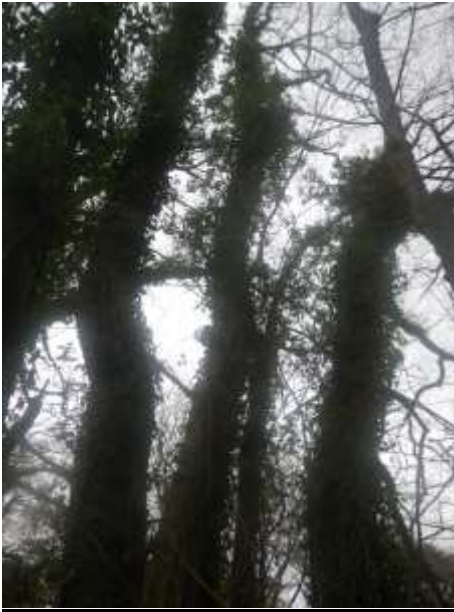
Tree 26B:

1. **Unique ref no:** 26B
2. **Grid Ref:**
3. **Measurements:** Diameter of stem 1.3m (measured); Height 18m (est.); Spread 14m(est.)
4. **Species:** Probably *Ulmus Procera*

5. **Estimated Age:** 40 years
6. **Tree Form and Vigour:** Appears to be maiden tree, upright, slight lean to west probably to seek light, active live growth, some lower deadwood

12. **Potential threats:** Nil biological observed other than general points noted in main text. Potential "sail" problem caused by ivy during strong winds.

13. **Management Recommendations:** Crown lift to approx. 5 metres., deadwood lower branches

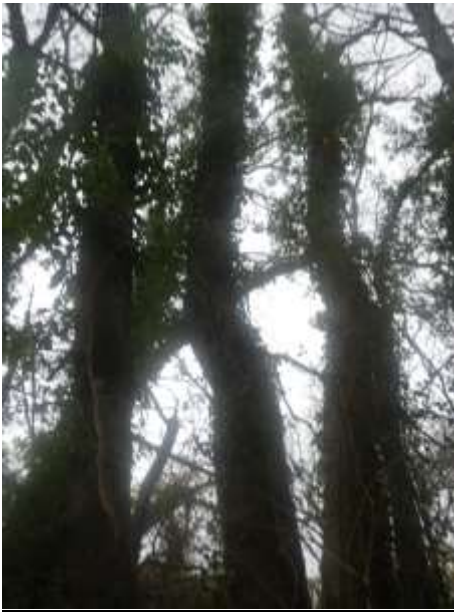
Tree 27B:

1. **Unique ref no:** 27B
2. **Grid Ref:**
3. **Measurements:** Diameter of stem 1.3m (measured); Height 18m (est.); Spread 14m(est.)
4. **Species:** Probably *Ulmus Procera*

5. **Estimated Age:** 40 years
6. **Tree Form and Vigour:** Appears to be maiden tree, upright, slight lean to west probably to seek light, active live growth, some lower deadwood

12. **Potential threats:** Nil biological observed other than general points noted in main text. Potential "sail" problem caused by ivy during strong winds.

13. **Management Recommendations:** Crown lift to approx. 5 metres., deadwood lower branches

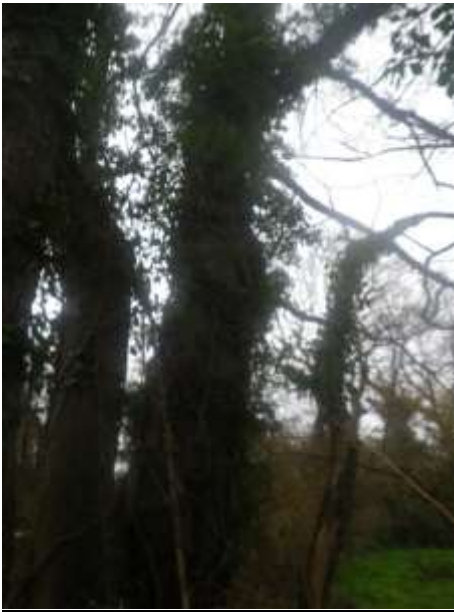
Tree 28B:

1. **Unique ref no:** 28B
2. **Grid Ref:**
3. **Measurements:** Diameter of stem 1.6m (measured); Height 18m (est.); Spread 14m(est.)
4. **Species:** Probably *Ulmus Procera*

5. **Estimated Age:** 70 years
6. **Tree Form and Vigour:** Appears to be maiden tree, upright, slight lean to east probably to seek light, active live growth, some lower deadwood, stem appears to be formed from two trees growing and fusing together

12. **Potential threats:** Nil biological observed other than general points noted in main text. Potential "sail" problem caused by ivy during strong winds.

13. **Management Recommendations:** Crown lift to approx. 5 metres., deadwood lower branches

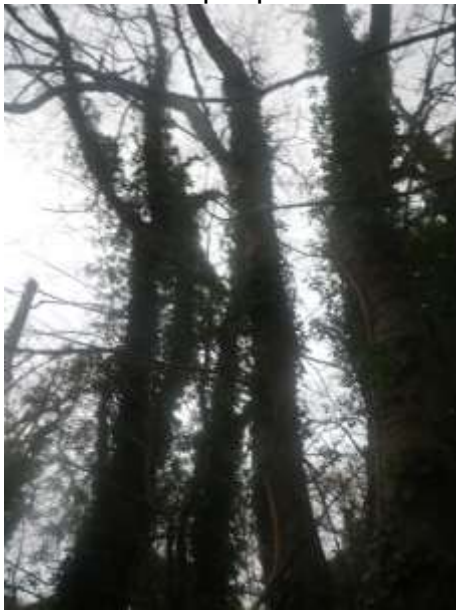
Tree 29B:

Bacidia incompta present

1. **Unique ref no:** 29B
2. **Grid Ref:**
3. **Measurements:** Diameter of stem 1.3m (measured); Height 18m (est.); Spread 14m(est.)
4. **Species:** Probably Ulmus Procera

5. **Estimated Age:** 40 years
6. **Tree Form and Vigour:** Appears to be maiden tree, upright, some lower deadwood, damage to limb growing to west
7. **Tree associates:** Ivy growing freely over tree; some evidence of historic bird nesting within ivy. *Bacidia incompta* noted by lichen survey.

12. **Potential threats:** Nil biological observed other than general points noted in main text. Potential "sail" problem caused by ivy during strong winds.

13. **Management Recommendations:** Crown lift to approx. 5 metres, deadwood lower branches, remove damaged limb

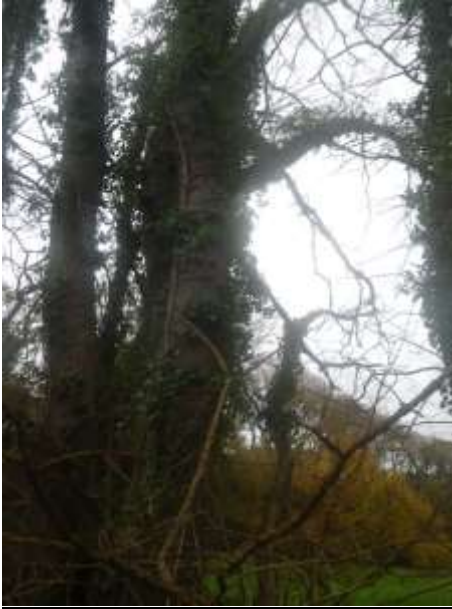
Tree 30B:

1. **Unique ref no:** 30B
2. **Grid Ref:**
3. **Measurements:** Diameter of stem 1.3m (measured); Height 18m (est.); Spread 14m(est.)
4. **Species:** Probably *Ulmus Procera*

5. **Estimated Age:** 40 years
6. **Tree Form and Vigour:** Appears to be maiden tree, upright, active live growth, some lower deadwood, lower limbs growing to east

12. **Potential threats:** Nil biological observed other than general points noted in main text. Potential "sail" problem caused by ivy during strong winds.

13. **Management Recommendations:** Crown lift to approx. 5 metres, deadwood lower branches, remove lower limbs to east

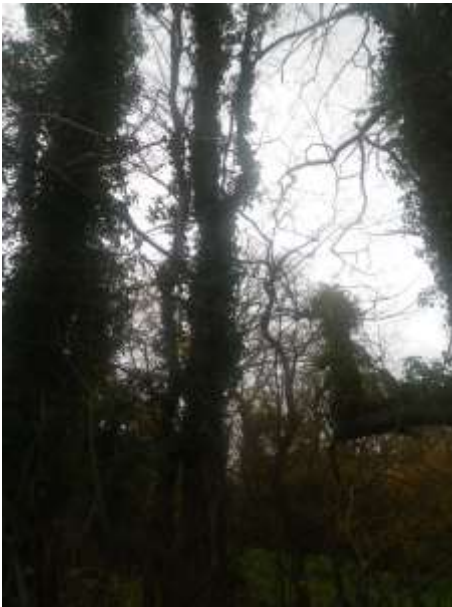
Tree 31B:

1. **Unique ref no:** 31B
2. **Grid Ref:**
3. **Measurements:** Diameter of stem 0.9m (measured); Height 18m (est.); Spread 14m(est.)
4. **Species:** Probably *Ulmus Procera*
5. **Estimated Age:** 30 years
6. **Tree Form and Vigour:** Appears to be maiden tree, upright, very thin, some lower deadwood
7. **Tree associates:** Ivy growing freely over tree; some evidence of historic bird nesting within ivy.
8. **Relationship to landscape features:** hedgerow tree
9. **Photographic record above.**
10. **Evidence of previous management works:** None evident
11. **Nil additional historic/ cultural value associated with tree.**
12. **Potential threats:** Nil biological observed other than general points noted in main text. Potential "sail" problem caused by ivy during strong winds.
13. **Management Recommendations:** Crown lift to approx. 5 metres., deadwood lower branches

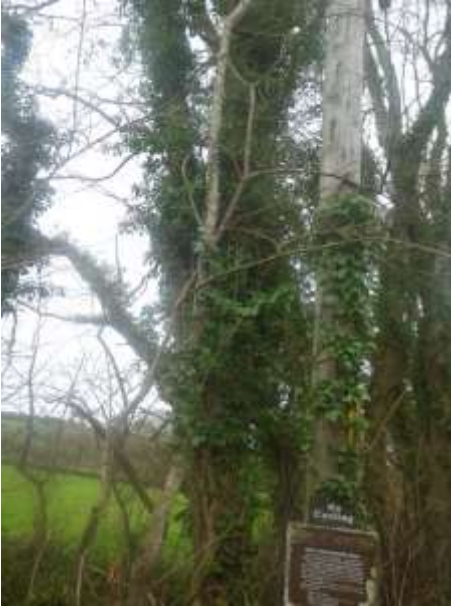
Tree 32B:

1. **Unique ref no:** 32B
2. **Grid Ref:**
3. **Measurements:** Diameter of stem 1.3m (measured); Height 18m (est.); Spread 14m(est.)
4. **Species:** Probably *Ulmus Procera*

5. **Estimated Age:** 50 years
6. **Tree Form and Vigour:** Appears to be maiden tree, two co-dominant stems, upright, active live growth, some lower deadwood, large limb to west

12. **Potential threats:** Nil biological observed other than general points noted in main text. Potential "sail" problem caused by ivy during strong winds.

13. **Management Recommendations:** Crown lift to approx. 5 metres., deadwood lower branches, remove lower limb to west

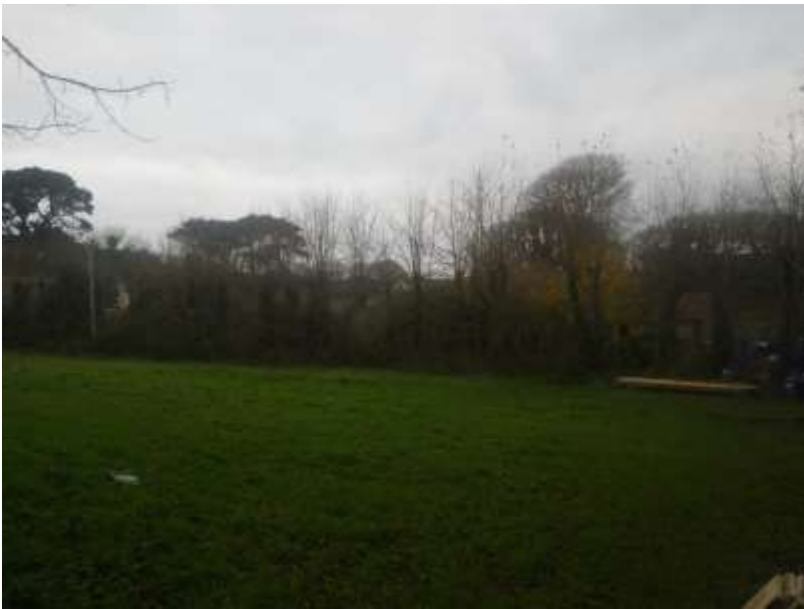
This is a number of mature hedgerow specimens growing along a boundary running approximately north/ south, and bordering a field to the west and a garden to the east. The trees have been surveyed starting at the southern end of the row. The FEP identified 29 trees which require major tree surgery along this row. The entire row of trees has been pollarded to approximately four metres within the last five years, and as a result, there is significant and dense epicormic and peripheral regrowth.

Fig 1.8 Elm row C viewed from west looking east

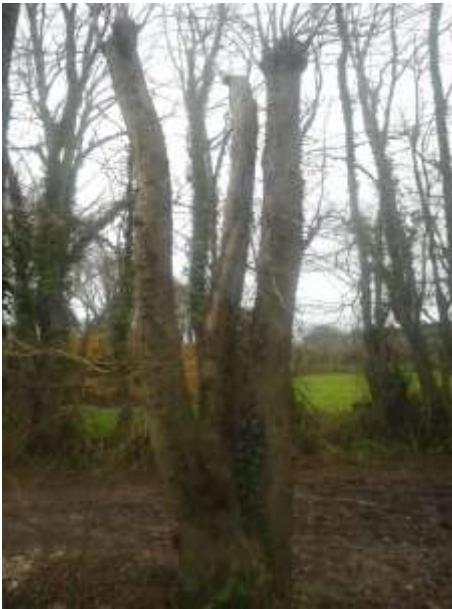
Tree 1C:

1. **Unique ref no:** 1C
2. **Grid Ref:**
3. **Measurements:** Diameter of stem 2.6m (measured); Height 7m (est.); Spread 5m(est.)
4. **Species:** Probably *Ulmus Procera*
5. **Estimated Age:** 90 years
6. **Tree Form and Vigour:** three co-dominant stems, possible from historic pollard at approx. 1.5 metres, upright, active live growth, recent pollard at approx. 4m, significant epicormics growth
7. **Tree associates:** Ivy growing sparsely over tree
8. **Relationship to landscape features:** hedgerow tree
9. **Photographic record above.**

10. Evidence of previous management works: Possible two historic pollard positions

12. Potential threats: Nil biological observed other than general points noted in main text.

13. Management Recommendations: Re-pollard above old wounds

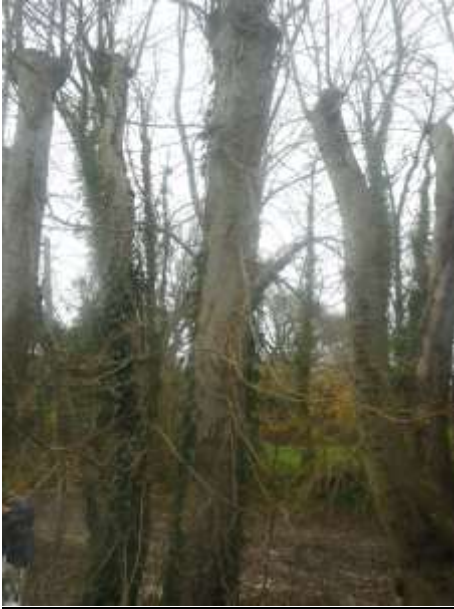
Tree 2C:

1. Unique ref no: 2C

12. Potential threats: Nil biological observed other than general points noted in main text.

13. Management Recommendations: Re-pollard above old wounds

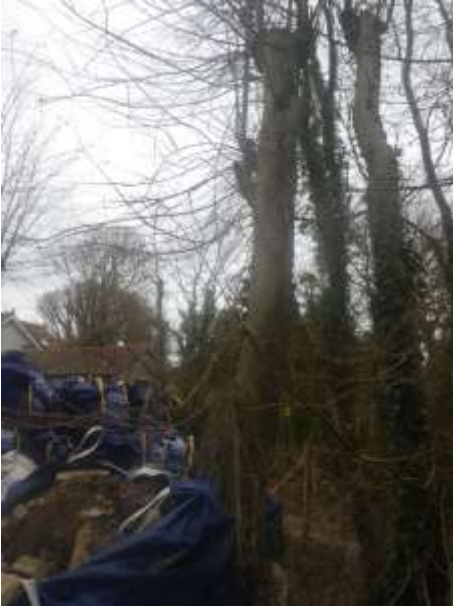
Tree 4C:

1. **Unique ref no:** 4C
2. **Grid Ref:**
3. **Measurements:** Diameter of stem 1.2m (measured); Height 7m (est.); Spread 5m(est.)
4. **Species:** Probably *Ulmus Procera*
5. **Estimated Age:** 60 years
6. **Tree Form and Vigour:** upright, active live growth, recent pollard at approx. 4m, significant epicormics growth
7. **Tree associates:** Ivy growing sparsely over tree
8. **Relationship to landscape features:** hedgerow tree
9. **Photographic record above.**
10. **Evidence of previous management works:** One recent pollard point evident
11. **Nil additional historic/ cultural value associated with tree.**
12. **Potential threats:** Nil biological observed other than general points noted in main text.
13. **Management Recommendations:** Re-pollard above old wounds

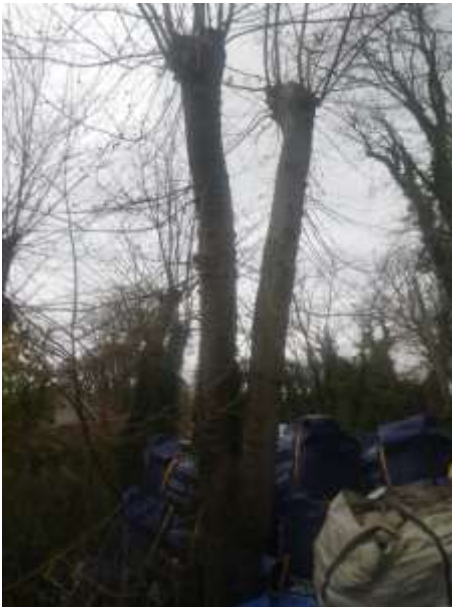
Tree 5C:

1. **Unique ref no:** 5C
2. **Grid Ref:**
3. **Measurements:** Diameter of stem 1.6m (measured); Height 7m (est.); Spread 5m(est.)
4. **Species:** Probably *Ulmus Procera*
5. **Estimated Age:** 70 years
6. **Tree Form and Vigour:** two co-dominant stems, possible from historic pollard at approx. 1.5 metres, upright, active live growth, recent pollard at approx. 4m, significant epicormics growth
7. **Tree associates:** Ivy growing sparsely over tree
8. **Relationship to landscape features:** hedgerow tree
9. **Photographic record above.**
10. **Evidence of previous management works:** Possible two historic pollard positions
11. **Nil additional historic/ cultural value associated with tree.**
12. **Potential threats:** Nil biological observed other than general points noted in main text.
13. **Management Recommendations:** Re-pollard above old wounds

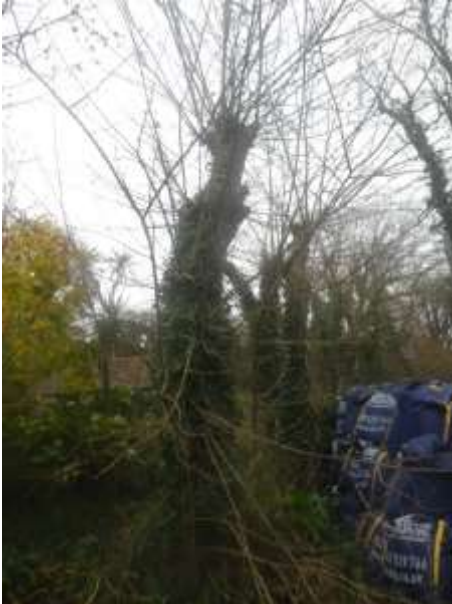
Tree 6C:

1. **Unique ref no:** 6C
2. **Grid Ref:**
3. **Measurements:** Diameter of stem 2.2m (measured); Height 7m (est.); Spread 5m(est.)
4. **Species:** Probably Ulmus Procera
5. **Estimated Age:** 90 years
6. **Tree Form and Vigour:** upright, active live growth, recent pollard at approx. 4m, significant epicormics growth
7. **Tree associates:** Ivy growing sparsely over tree
8. **Relationship to landscape features:** hedgerow tree
9. **Photographic record above.**
10. **Evidence of previous management works:** One historic pollard position evident
11. **Nil additional historic/ cultural value associated with tree.**
12. **Potential threats:** Nil biological observed other than general points noted in main text.
13. **Management Recommendations:** Re-pollard above old wounds

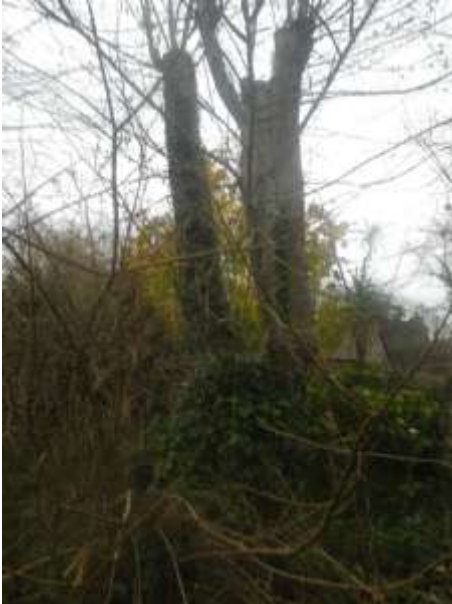
Tree 7C:

1. **Unique ref no:** 7C
2. **Grid Ref:**
3. **Measurements:** Diameter of stem 3.7m (measured); Height 7m (est.); Spread 5m(est.)
4. **Species:** Probably *Ulmus Procera*
5. **Estimated Age:** 100 years+
6. **Tree Form and Vigour:** four co-dominant stems, possible from historic pollard at approx. 1.5 metres, upright, active live growth, recent pollard at approx. 4m, significant epicormics growth
7. **Tree associates:** Ivy growing sparsely over tree
8. **Relationship to landscape features:** hedgerow tree
9. **Photographic record above.**
10. **Evidence of previous management works:** Possible two historic pollard positions
11. **Nil additional historic/ cultural value associated with tree.**
12. **Potential threats:** Nil biological observed other than general points noted in main text.
13. **Management Recommendations:** Re-pollard above old wounds

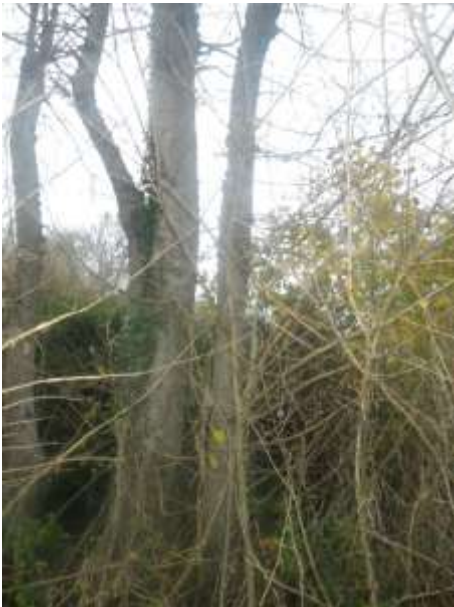
Tree 8C:

1. **Unique ref no:** 8C
2. **Grid Ref:**
3. **Measurements:** Diameter of stem 2.9m (measured); Height 7m (est.); Spread 5m(est.)
4. **Species:** Probably *Ulmus Procera*
5. **Estimated Age:** 100 years+
6. **Tree Form and Vigour:** four co-dominant stems, possible from historic pollard at hedge height, upright, active live growth, recent pollard at approx. 4m, significant epicormic growth
7. **Tree associates:** Ivy growing sparsely over tree
8. **Relationship to landscape features:** hedgerow tree
9. **Photographic record above.**
10. **Evidence of previous management works:** Possible two historic pollard positions
11. **Nil additional historic/ cultural value associated with tree.**
12. **Potential threats:** Nil biological observed other than general points noted in main text.
13. **Management Recommendations:** Re-pollard above old wounds

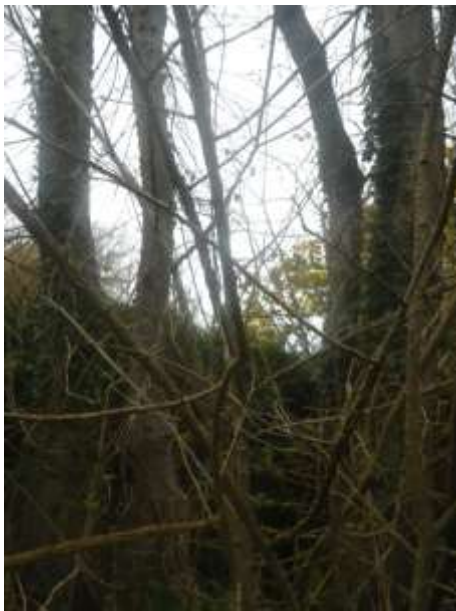
Tree 9C:

1. **Unique ref no:** 8C
2. **Grid Ref:**
3. **Measurements:** Diameter of stem 0.9m (measured); Height 7m (est.); Spread 5m(est.)
4. **Species:** Probably *Ulmus Procera*
5. **Estimated Age:** 40 years
6. **Tree Form and Vigour:** upright, active live growth, recent pollard at approx. 4m, significant epicormic growth
7. **Tree associates:** Ivy growing sparsely over tree
8. **Relationship to landscape features:** hedgerow tree
9. **Photographic record above.**
10. **Evidence of previous management works:** One historic pollard point evident
11. **Nil additional historic/ cultural value associated with tree.**
12. **Potential threats:** Nil biological observed other than general points noted in main text.
13. **Management Recommendations:** Re-pollard above old wounds
