HOLY VALE TREE SURVEY

For works under Natural England Higher
Level Stewardship AG00596391

Written by Matthew Rogers B.A. (Hons.), NPTC
City and Guilds Level 3 Arboriculture

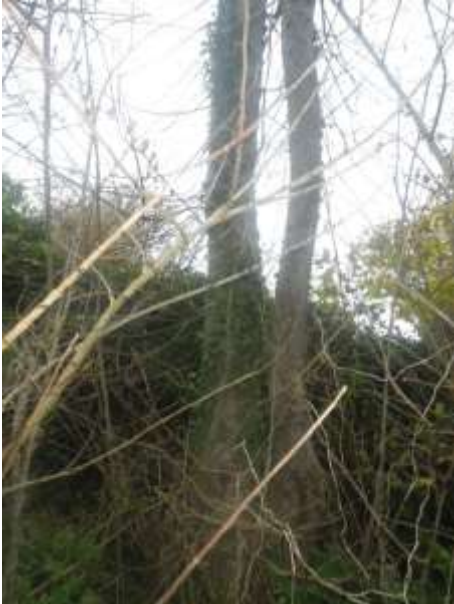
Tree 10C:

1. **Unique ref no:** 10C
2. **Grid Ref:**
3. **Measurements:** Diameter of stem 1.0m (measured); Height 7m (est.); Spread 5m(est.)
4. **Species:** Probably *Ulmus Procera*
5. **Estimated Age:** 40 years
6. **Tree Form and Vigour:** upright, active live growth, recent pollard at approx. 4m, significant epicormics growth
7. **Tree associates:** Ivy growing sparsely over tree
8. **Relationship to landscape features:** hedgerow tree
9. **Photographic record above.**
10. **Evidence of previous management works:** One historic pollard position evident
11. **Nil additional historic/ cultural value associated with tree.**
12. **Potential threats:** Nil biological observed other than general points noted in main text.
13. **Management Recommendations:** Re-pollard above old wounds

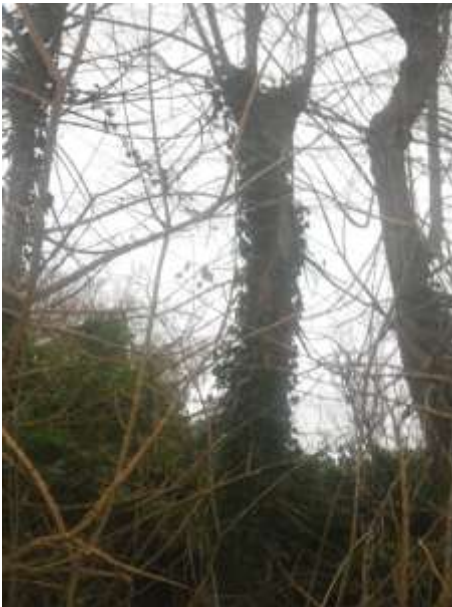
Tree 11C:

1. **Unique ref no:** 11C
2. **Grid Ref:**
3. **Measurements:** Diameter of stem 0.9m (measured); Height 7m (est.); Spread 5m(est.)
4. **Species:** Probably *Ulmus Procera*
5. **Estimated Age:** 40 years
6. **Tree Form and Vigour:** upright, active live growth, recent pollard at approx. 4m, significant epicormic growth
7. **Tree associates:** Ivy growing sparsely over tree
8. **Relationship to landscape features:** hedgerow tree
9. **Photographic record above.**
10. **Evidence of previous management works:** One historic pollard position evident
11. **Nil additional historic/ cultural value associated with tree.**
12. **Potential threats:** Nil biological observed other than general points noted in main text.
13. **Management Recommendations:** Re-pollard above old wounds

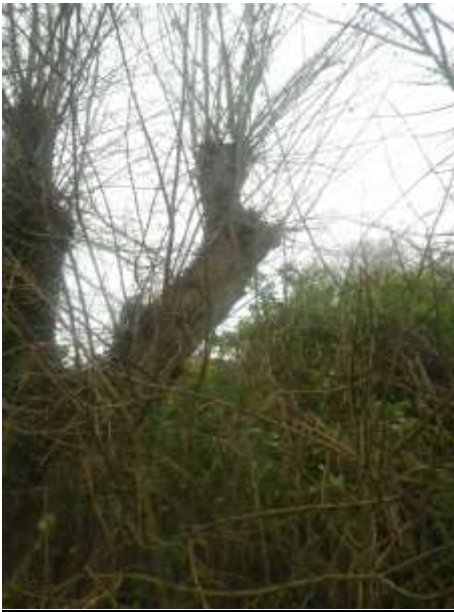
Tree 12C:

1. **Unique ref no:** 12C
2. **Grid Ref:**
3. **Measurements:** Diameter of stem 2.1m (measured); Height 7m (est.); Spread 5m(est.)
4. **Species:** Probably *Ulmus Procera*
5. **Estimated Age:** 90 years
6. **Tree Form and Vigour:** lean to east, significant scarring from previous removal of branches, active live growth, recent pollard at approx. 4m, significant epicormic growth
7. **Tree associates:** Ivy growing sparsely over tree
8. **Relationship to landscape features:** hedgerow tree
9. **Photographic record above.**
10. **Evidence of previous management works:** One historic pollard position evident, historic scarring from limb removal
11. **Nil additional historic/ cultural value associated with tree.**
12. **Potential threats:** Nil biological observed other than general points noted in main text.
13. **Management Recommendations:** Re-pollard above old wounds

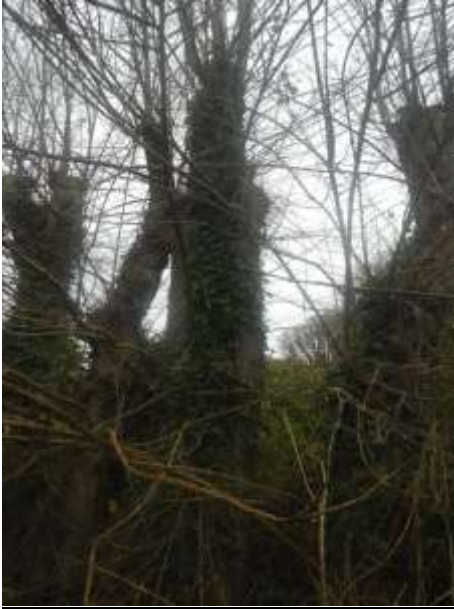
Tree 13C:

1. **Unique ref no:** 13C
2. **Grid Ref:**
3. **Measurements:** Diameter of stem 2.4m (measured); Height 7m (est.); Spread 5m(est.)
4. **Species:** Probably *Ulmus Procera*
5. **Estimated Age:** 90 years
6. **Tree Form and Vigour:** upright, active live growth, recent pollard at approx. 4m, significant epicormic growth, some scarring from historic limb removal
7. **Tree associates:** Ivy growing sparsely over tree
8. **Relationship to landscape features:** hedgerow tree
9. **Photographic record above.**
10. **Evidence of previous management works:** One historic pollard position evident, some scarring from limb removal
11. **Nil additional historic/ cultural value associated with tree.**
12. **Potential threats:** Nil biological observed other than general points noted in main text.
13. **Management Recommendations:** Re-pollard above old wounds

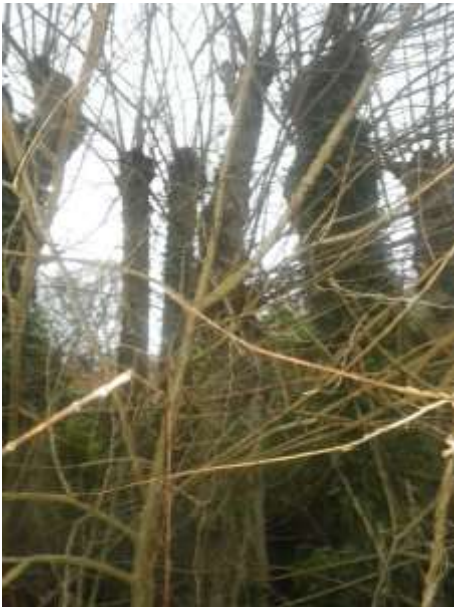
Tree 14C:

1. **Unique ref no:** 14C
2. **Grid Ref:**
3. **Measurements:** Diameter of stem 1.1m (measured); Height 7m (est.); Spread 5m(est.)
4. **Species:** Probably *Ulmus Procera*
5. **Estimated Age:** 40 years
6. **Tree Form and Vigour:** upright, active live growth, recent pollard at approx. 4m, significant epicormic growth
7. **Tree associates:** Ivy growing sparsely over tree
8. **Relationship to landscape features:** hedgerow tree
9. **Photographic record above.**
10. **Evidence of previous management works:** One historic pollard position noted
11. **Nil additional historic/ cultural value associated with tree.**
12. **Potential threats:** Nil biological observed other than general points noted in main text.
13. **Management Recommendations:** Re-pollard above old wounds

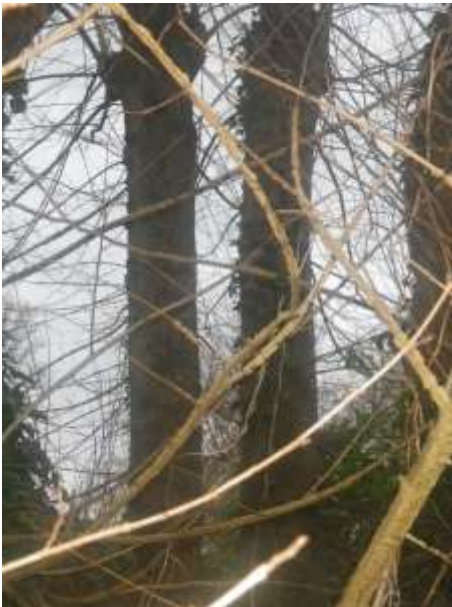
Tree 15C:

1. **Unique ref no:** 15C
2. **Grid Ref:**
3. **Measurements:** Diameter of stem 2.4m (measured); Height 7m (est.); Spread 5m(est.)
4. **Species:** Probably *Ulmus Procera*
5. **Estimated Age:** 90 years
6. **Tree Form and Vigour:** two co-dominant stems growing to east then upright, active live growth, recent pollard at approx. 4m, possible historic pollard at approx. 1 metre, significant epicormic growth
7. **Tree associates:** Ivy growing sparsely over tree
8. **Relationship to landscape features:** hedgerow tree
9. **Photographic record above.**
10. **Evidence of previous management works:** Possible two historic pollard positions
11. **Nil additional historic/ cultural value associated with tree.**
12. **Potential threats:** Nil biological observed other than general points noted in main text.
13. **Management Recommendations:** Re-pollard above old wounds

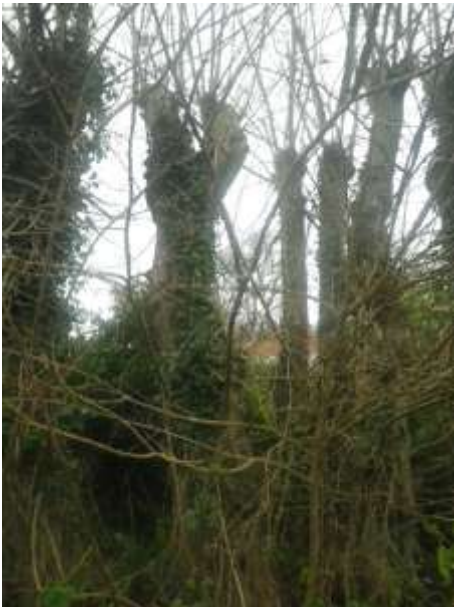
Tree 16C:

1. **Unique ref no:** 16C
2. **Grid Ref:**
3. **Measurements:** Diameter of stem 2.1m (measured); Height 7m (est.); Spread 5m(est.)
4. **Species:** Probably *Ulmus Procera*
5. **Estimated Age:** 90 years
6. **Tree Form and Vigour:** three co-dominant stems, possible from historic pollard at approx. 1.5 metres, upright, active live growth, recent pollard at approx. 4m, significant epicormic growth
7. **Tree associates:** Ivy growing sparsely over tree
8. **Relationship to landscape features:** hedgerow tree
9. **Photographic record above.**
10. **Evidence of previous management works:** Possible two historic pollard positions
11. **Nil additional historic/ cultural value associated with tree.**
12. **Potential threats:** Nil biological observed other than general points noted in main text.
13. **Management Recommendations:** Re-pollard above old wounds

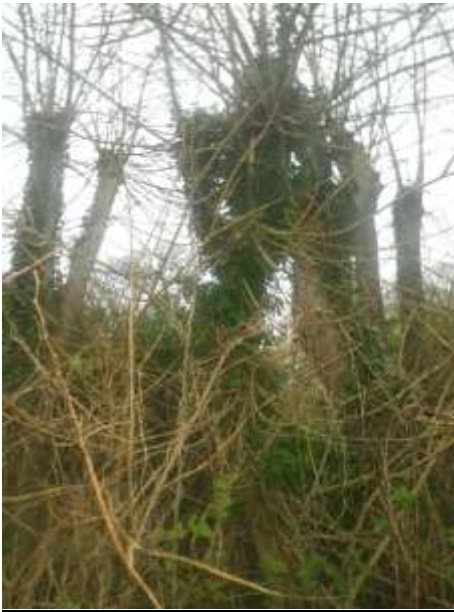
Tree 17C:

1. **Unique ref no:** 17C
2. **Grid Ref:**
3. **Measurements:** Diameter of stem 1.2m (measured); Height 7m (est.); Spread 5m(est.)
4. **Species:** Probably *Ulmus Procera*
5. **Estimated Age:** 50 years
6. **Tree Form and Vigour:** two co-dominant stems, possible from historic pollard at approx. 1.5 metres, upright, active live growth, recent pollard at approx. 4m, significant epicormic growth
7. **Tree associates:** Ivy growing sparsely over tree
8. **Relationship to landscape features:** hedgerow tree
9. **Photographic record above.**
10. **Evidence of previous management works:** Possible two historic pollard positions
11. **Nil additional historic/ cultural value associated with tree.**
12. **Potential threats:** Nil biological observed other than general points noted in main text.
13. **Management Recommendations:** Re-pollard above old wounds

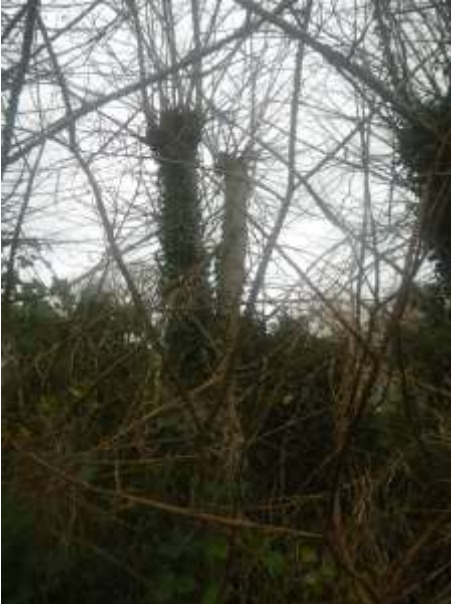
Tree 18C:

1. **Unique ref no:** 18C
2. **Grid Ref:**
3. **Measurements:** Diameter of stem 1.6m (measured); Height 7m (est.); Spread 5m(est.)
4. **Species:** Probably *Ulmus Procera*
5. **Estimated Age:** 70 years
6. **Tree Form and Vigour:** upright, active live growth, recent pollard at approx. 4m, significant epicormics growth
7. **Tree associates:** Ivy growing sparsely over tree
8. **Relationship to landscape features:** hedgerow tree
9. **Photographic record above.**
10. **Evidence of previous management works:** One historic pollard position evident
11. **Nil additional historic/ cultural value associated with tree.**
12. **Potential threats:** Nil biological observed other than general points noted in main text.
13. **Management Recommendations:** Re-pollard above old wounds

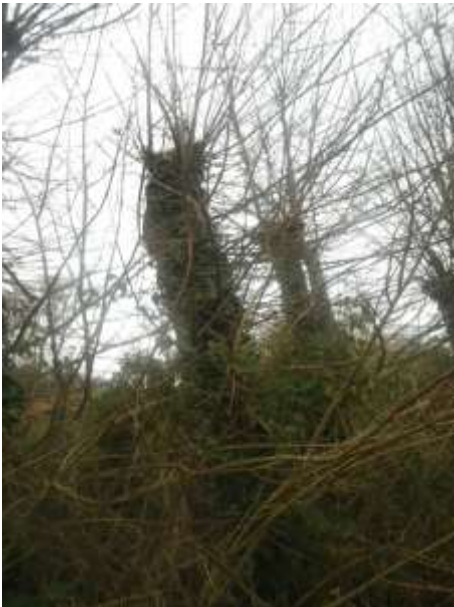
Tree 19C:

1. **Unique ref no:** 19C
2. **Grid Ref:**
3. **Measurements:** Diameter of stem 1.6m (measured); Height 7m (est.); Spread 5m(est.)
4. **Species:** Probably *Ulmus Procera*
5. **Estimated Age:** 70 years
6. **Tree Form and Vigour:** upright, active live growth, recent pollard at approx. 4m, significant epicormic growth
7. **Tree associates:** Ivy growing sparsely over tree
8. **Relationship to landscape features:** hedgerow tree
9. **Photographic record above.**
10. **Evidence of previous management works:** One historic pollard position noted
11. **Nil additional historic/ cultural value associated with tree.**
12. **Potential threats:** Nil biological observed other than general points noted in main text.
13. **Management Recommendations:** Re-pollard above old wounds

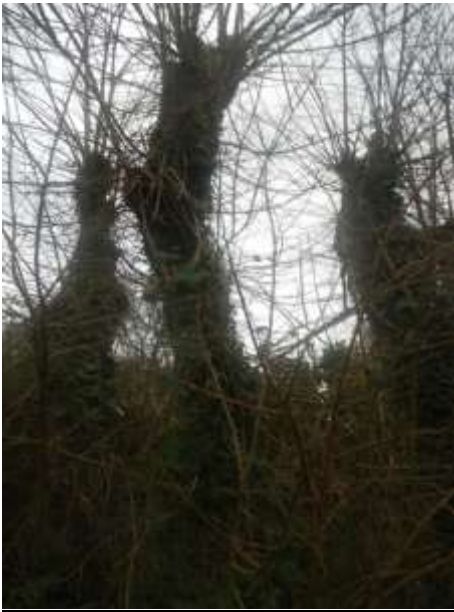
Tree 20C:

1. **Unique ref no:** 20C
2. **Grid Ref:**
3. **Measurements:** Diameter of stem 1.8m (measured); Height 7m (est.); Spread 5m(est.)
4. **Species:** Probably *Ulmus Procera*
5. **Estimated Age:** 70 years
6. **Tree Form and Vigour:** two co-dominant stems, possible from historic pollard at approx. 3 metres, growing to east, active live growth, recent pollard at approx. 4m, significant epicormic growth
7. **Tree associates:** Ivy growing sparsely over tree
8. **Relationship to landscape features:** hedgerow tree
9. **Photographic record above.**
10. **Evidence of previous management works:** Possible two historic pollard positions
11. **Nil additional historic/ cultural value associated with tree.**
12. **Potential threats:** Nil biological observed other than general points noted in main text.
13. **Management Recommendations:** Re-pollard above old wounds

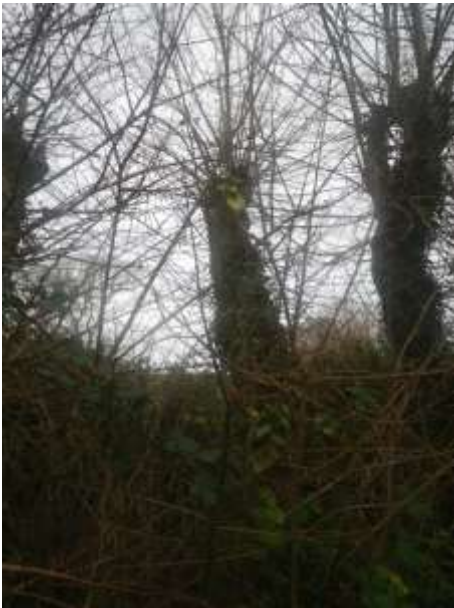
Tree 21C:

1. **Unique ref no:** 21C
2. **Grid Ref:**
3. **Measurements:** Diameter of stem 1.9m (measured); Height 7m (est.); Spread 5m(est.)
4. **Species:** Probably *Ulmus Procera*
5. **Estimated Age:** 80 years
6. **Tree Form and Vigour:** two co-dominant stems, possible from historic pollard at approx. 3 metres, growing to east, active live growth, recent pollard at approx. 4m, significant epicormic growth
7. **Tree associates:** Ivy growing sparsely over tree
8. **Relationship to landscape features:** hedgerow tree
9. **Photographic record above.**
10. **Evidence of previous management works:** Possible two historic pollard positions
11. **Nil additional historic/ cultural value associated with tree.**
12. **Potential threats:** Nil biological observed other than general points noted in main text.
13. **Management Recommendations:** Re-pollard above old wounds

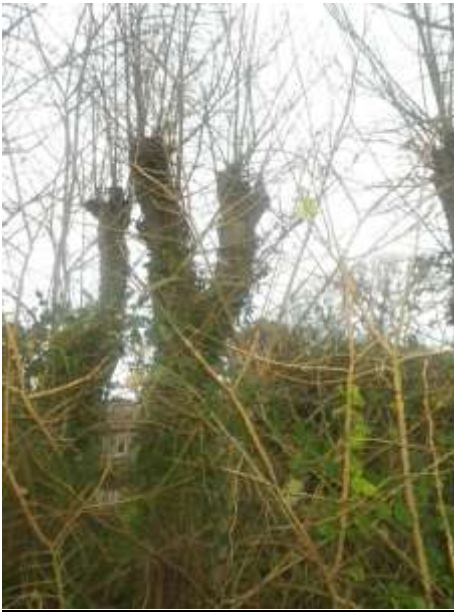
Tree 22C:

1. **Unique ref no:** 22C
2. **Grid Ref:**
3. **Measurements:** Diameter of stem 1.4m (measured); Height 7m (est.); Spread 5m(est.)
4. **Species:** Probably *Ulmus Procera*
5. **Estimated Age:** 50 years
6. **Tree Form and Vigour:** two co-dominant stems, one has died out, possible from historic pollard at approx. 3 metres, upright, active live growth, recent pollard at approx. 4m, significant epicormic growth
7. **Tree associates:** Ivy growing sparsely over tree
8. **Relationship to landscape features:** hedgerow tree
9. **Photographic record above.**
10. **Evidence of previous management works:** Possible two historic pollard positions
11. **Nil additional historic/ cultural value associated with tree.**
12. **Potential threats:** Nil biological observed other than general points noted in main text.
13. **Management Recommendations:** Re-pollard above old wounds

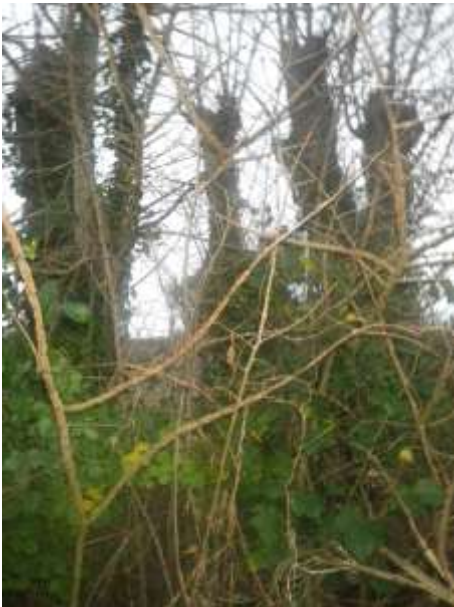
Tree 23C:

1. **Unique ref no:** 23C
2. **Grid Ref:**
3. **Measurements:** Diameter of stem 1.7m (measured); Height 7m (est.); Spread 5m(est.)
4. **Species:** Probably *Ulmus Procera*
5. **Estimated Age:** 70 years
6. **Tree Form and Vigour:** two co-dominant stems, possible from historic pollard at approx. 3 metres, upright, active live growth, recent pollard at approx. 4m, significant epicormic growth
7. **Tree associates:** Ivy growing sparsely over tree
8. **Relationship to landscape features:** hedgerow tree
9. **Photographic record above.**
10. **Evidence of previous management works:** Possible two historic pollard positions
11. **Nil additional historic/ cultural value associated with tree.**
12. **Potential threats:** Nil biological observed other than general points noted in main text.
13. **Management Recommendations:** Re-pollard above old wounds

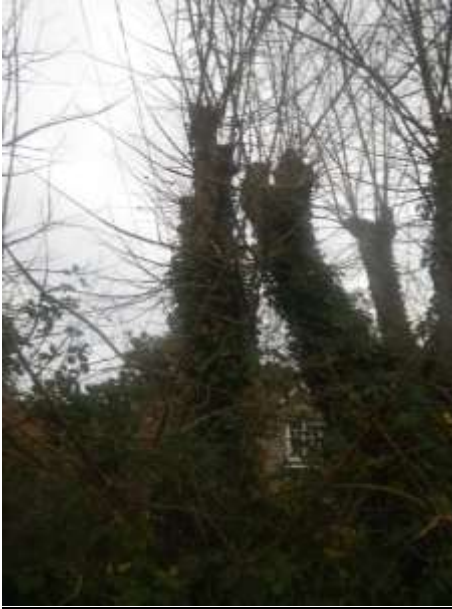
Tree 24C:

1. **Unique ref no:** 24C
2. **Grid Ref:**
3. **Measurements:** Diameter of stem 1.6m (measured); Height 7m (est.); Spread 5m(est.)
4. **Species:** Probably *Ulmus Procera*
5. **Estimated Age:** 70 years
6. **Tree Form and Vigour:** two co-dominant stems, possible from historic pollard at approx. 3 metres, active live growth, recent pollard at approx. 4m, significant epicormic growth
7. **Tree associates:** Ivy growing sparsely over tree
8. **Relationship to landscape features:** hedgerow tree
9. **Photographic record above.**
10. **Evidence of previous management works:** Possible two historic pollard positions
11. **Nil additional historic/ cultural value associated with tree.**
12. **Potential threats:** Nil biological observed other than general points noted in main text.
13. **Management Recommendations:** Re-pollard above old wounds

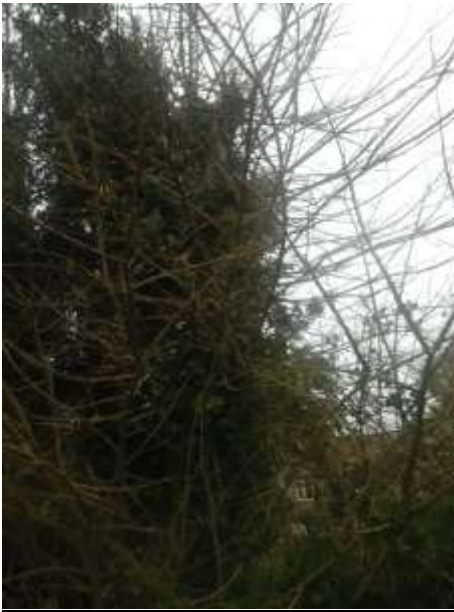
Tree 25C:

1. **Unique ref no:** 25C
2. **Grid Ref:**
3. **Measurements:** Diameter of stem 1.0m (measured); Height 7m (est.); Spread 5m(est.)
4. **Species:** Probably *Ulmus Procera*
5. **Estimated Age:** 40 years
6. **Tree Form and Vigour:** upright, active live growth, recent pollard at approx. 4m, significant epicormic growth, significant scarring on trunk from previous limb removal
7. **Tree associates:** Ivy growing sparsely over tree
8. **Relationship to landscape features:** hedgerow tree
9. **Photographic record above.**
10. **Evidence of previous management works:** One historic pollard position evident, scarring from historic limb removal
11. **Nil additional historic/ cultural value associated with tree.**
12. **Potential threats:** Nil biological observed other than general points noted in main text.
13. **Management Recommendations:** Re-pollard above old wounds

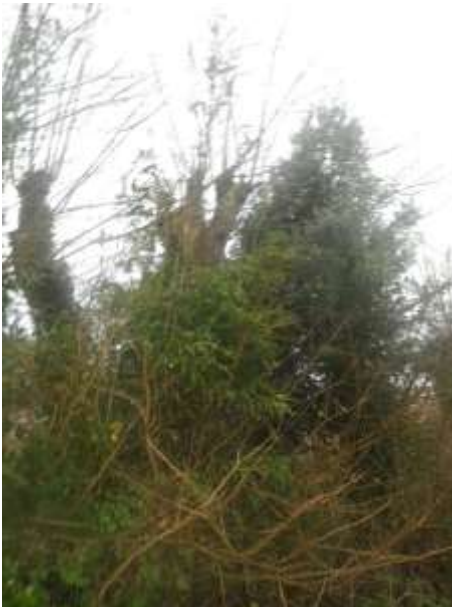
Tree 26C:

1. **Unique ref no:** 26C
2. **Grid Ref:**
3. **Measurements:** Diameter of stem 1.9m (measured); Height 7m (est.); Spread 5m(est.)
4. **Species:** Probably *Ulmus Procera*
5. **Estimated Age:** 80 years
6. **Tree Form and Vigour:** two co-dominant stems, possible from historic pollard at approx. 3 metres, growing to east, active live growth, recent pollard at approx. 4m, significant epicormic growth
7. **Tree associates:** Ivy growing sparsely over tree
8. **Relationship to landscape features:** hedgerow tree
9. **Photographic record above.**
10. **Evidence of previous management works:** Possible two historic pollard positions
11. **Nil additional historic/ cultural value associated with tree.**
12. **Potential threats:** Nil biological observed other than general points noted in main text.
13. **Management Recommendations:** Re-pollard above old wounds

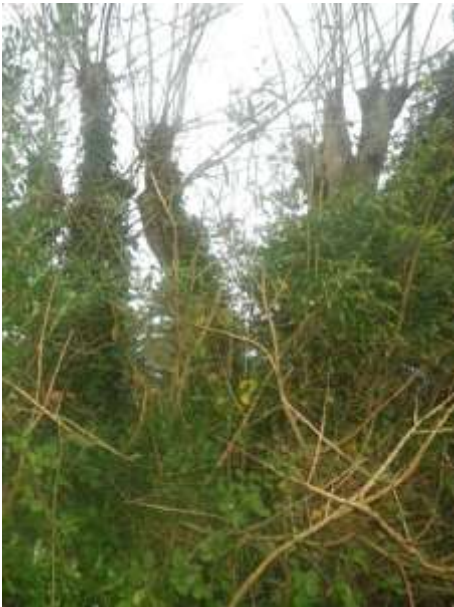
Tree 27C:

1. **Unique ref no:** 27C
2. **Grid Ref:**
3. **Measurements:** Diameter of stem 1.8m (measured); Height 7m (est.); Spread 5m(est.)
4. **Species:** Probably *Ulmus Procera*
5. **Estimated Age:** 80 years
6. **Tree Form and Vigour:** growing to east, active live growth, recent pollard at approx. 4m, significant epicormic growth
7. **Tree associates:** Ivy growing sparsely over tree
8. **Relationship to landscape features:** hedgerow tree
9. **Photographic record above.**
10. **Evidence of previous management works:** One historic pollard position evident
11. **Nil additional historic/ cultural value associated with tree.**
12. **Potential threats:** Nil biological observed other than general points noted in main text.
13. **Management Recommendations:** Re-pollard above old wounds

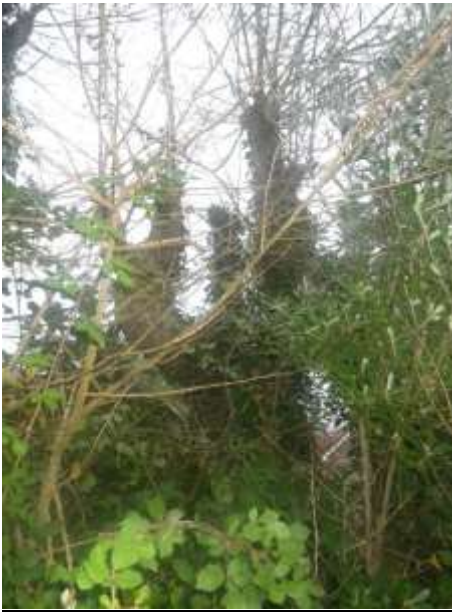
Tree 28C:

1. **Unique ref no:** 28C
2. **Grid Ref:**
3. **Measurements:** Diameter of stem 2.1m (measured); Height 7m (est.); Spread 5m(est.)
4. **Species:** Probably *Ulmus Procera*
5. **Estimated Age:** 90 years
6. **Tree Form and Vigour:** three co-dominant stems, possible from historic pollard at approx. 3 metres, active live growth, recent pollard at approx. 4m, significant epicormic growth
7. **Tree associates:** Ivy growing sparsely over tree
8. **Relationship to landscape features:** hedgerow tree
9. **Photographic record above.**
10. **Evidence of previous management works:** Possible two historic pollard positions
11. **Nil additional historic/ cultural value associated with tree.**
12. **Potential threats:** Nil biological observed other than general points noted in main text.
13. **Management Recommendations:** Re-pollard above old wounds

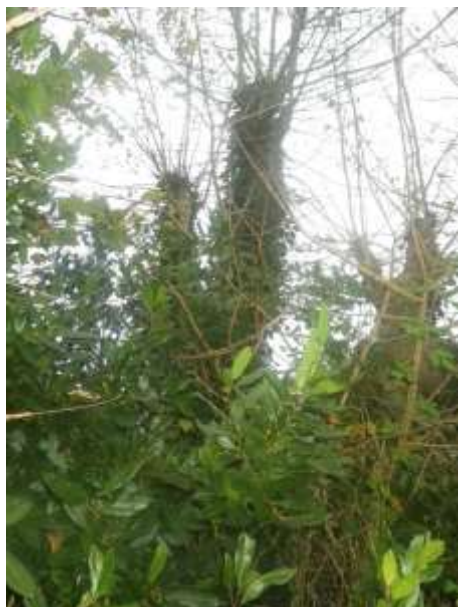
Tree 29C:

1. **Unique ref no:** 29C
2. **Grid Ref:**
3. **Measurements:** Diameter of stem 2.1m (measured); Height 7m (est.); Spread 5m(est.)
4. **Species:** Probably Ulmus Procera
5. **Estimated Age:** 90 years
6. **Tree Form and Vigour:** two co-dominant stems, possible from historic pollard at approx. 3 metres, active live growth, recent pollard at approx. 4m, significant epicormic growth
7. **Tree associates:** Ivy growing sparsely over tree
8. **Relationship to landscape features:** hedgerow tree
9. **Photographic record above.**
10. **Evidence of previous management works:** Possible two historic pollard positions
11. **Nil additional historic/ cultural value associated with tree.**
12. **Potential threats:** Nil biological observed other than general points noted in main text.
13. **Management Recommendations:** Re-pollard above old wounds

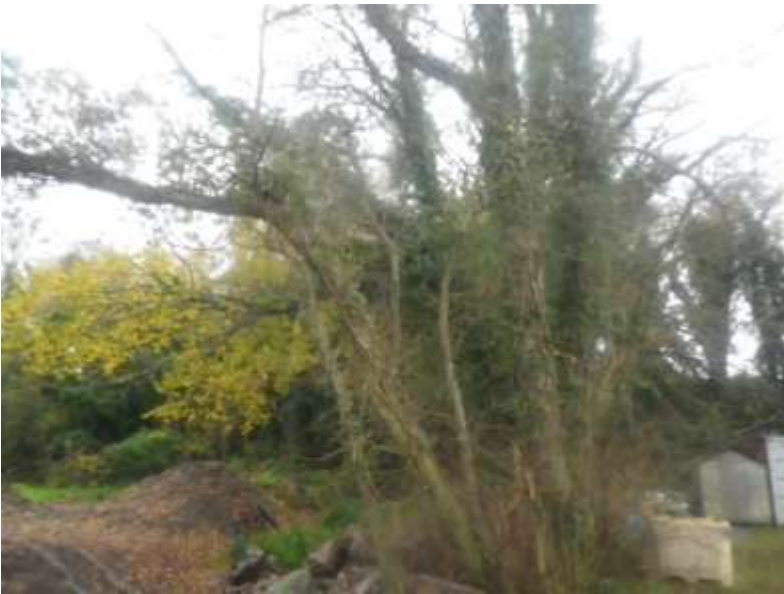
Fig 1.9 Elm row D viewed from east looking west. Extent of lateral lean evident

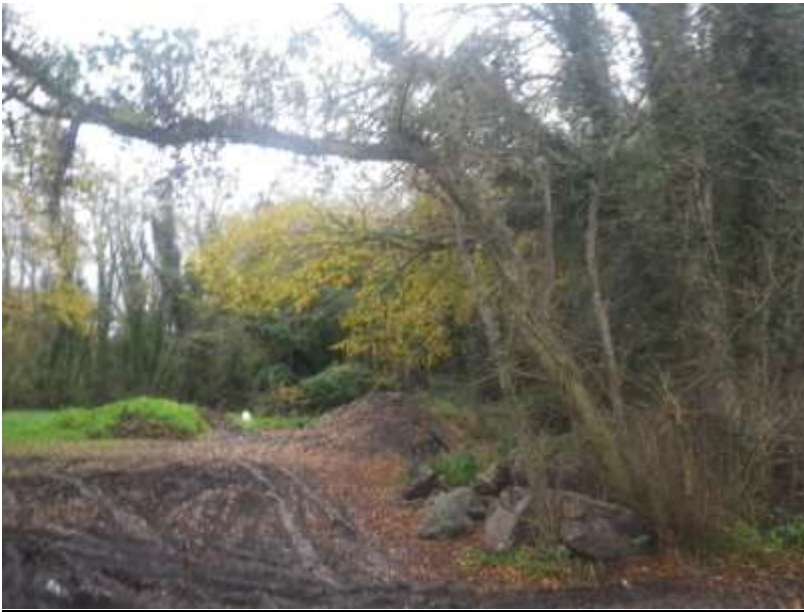
Tree 1D:

1. **Unique ref no:** 1D
2. **Grid Ref:**
3. **Measurements:** Diameter of stem 1.9m (measured); Height 5m (est.); Spread 18m(est.)
4. **Species:** Probably *Ulmus Procera*

5. **Estimated Age:** 70 years
6. **Tree Form and Vigour:** Tree is peculiarly shaped, growing significantly to south. Tree appears to be maiden with active live growth and some deadwood near to base.

12. **Potential threats:** Nil biological observed other than general points noted in main text. Potential “sail” problem caused by ivy during strong winds.

13. **Management Recommendations:** Pollard to approx. 3 metres.

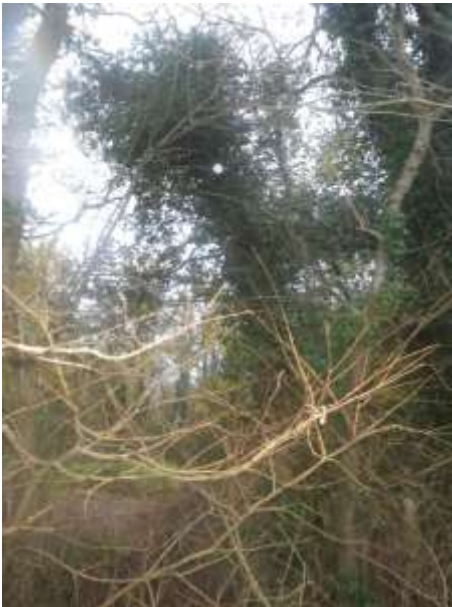
Tree 3D:

1. **Unique ref no:** 3D
2. **Grid Ref:**
3. **Measurements:** Diameter of stem 1.6m (measured); Height 18m (est.); Spread 14m(est.)
4. **Species:** Probably *Ulmus Procera*
5. **Estimated Age:** 70 years
6. **Tree Form and Vigour:** Appears to be maiden tree, significant lean to south, active live growth, some lower deadwood
7. **Tree associates:** Ivy growing freely over tree; some evidence of historic bird nesting within ivy.
8. **Relationship to landscape features:** hedgerow tree
9. **Photographic record above.**
10. **Evidence of previous management works:** None evident
11. **Nil additional historic/ cultural value associated with tree.**
12. **Potential threats:** Nil biological observed other than general points noted in main text. Potential "sail" problem caused by ivy during strong winds.
13. **Management Recommendations:** Pollard to approx. 3 metres

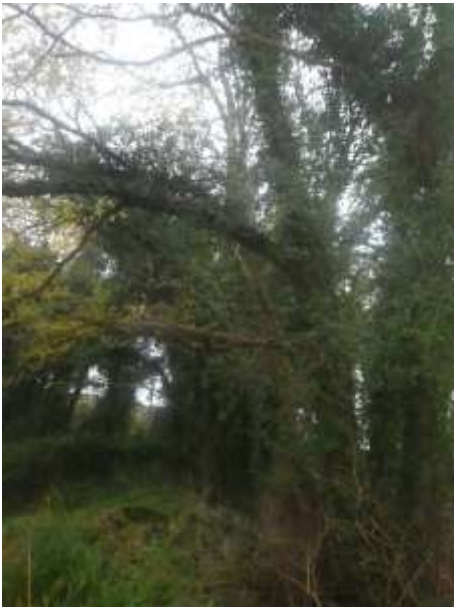
Tree 4D:

1. **Unique ref no:** 4D
2. **Grid Ref:**
3. **Measurements:** Diameter of stem 2.1m (measured); Height 23m (est.); Spread 18m(est.)
4. **Species:** Probably *Ulmus Procera*
5. **Estimated Age:** 80 years
6. **Tree Form and Vigour:** Appears to be maiden tree, significant lean to south, active live growth, significant deadwood to north
7. **Tree associates:** Ivy growing freely over tree; some evidence of historic bird nesting within ivy.
8. **Relationship to landscape features:** hedgerow tree
9. **Photographic record above.**
10. **Evidence of previous management works:** None evident
11. **Nil additional historic/ cultural value associated with tree.**
12. **Potential threats:** Nil biological observed other than general points noted in main text. Potential "sail" problem caused by ivy during strong winds.
13. **Management Recommendations:** Pollard to approx. 3 metres

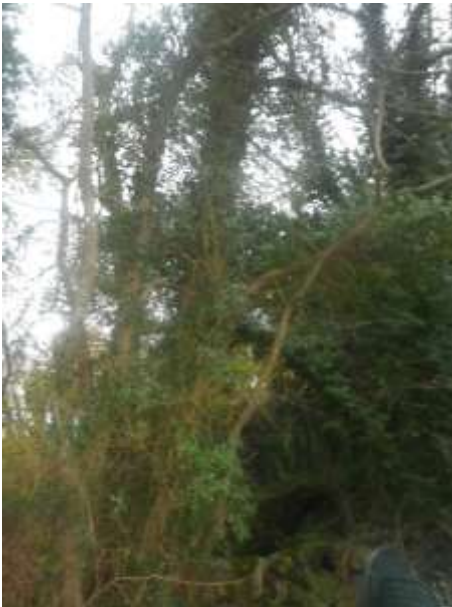
Tree 5D:

1. **Unique ref no:** 5D
2. **Grid Ref:**
3. **Measurements:** Diameter of stem 1.7m (measured); Height 24m (est.); Spread 14m(est.)
4. **Species:** Probably *Ulmus Procera*

5. **Estimated Age:** 70 years
6. **Tree Form and Vigour:** Appears to be maiden tree, significant lean to north, active live growth, some lower deadwood, large limb unbalancing to north

12. **Potential threats:** Nil biological observed other than general points noted in main text. Potential "sail" problem caused by ivy during strong winds.

13. **Management Recommendations:** Pollard to approx. 3 metres

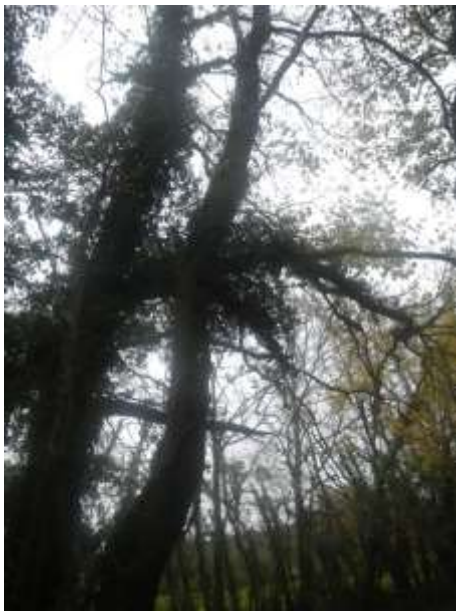
Tree 6D:

1. **Unique ref no:** 6D
2. **Grid Ref:**
3. **Measurements:** Diameter of stem 1.5m (measured); Height 24m (est.); Spread 16m(est.)
4. **Species:** Probably *Ulmus Procera*

5. **Estimated Age:** 60 years
6. **Tree Form and Vigour:** Appears to be maiden tree, significant lean to south in conjunction with 4D above, active live growth, some lower deadwood, large limb unbalancing to south

12. **Potential threats:** Nil biological observed other than general points noted in main text. Potential "sail" problem caused by ivy during strong winds.

13. **Management Recommendations:** Pollard to approx. 3 metres

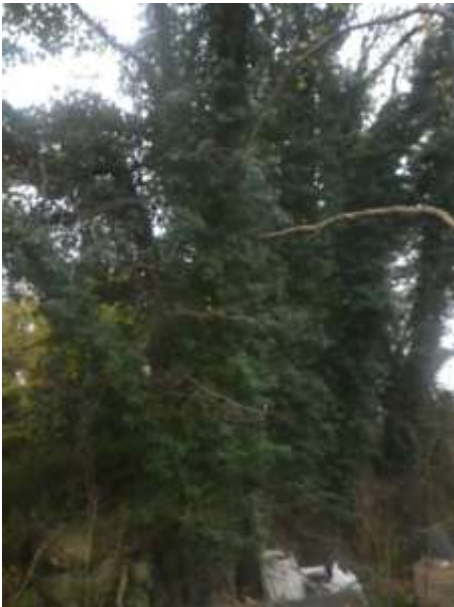
Tree 7D:

1. **Unique ref no:** 7D
2. **Grid Ref:**
3. **Measurements:** Diameter of stem 2.1m (measured); Height 24m (est.); Spread 14m(est.)
4. **Species:** Probably *Ulmus Procera*
5. **Estimated Age:** 80 years
6. **Tree Form and Vigour:** Appears to be maiden tree, upright, active live growth, some lower deadwood, large limb unbalancing to north
7. **Tree associates:** Ivy growing freely over tree; some evidence of historic bird nesting within ivy.
8. **Relationship to landscape features:** hedgerow tree
9. **Photographic record above.**
10. **Evidence of previous management works:** None evident
11. **Nil additional historic/ cultural value associated with tree.**
12. **Potential threats:** Nil biological observed other than general points noted in main text. Potential "sail" problem caused by ivy during strong winds.
13. **Management Recommendations:** Pollard to approx. 3 metres

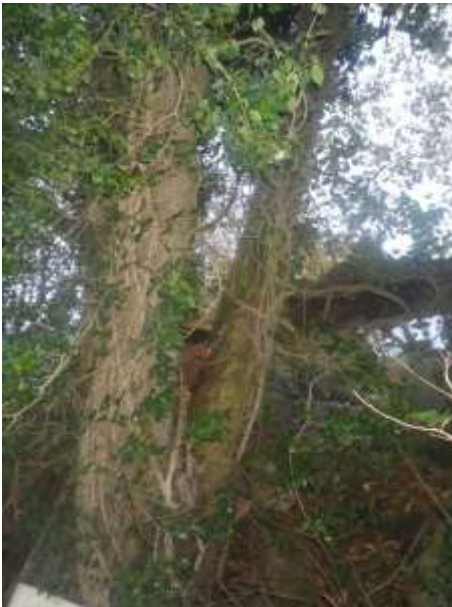
Tree 8D:

1. **Unique ref no:** 8D
2. **Grid Ref:**
3. **Measurements:** Diameter of stem 3.2m (measured); Height 24m (est.); Spread 14m(est.)
4. **Species:** Probably *Ulmus Procera*

5. **Estimated Age:** 100+ years
6. **Tree Form and Vigour:** Appears to be two trees grown together and then previously pollarded, giving 5 co-dominant stems, one large co-dominant fallen recently to south

12. **Potential threats:** Nil biological observed other than general points noted in main text. Potential "sail" problem caused by ivy during strong winds.

13. **Management Recommendations:** Pollard to approx. 3 metres

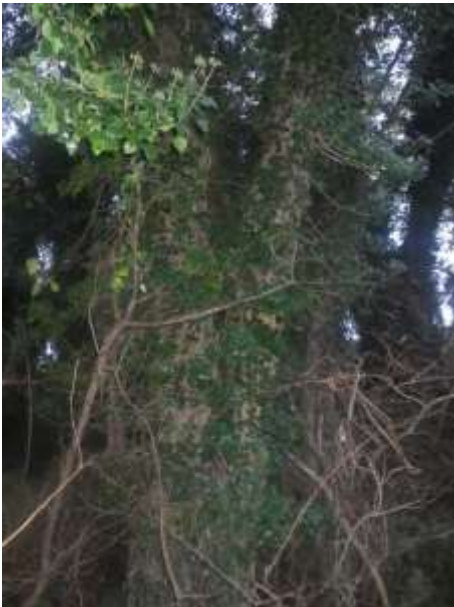
Tree 9D:

1. **Unique ref no:** 9D
2. **Grid Ref:**
3. **Measurements:** Diameter of stem 1.9m (measured); Height 24m (est.); Spread 14m(est.)
4. **Species:** Probably *Ulmus Procera*

5. **Estimated Age:** 80 years
6. **Tree Form and Vigour:** Appears to be previous pollard causing 2 co-dominant stems to form, active live growth, some lower deadwood, one co-dominant leaning dangerously to north

12. **Potential threats:** Nil biological observed other than general points noted in main text. Potential "sail" problem caused by ivy during strong winds.

13. **Management Recommendations:** Pollard to approx. 3 metres

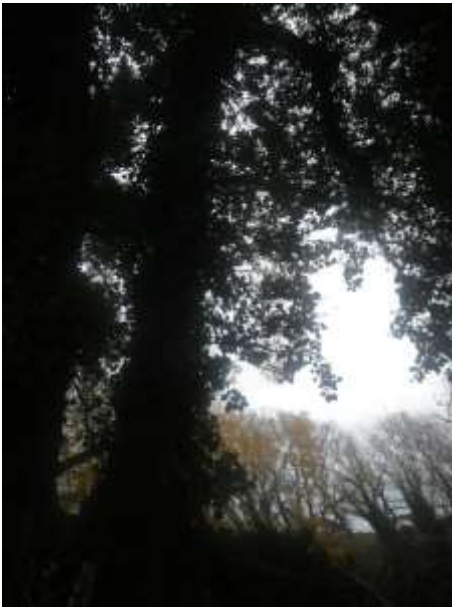
Tree 10D:

1. **Unique ref no:** 10D
2. **Grid Ref:**
3. **Measurements:** Diameter of stem 1.8m (measured); Height 24m (est.); Spread 14m(est.)
4. **Species:** Probably *Ulmus Procera*
5. **Estimated Age:** 70 years
6. **Tree Form and Vigour:** Appears to be maiden tree, single stem upright, active live growth, some lower deadwood to north,
7. **Tree associates:** Ivy growing freely over tree; some evidence of historic bird nesting within ivy.
8. **Relationship to landscape features:** hedgerow tree
9. **Photographic record above.**
10. **Evidence of previous management works:** None evident
11. **Nil additional historic/ cultural value associated with tree.**
12. **Potential threats:** Nil biological observed other than general points noted in main text. Potential "sail" problem caused by ivy during strong winds.
13. **Management Recommendations:** Pollard to approx. 3 metres

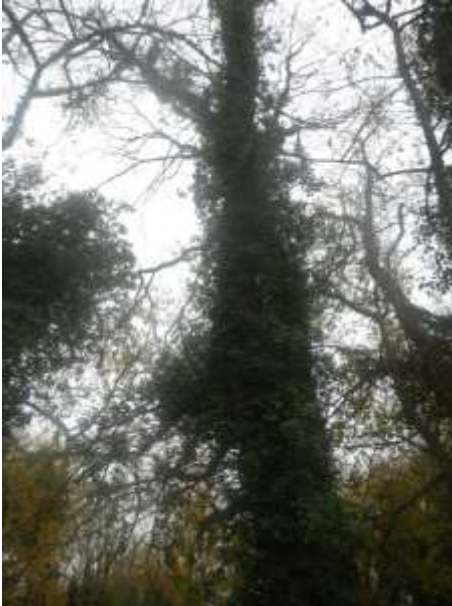
Tree 11D:

1. **Unique ref no:** 11D
2. **Grid Ref:**
3. **Measurements:** Diameter of stem 1.4m (measured); Height 24m (est.); Spread 14m(est.)
4. **Species:** Probably *Ulmus Procera*

5. **Estimated Age:** 60 years
6. **Tree Form and Vigour:** Appears to be maiden tree, significant lean to north, active live growth, some lower deadwood, large limb unbalancing to north

12. **Potential threats:** Nil biological observed other than general points noted in main text. Potential "sail" problem caused by ivy during strong winds.

13. **Management Recommendations:** Pollard to approx. 3 metres

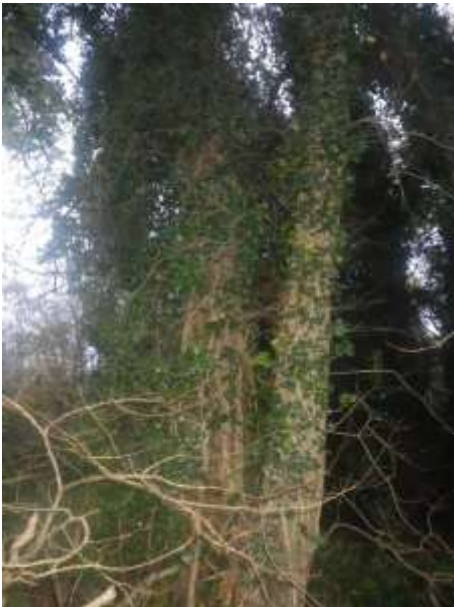
Tree 12D:

1. **Unique ref no:** 12D
2. **Grid Ref:**
3. **Measurements:** Diameter of stem 2.3m (measured); Height 24m (est.); Spread 14m(est.)
4. **Species:** Probably *Ulmus Procera*

5. **Estimated Age:** 80 years
6. **Tree Form and Vigour:** Appears to be previous pollard at approx. 1 metre causing two thin co-dominant stems to form, active live growth, some lower deadwood

12. **Potential threats:** Nil biological observed other than general points noted in main text. Potential "sail" problem caused by ivy during strong winds.

13. **Management Recommendations:** Pollard to approx. 3 metres

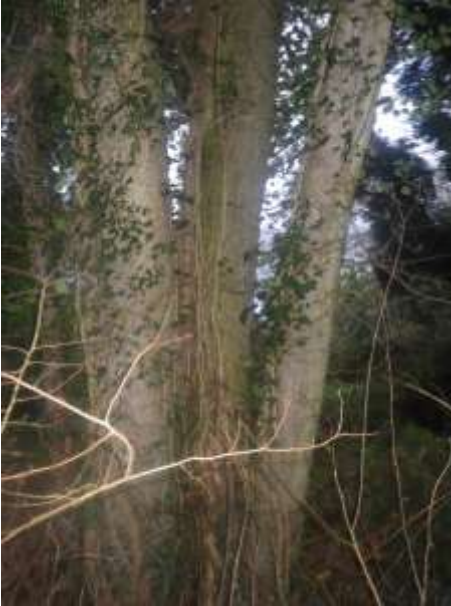
Tree 13D:

1. **Unique ref no:** 13D
2. **Grid Ref:**
3. **Measurements:** Diameter of stem 2.8m (measured); Height 24m (est.); Spread 14m(est.)
4. **Species:** Probably *Ulmus Procera*

5. **Estimated Age:** 80 years
6. **Tree Form and Vigour:** Appears to be previous pollard causing 3 co-dominant stems to form, all upright, active live growth, some lower deadwood

12. **Potential threats:** Nil biological observed other than general points noted in main text. Potential "sail" problem caused by ivy during strong winds.

13. **Management Recommendations:** Pollard to approx. 3 metres

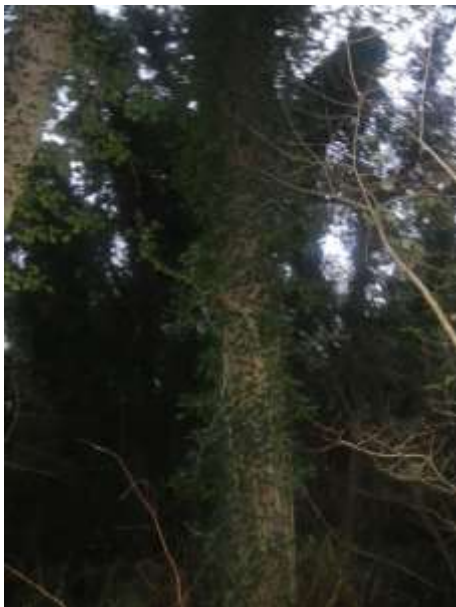
Tree 14D:

1. **Unique ref no:** 14D
2. **Grid Ref:**
3. **Measurements:** Diameter of stem 1.9m (measured); Height 24m (est.); Spread 14m(est.)
4. **Species:** Probably *Ulmus Procera*
5. **Estimated Age:** 80 years
6. **Tree Form and Vigour:** Appears to be maiden tree, upright with few lateral branches
7. **Tree associates:** Ivy growing freely over tree; some evidence of historic bird nesting within ivy.
8. **Relationship to landscape features:** hedgerow tree
9. **Photographic record above.**
10. **Evidence of previous management works:** None evident
11. **Nil additional historic/ cultural value associated with tree.**
12. **Potential threats:** Nil biological observed other than general points noted in main text. Potential "sail" problem caused by ivy during strong winds.
13. **Management Recommendations:** Pollard to approx. 3 metres

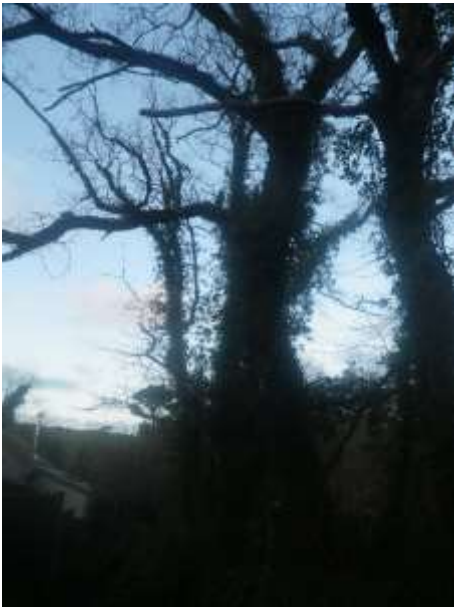
Tree 1F:

1. **Unique ref no:** 1F
2. **Grid Ref:**
3. **Measurements:** Diameter of stem 2.2m (measured); Height 20m (est.); Spread 14m(est.)
4. **Species:** Probably *Ulmus Procera*

5. **Estimated Age:** 90 years
6. **Tree Form and Vigour:** Appears to be maiden tree, single trunk, lean to west, some deadwood and large lateral limbs to west

12. **Potential threats:** Nil biological observed other than general points noted in main text. Potential “sail” problem caused by ivy during strong winds.

13. **Management Recommendations:** Crown lift to approx. 6 metres, re-balance tree

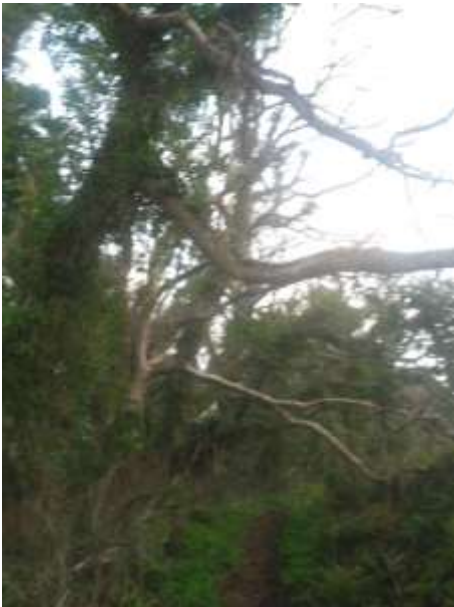
Tree 2F:

1. **Unique ref no:** 2F
2. **Grid Ref:**
3. **Measurements:** Diameter of stem 2.0m (measured); Height 20m (est.); Spread 14m(est.)
4. **Species:** Probably *Ulmus Procera*

5. **Estimated Age:** 90 years
6. **Tree Form and Vigour:** Appears to be maiden tree, single trunk, significant lean to west, some deadwood and large lateral limbs to west

12. **Potential threats:** Nil biological observed other than general points noted in main text. Potential "sail" problem caused by ivy during strong winds.

13. **Management Recommendations:** Crown lift to approx. 6 metres, re-balance tree by removing limbs to west

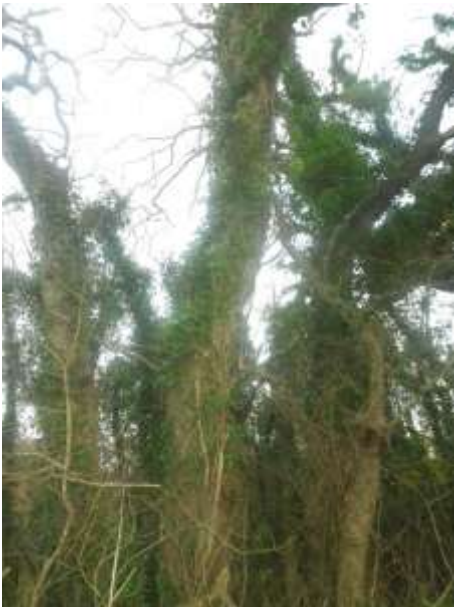
Tree 3F:

1. **Unique ref no:** 3F
2. **Grid Ref:**
3. **Measurements:** Diameter of stem 2.0m (measured); Height 20m (est.); Spread 14m(est.)
4. **Species:** Probably *Ulmus Procera*
5. **Estimated Age:** 90 years
6. **Tree Form and Vigour:** Appears to be maiden tree, single trunk, lean to east, some low lateral limbs to east
7. **Tree associates:** Ivy growing freely over tree; some evidence of historic bird nesting within ivy.
8. **Relationship to landscape features:** hedgerow tree
9. **Photographic record above.**
10. **Evidence of previous management works:** None evident
11. **Nil additional historic/ cultural value associated with tree.**
12. **Potential threats:** Nil biological observed other than general points noted in main text. Potential "sail" problem caused by ivy during strong winds.
13. **Management Recommendations:** Crown lift to approx. 6 metres, re-balance tree

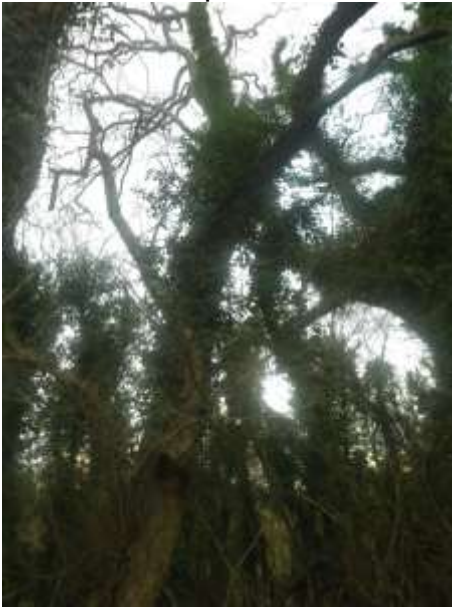
Tree 4F:

Medium roost potential

1. **Unique ref no:** 4F
2. **Grid Ref:**
3. **Measurements:** Diameter of stem 1.8m (measured); Height 22m (est.); Spread 14m(est.)
4. **Species:** Probably *Ulmus Procera*

5. **Estimated Age:** 80 years
6. **Tree Form and Vigour:** Appears to be maiden tree, single trunk, lean to east, some low lateral limbs to east, small limb hole to west shown in bat survey

12. **Potential threats:** Nil biological observed other than general points noted in main text. Potential "sail" problem caused by ivy during strong winds.

13. **Management Recommendations:** Minimal crown lift to approx. 6 metres, re-balance tree, taking into consideration the recommendations for mitigating the risk to any potential bat roost.

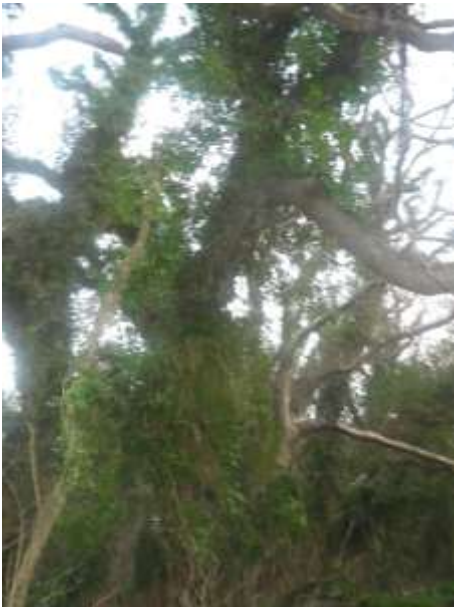
Tree 5F:

1. **Unique ref no:** 5F
2. **Grid Ref:**
3. **Measurements:** Diameter of stem 2.2m (measured); Height 22m (est.); Spread 14m(est.)
4. **Species:** Probably *Ulmus Procera*

5. **Estimated Age:** 90 years
6. **Tree Form and Vigour:** Appears to be maiden tree, single trunk, very significant lean to east, some low lateral limbs to east

12. **Potential threats:** Nil biological observed other than general points noted in main text. Potential "sail" problem caused by ivy during strong winds.

13. **Management Recommendations:** Crown lift to approx. 6 metres, re-balance tree

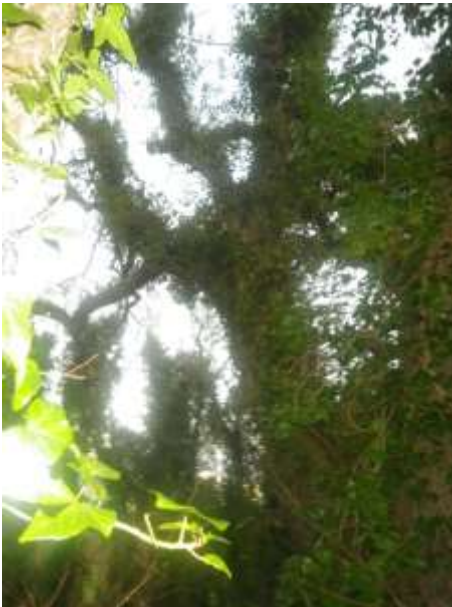
Tree 6F:

1. **Unique ref no:** 6F
2. **Grid Ref:**
3. **Measurements:** Diameter of stem 2.0m (measured); Height 20m (est.); Spread 14m(est.)
4. **Species:** Probably *Ulmus Procera*
5. **Estimated Age:** 90 years
6. **Tree Form and Vigour:** Appears to be maiden tree, single trunk, lean to east, some low lateral limbs to east
7. **Tree associates:** Ivy growing freely over tree; some evidence of historic bird nesting within ivy.
8. **Relationship to landscape features:** hedgerow tree
9. **Photographic record above.**
10. **Evidence of previous management works:** None evident
11. **Nil additional historic/ cultural value associated with tree.**
12. **Potential threats:** Nil biological observed other than general points noted in main text. Potential "sail" problem caused by ivy during strong winds.
13. **Management Recommendations:** Crown lift to approx. 6 metres, re-balance tree

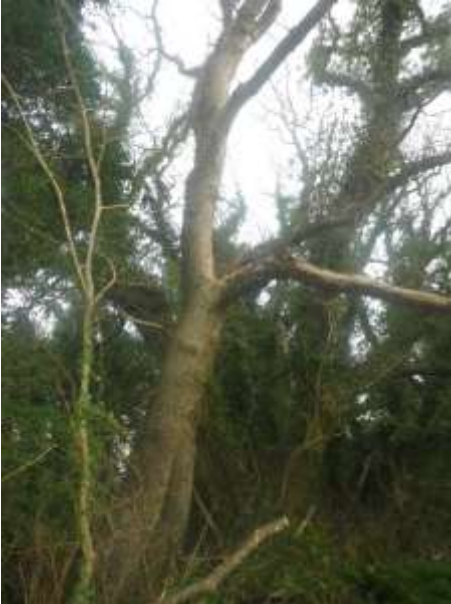
Tree 7F:

1. **Unique ref no:** 7F
2. **Grid Ref:**
3. **Measurements:** Diameter of stem 1.8m (measured); Height 20m (est.); Spread 14m(est.)
4. **Species:** Probably *Ulmus Procera*
5. **Estimated Age:** 80 years
6. **Tree Form and Vigour:** Appears to be maiden tree, single trunk, lean to west, some low lateral limbs to west and low deadwood
7. **Tree associates:** No ivy growing
8. **Relationship to landscape features:** hedgerow tree
9. **Photographic record above.**
10. **Evidence of previous management works:** None evident
11. **Nil additional historic/ cultural value associated with tree.**
12. **Potential threats:** Nil biological observed other than general points noted in main text. Potential "sail" problem caused by ivy during strong winds.
13. **Management Recommendations:** Crown lift to approx. 6 metres, re-balance tree

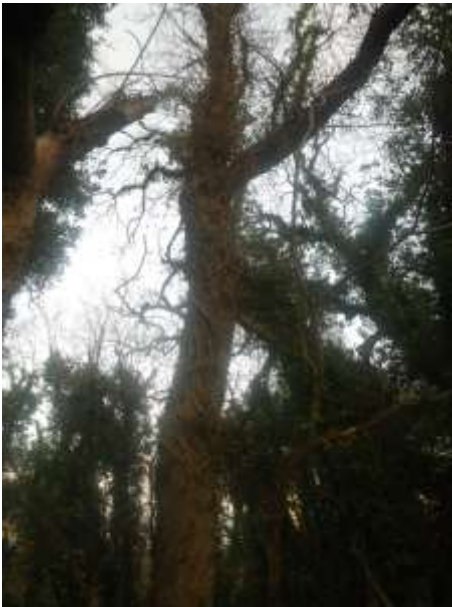
Tree 8F:

1. **Unique ref no:** 8F
2. **Grid Ref:**
3. **Measurements:** Diameter of stem 2.0m (measured); Height 20m (est.); Spread 14m(est.)
4. **Species:** Probably *Ulmus Procera*
5. **Estimated Age:** 80 years
6. **Tree Form and Vigour:** Appears to be maiden tree, single trunk, lean to west, some low lateral limbs to west
7. **Tree associates:** Ivy growing freely over tree; some evidence of historic bird nesting within ivy.
8. **Relationship to landscape features:** hedgerow tree
9. **Photographic record above.**
10. **Evidence of previous management works:** None evident
11. **Nil additional historic/ cultural value associated with tree.**
12. **Potential threats:** Nil biological observed other than general points noted in main text. Potential “sail” problem caused by ivy during strong winds.
13. **Management Recommendations:** Crown lift to approx. 6 metres, re-balance tree

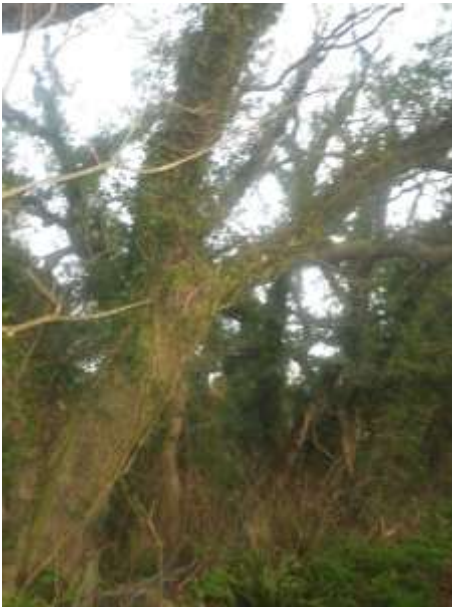
Tree 9F:

1. **Unique ref no:** 9F
2. **Grid Ref:**
3. **Measurements:** Diameter of stem 2.2m (measured); Height 20m (est.); Spread 14m(est.)
4. **Species:** Probably *Ulmus Procera*

5. **Estimated Age:** 90+ years
6. **Tree Form and Vigour:** Appears to be maiden tree, single trunk, very significant lean to west, some low lateral limbs to west

12. **Potential threats:** Nil biological observed other than general points noted in main text. Potential "sail" problem caused by ivy during strong winds.

13. **Management Recommendations:** Crown lift to approx. 6 metres, re-balance tree

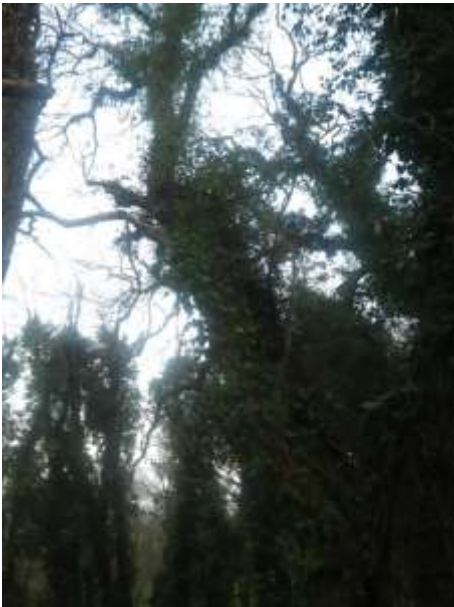
Tree 10F:

1. **Unique ref no:** 10F
2. **Grid Ref:**
3. **Measurements:** Diameter of stem 2.0m (measured); Height 20m (est.); Spread 14m(est.)
4. **Species:** Probably *Ulmus Procera*

5. **Estimated Age:** 90 years
6. **Tree Form and Vigour:** Appears to be maiden tree, single trunk, very significant lean to east, some low lateral limbs to east

12. **Potential threats:** Nil biological observed other than general points noted in main text. Potential "sail" problem caused by ivy during strong winds.

13. **Management Recommendations:** Crown lift to approx. 6 metres, re-balance tree
