HOLY VALE TREE SURVEY

For works under Natural England Higher
Level Stewardship AG00596391

Written by Matthew Rogers B.A. (Hons.), NPTC
City and Guilds Level 3 Arboriculture

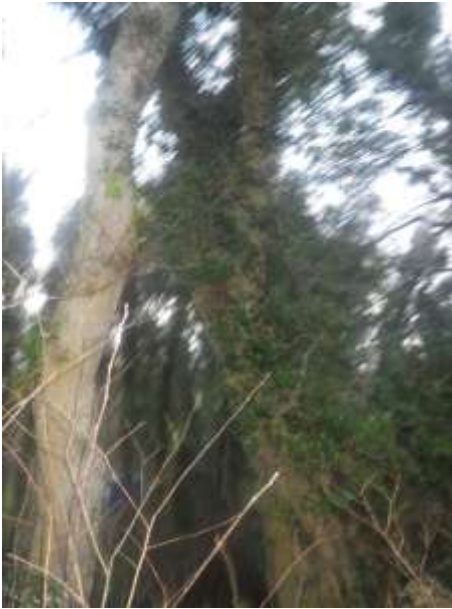
Tree 11F:

1. **Unique ref no:** 11F
2. **Grid Ref:**
3. **Measurements:** Diameter of stem 2.2m (measured); Height 20m (est.); Spread 14m(est.)
4. **Species:** Probably *Ulmus Procera*
5. **Estimated Age:** 90+ years
6. **Tree Form and Vigour:** Appears to be maiden tree, single trunk, lean to east, some low lateral limbs to east
7. **Tree associates:** Ivy growing freely over tree; some evidence of historic bird nesting within ivy.
8. **Relationship to landscape features:** hedgerow tree
9. **Photographic record above.**
10. **Evidence of previous management works:** None evident
11. **Nil additional historic/ cultural value associated with tree.**
12. **Potential threats:** Nil biological observed other than general points noted in main text. Potential "sail" problem caused by ivy during strong winds.
13. **Management Recommendations:** Crown lift to approx. 6 metres, re-balance tree

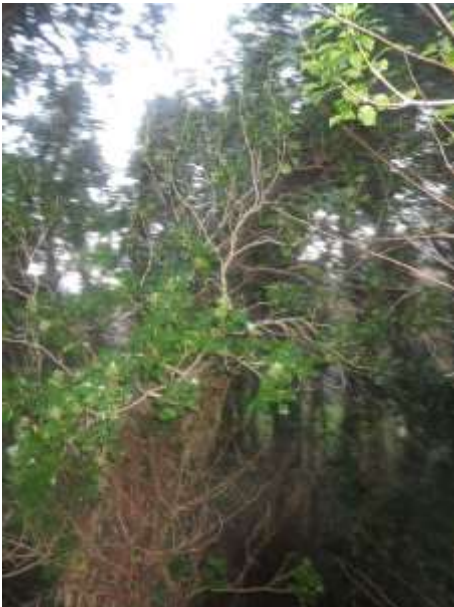
Tree 12F:

1. **Unique ref no:** 12F
2. **Grid Ref:**
3. **Measurements:** Diameter of stem 1.8m (measured); Height 20m (est.); Spread 14m(est.)
4. **Species:** Probably *Ulmus Procera*

5. **Estimated Age:** 90 years
6. **Tree Form and Vigour:** Appears to be maiden tree, single trunk, very significant lean to east, some low lateral limbs to east

12. **Potential threats:** Nil biological observed other than general points noted in main text. Potential "sail" problem caused by ivy during strong winds. Tree is already partially windblown

13. **Management Recommendations:** Pollard to approx. 3 metres

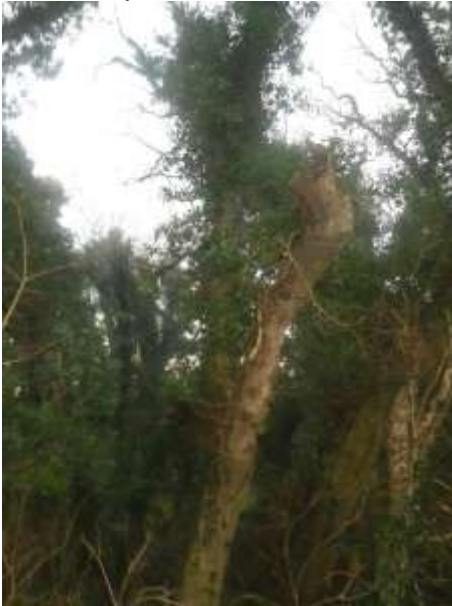
Tree 13F:

Medium potential for bat roost

1. **Unique ref no:** 13F
2. **Grid Ref:**
3. **Measurements:** Diameter of stem 1.8m (measured); Height 20m (est.); Spread 14m(est.)
4. **Species:** Probably *Ulmus Procera*

5. **Estimated Age:** 80 years
6. **Tree Form and Vigour:** Appears to be maiden tree, single trunk, lean to west, large dead limb to west, possible historic wind damage

12. **Potential threats:** Significant rot observed in large limb to west. Potential "sail" problem caused by ivy during strong winds.
13. **Management Recommendations:** Minimal crown lift to approx. 6 metres, re-balance tree, taking into consideration the recommendations for mitigating the risk to any potential bat roost.

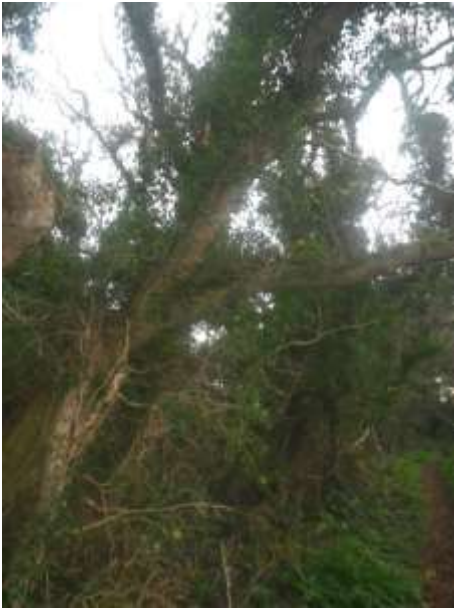
Tree 14F:

1. **Unique ref no:** 14F
2. **Grid Ref:**
3. **Measurements:** Diameter of stem 2.0m (measured); Height 20m (est.); Spread 14m(est.)
4. **Species:** Probably *Ulmus Procera*

5. **Estimated Age:** 90 years
6. **Tree Form and Vigour:** Appears to be maiden tree, single main trunk, very significant lean to west, one large low lateral branch to west

12. **Potential threats:** Nil biological observed other than general points noted in main text. Potential "sail" problem caused by ivy during strong winds.

13. **Management Recommendations:** Crown lift to approx. 6 metres, re-balance tree

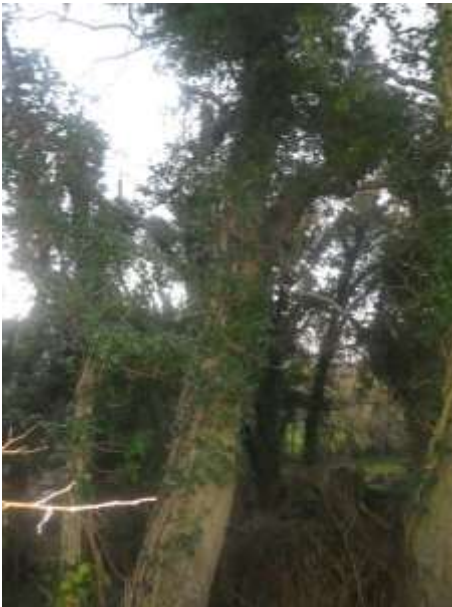
Tree 15F:

1. **Unique ref no:** 15F
2. **Grid Ref:**
3. **Measurements:** Diameter of stem 2.0m (measured); Height 20m (est.); Spread 14m(est.)
4. **Species:** Probably *Ulmus Procera*
5. **Estimated Age:** 90 years
6. **Tree Form and Vigour:** Appears to be maiden tree, single trunk, lean to east, one large low limb to east, some deadwood
7. **Tree associates:** Ivy growing freely over tree; some evidence of historic bird nesting within ivy.
8. **Relationship to landscape features:** hedgerow tree
9. **Photographic record above.**
10. **Evidence of previous management works:** None evident
11. **Nil additional historic/ cultural value associated with tree.**
12. **Potential threats:** Nil biological observed other than general points noted in main text. Potential "sail" problem caused by ivy during strong winds.
13. **Management Recommendations:** Crown lift to approx. 6 metres, re-balance tree

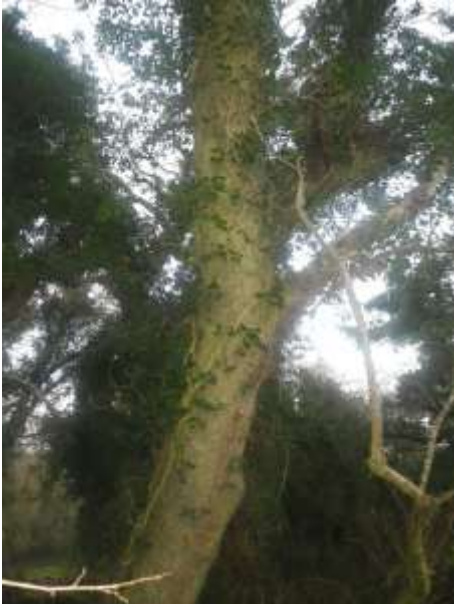
Tree 16F:

1. **Unique ref no:** 16F
2. **Grid Ref:**
3. **Measurements:** Diameter of stem 2.2m (measured); Height 20m (est.); Spread 14m(est.)
4. **Species:** Probably *Ulmus Procera*
5. **Estimated Age:** 90+ years
6. **Tree Form and Vigour:** Appears to be maiden tree, upright single stem, some lower deadwood
7. **Tree associates:** Ivy growing freely over tree; some evidence of historic bird nesting within ivy.
8. **Relationship to landscape features:** hedgerow tree
9. **Photographic record above.**
10. **Evidence of previous management works:** None evident
11. **Nil additional historic/ cultural value associated with tree.**
12. **Potential threats:** Nil biological observed other than general points noted in main text. Potential "sail" problem caused by ivy during strong winds.
13. **Management Recommendations:** Crown lift to approx. 6 metres, remove deadwood

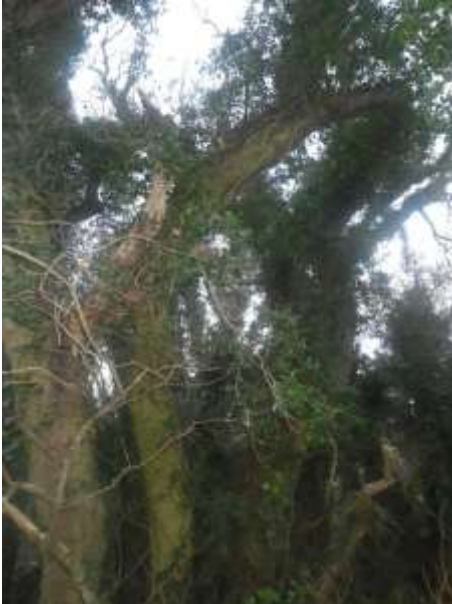
Tree 17F:

1. **Unique ref no:** 17F
2. **Grid Ref:**
3. **Measurements:** Diameter of stem 1.8m (measured); Height 20m (est.); Spread 14m(est.)
4. **Species:** Probably *Ulmus Procera*
5. **Estimated Age:** 90 years
6. **Tree Form and Vigour:** Appears to be maiden tree, single trunk with odd growth shape, upright, some deadwood
7. **Tree associates:** Ivy growing freely over tree; some evidence of historic bird nesting within ivy.
8. **Relationship to landscape features:** hedgerow tree
9. **Photographic record above.**
10. **Evidence of previous management works:** None evident
11. **Nil additional historic/ cultural value associated with tree.**
12. **Potential threats:** Nil biological observed other than general points noted in main text. Potential "sail" problem caused by ivy during strong winds.
13. **Management Recommendations:** Crown lift to approx. 6 metres, deadwood

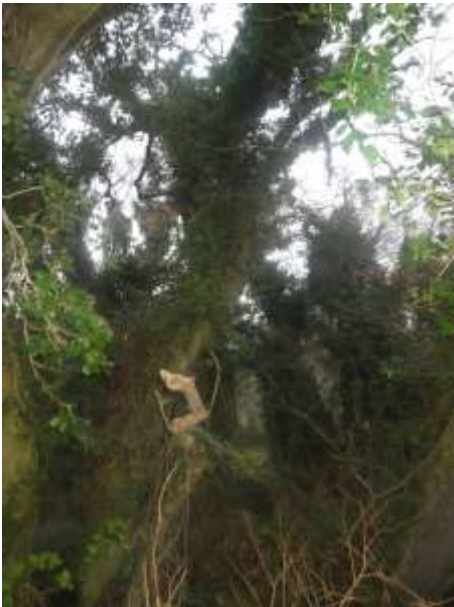
Tree 18F:

1. **Unique ref no:** 18F
2. **Grid Ref:**
3. **Measurements:** Diameter of stem 2.0m (measured); Height 20m (est.); Spread 14m(est.)
4. **Species:** Probably *Ulmus Procera*
5. **Estimated Age:** 90 years
6. **Tree Form and Vigour:** Appears to be maiden tree, single trunk, lean to east, some low lateral limbs to east
7. **Tree associates:** Ivy growing freely over tree; some evidence of historic bird nesting within ivy.
8. **Relationship to landscape features:** hedgerow tree
9. **Photographic record above.**
10. **Evidence of previous management works:** None evident
11. **Nil additional historic/ cultural value associated with tree.**
12. **Potential threats:** Nil biological observed other than general points noted in main text. Potential "sail" problem caused by ivy during strong winds.
13. **Management Recommendations:** Crown lift to approx. 6 metres, re-balance tree

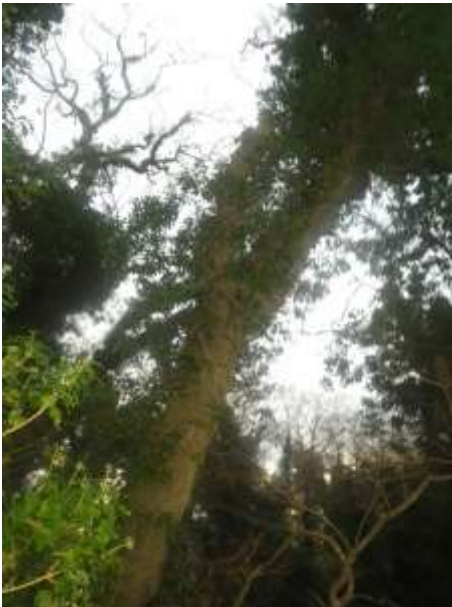
Tree 19F:

1. **Unique ref no:** 19F
2. **Grid Ref:**
3. **Measurements:** Diameter of stem 2.0m (measured); Height 20m (est.); Spread 14m(est.)
4. **Species:** Probably *Ulmus Procera*
5. **Estimated Age:** 90 years
6. **Tree Form and Vigour:** Appears to be maiden tree, single trunk, lean to south, some low lateral limbs to south
7. **Tree associates:** Ivy growing freely over tree; some evidence of historic bird nesting within ivy.
8. **Relationship to landscape features:** hedgerow tree
9. **Photographic record above.**
10. **Evidence of previous management works:** None evident
11. **Nil additional historic/ cultural value associated with tree.**
12. **Potential threats:** Nil biological observed other than general points noted in main text. Potential "sail" problem caused by ivy during strong winds.
13. **Management Recommendations:** Crown lift to approx. 6 metres, re-balance tree

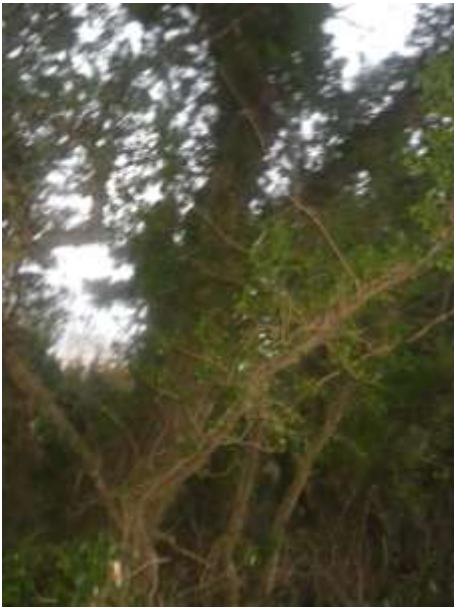
Tree 20F:

1. **Unique ref no:** 20F
2. **Grid Ref:**
3. **Measurements:** Diameter of stem 2.3m (measured); Height 20m (est.); Spread 14m(est.)
4. **Species:** Probably *Ulmus Procera*
5. **Estimated Age:** 90+ years
6. **Tree Form and Vigour:** Appears to be maiden tree, single trunk, lean to west, some low lateral limbs to west
7. **Tree associates:** Ivy growing freely over tree; some evidence of historic bird nesting within ivy.
8. **Relationship to landscape features:** hedgerow tree
9. **Photographic record above.**
10. **Evidence of previous management works:** None evident
11. **Nil additional historic/ cultural value associated with tree.**
12. **Potential threats:** Nil biological observed other than general points noted in main text. Potential "sail" problem caused by ivy during strong winds.
13. **Management Recommendations:** Crown lift to approx. 6 metres, re-balance tree

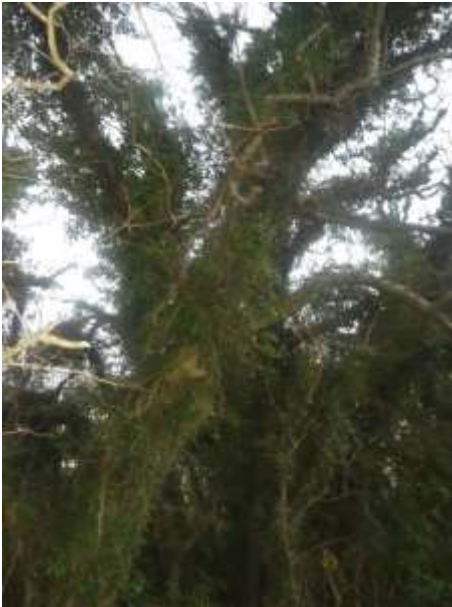
Tree 21F:

1. **Unique ref no:** 21F
2. **Grid Ref:**
3. **Measurements:** Diameter of stem 2.4m (measured); Height 20m (est.); Spread 14m(est.)
4. **Species:** Probably *Ulmus Procera*

5. **Estimated Age:** 90+ years
6. **Tree Form and Vigour:** Appears to be maiden tree, single main trunk but multiple lower lateral limbs at approx. 4 metres, upright

12. **Potential threats:** Nil biological observed other than general points noted in main text. Potential "sail" problem caused by ivy during strong winds.

13. **Management Recommendations:** Crown lift to approx. 6 metres, re-balance tree

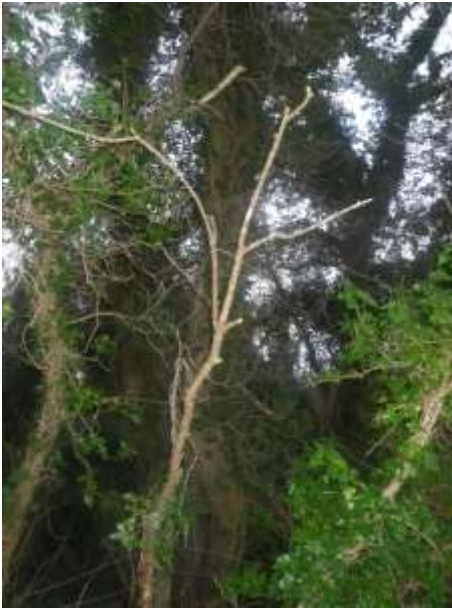
Tree 22F:

1. **Unique ref no:** 22F
2. **Grid Ref:**
3. **Measurements:** Diameter of stem 1.8m (measured); Height 20m (est.); Spread 14m(est.)
4. **Species:** Probably *Ulmus Procera*

5. **Estimated Age:** 80 years
6. **Tree Form and Vigour:** Appears to be maiden tree, single trunk, slight lean to west, and large low limb to west, some scarring on main trunk suggests historic injury

12. **Potential threats:** Scarring on main stem maybe source of future rot and bacterial infection. Potential "sail" problem caused by ivy during strong winds.

13. **Management Recommendations:** Crown lift to approx. 6 metres, re-balance tree, monitor overall health of tree

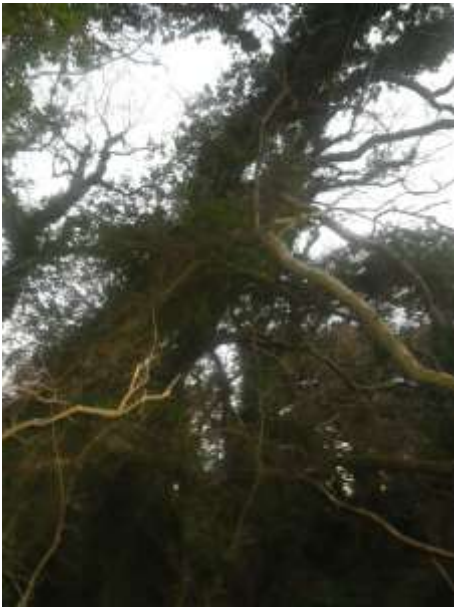
Tree 23F:

1. **Unique ref no:** 23F
2. **Grid Ref:**
3. **Measurements:** Diameter of stem 2.0m (measured); Height 20m (est.); Spread 14m(est.)
4. **Species:** Probably *Ulmus Procera*
5. **Estimated Age:** 90 years
6. **Tree Form and Vigour:** Appears to be maiden tree, single trunk, lean to west, some low lateral limbs to west
7. **Tree associates:** Ivy growing freely over tree; some evidence of historic bird nesting within ivy.
8. **Relationship to landscape features:** hedgerow tree
9. **Photographic record above.**
10. **Evidence of previous management works:** None evident
11. **Nil additional historic/ cultural value associated with tree.**
12. **Potential threats:** Nil biological observed other than general points noted in main text. Potential "sail" problem caused by ivy during strong winds.
13. **Management Recommendations:** Crown lift to approx. 6 metres, re-balance tree

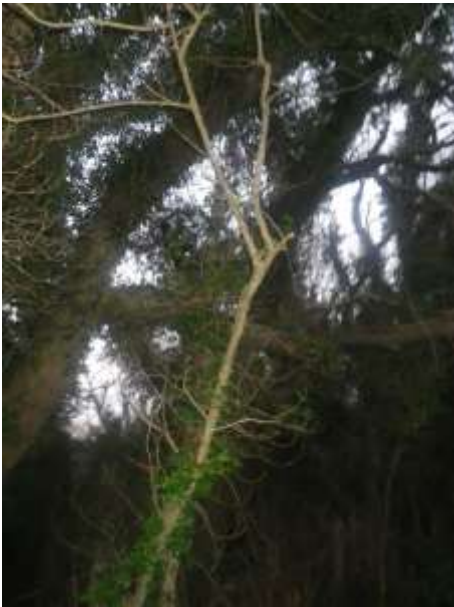
Tree 24F:

1. **Unique ref no:** 24F
2. **Grid Ref:**
3. **Measurements:** Diameter of stem 1.9m (measured); Height 20m (est.); Spread 14m(est.)
4. **Species:** Probably *Ulmus Procera*

5. **Estimated Age:** 80 years
6. **Tree Form and Vigour:** Appears to be maiden tree, single trunk, lean to west, some low lateral limbs to west including one very large lateral limb overhanging public path adjacent

12. **Potential threats:** Nil biological observed other than general points noted in main text. Potential "sail" problem caused by ivy during strong winds.

13. **Management Recommendations:** Crown lift to approx. 6 metres, re-balance tree

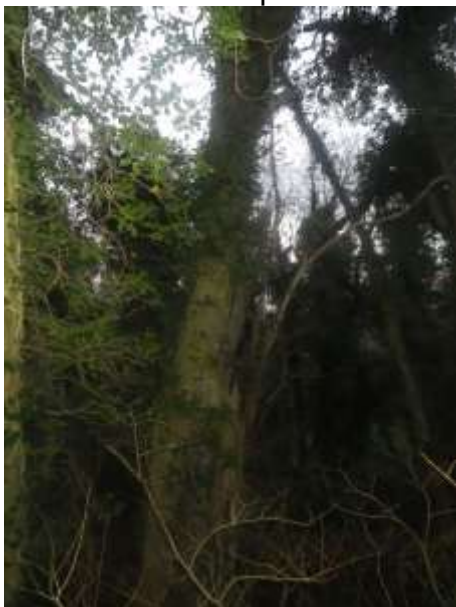
Tree 25F:

Medium bat roost potential

1. **Unique ref no:** 25F
2. **Grid Ref:**
3. **Measurements:** Diameter of stem 2.0m (measured); Height 20m (est.); Spread 14m(est.)
4. **Species:** Probably *Ulmus Procera*

5. **Estimated Age:** 90 years
6. **Tree Form and Vigour:** Appears to be maiden tree, single trunk, lean to west, some low lateral limbs to west, large vertical split in bark and trunk evident possibly from historic wound

12. **Potential threats:** Potential for bacteria and additional rot to enter through split in trunk, Nil additional biological observed other than general points noted in main text. Potential "sail" problem caused by ivy during strong winds.

13. **Management Recommendations:** Minimal crown lift to approx. 6 metres, re-balance tree, regularly monitor tree's overall condition, taking into consideration the recommendations for mitigating the risk to any potential bat roost.

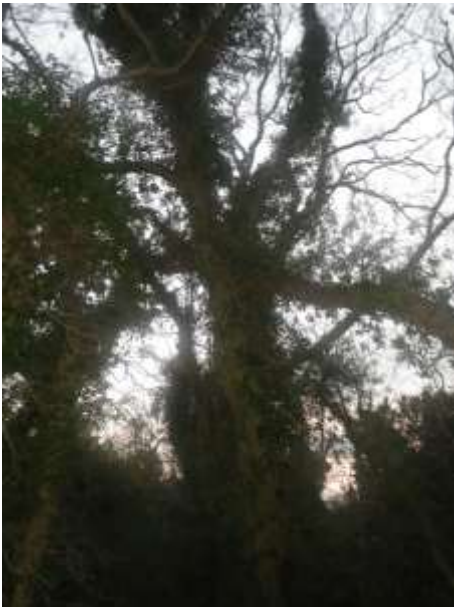
Tree 26F:

1. **Unique ref no:** 26F
2. **Grid Ref:**
3. **Measurements:** Diameter of stem 2.5m (measured); Height 20m (est.); Spread 14m(est.)
4. **Species:** Probably *Ulmus Procera*

5. **Estimated Age:** 90+ years
6. **Tree Form and Vigour:** Appears to be maiden tree, single trunk, upright, multiple vertical splits in trunk and bark

12. **Potential threats:** Nil biological observed other than general points noted in main text. Potential "sail" problem caused by ivy during strong winds.

13. **Management Recommendations:** Crown lift to approx. 6 metres, re-balance tree, monitor condition of tree regularly

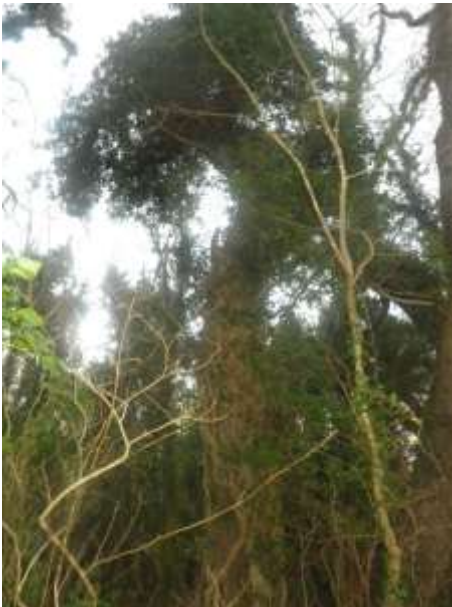
Tree 27F:

1. **Unique ref no:** 27F
2. **Grid Ref:**
3. **Measurements:** Diameter of stem 2.0m (measured); Height 20m (est.); Spread 14m(est.)
4. **Species:** Probably *Ulmus Procera*
5. **Estimated Age:** 90 years
6. **Tree Form and Vigour:** Appears to be maiden tree, single trunk, lean to east, some low lateral limbs to east
7. **Tree associates:** Ivy growing freely over tree; some evidence of historic bird nesting within ivy.
8. **Relationship to landscape features:** hedgerow tree
9. **Photographic record above.**
10. **Evidence of previous management works:** None evident
11. **Nil additional historic/ cultural value associated with tree.**
12. **Potential threats:** Nil biological observed other than general points noted in main text. Potential "sail" problem caused by ivy during strong winds.
13. **Management Recommendations:** Crown lift to approx. 6 metres, re-balance tree

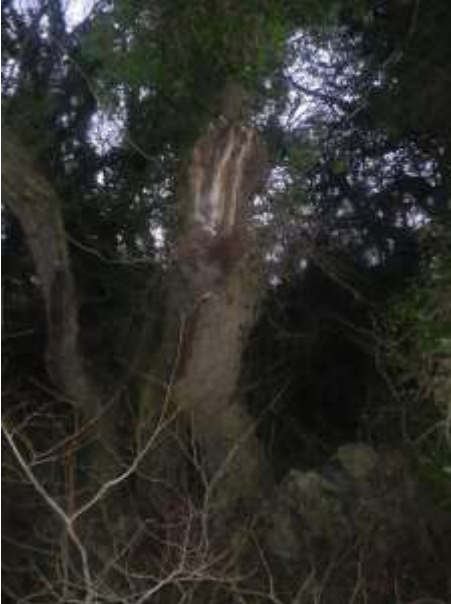
Tree 28F:

1. **Unique ref no:** 28F
2. **Grid Ref:**
3. **Measurements:** Diameter of stem 2.0m (measured); Height 20m (est.); Spread 14m(est.)
4. **Species:** Probably *Ulmus Procera*
5. **Estimated Age:** 90 years
6. **Tree Form and Vigour:** Appears to be maiden tree, single trunk, snapped off probably due to wind at burr approx. 3 metres
7. **Tree associates:** Ivy growing freely over tree; some evidence of historic bird nesting within ivy.
8. **Relationship to landscape features:** hedgerow tree
9. **Photographic record above.**
10. **Evidence of previous management works:** None evident
11. **Nil additional historic/ cultural value associated with tree.**
12. **Potential threats:** Nil biological observed other than general points noted in main text. Potential “sail” problem caused by ivy during strong winds.
13. **Management Recommendations:** Pollard to approx. 2.5 metres

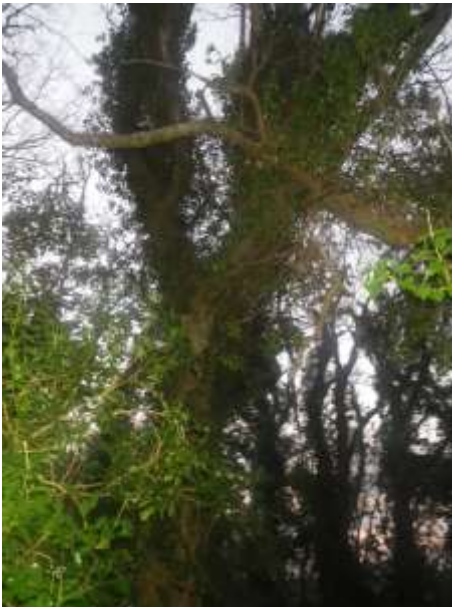
Tree 29F:

1. **Unique ref no:** 29F
2. **Grid Ref:**
3. **Measurements:** Diameter of stem 2.2m (measured); Height 20m (est.); Spread 14m(est.)
4. **Species:** Probably *Ulmus Procera*

5. **Estimated Age:** 90 years
6. **Tree Form and Vigour:** Appears to be maiden tree, three co-dominant stems at approx. 4 metres, some lower limbs and deadwood to west

12. **Potential threats:** Nil biological observed other than general points noted in main text. Potential “sail” problem caused by ivy during strong winds.

13. **Management Recommendations:** Crown lift to approx. 6 metres, re-balance tree

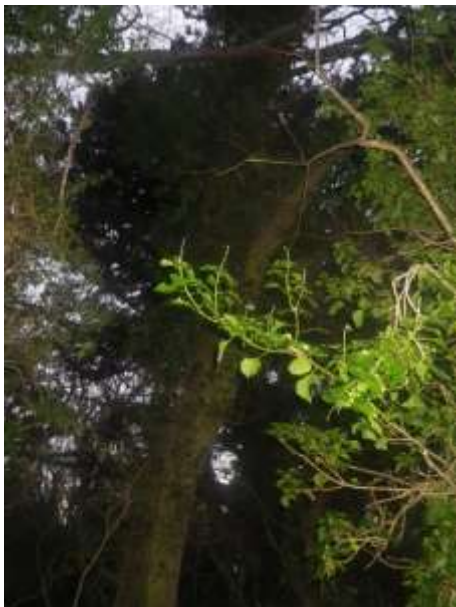
Tree 30F:

1. **Unique ref no:** 30F
2. **Grid Ref:**
3. **Measurements:** Diameter of stem 2.0m (measured); Height 20m (est.); Spread 14m(est.)
4. **Species:** Probably *Ulmus Procera*
5. **Estimated Age:** 90 years
6. **Tree Form and Vigour:** Appears to be maiden tree, single trunk, lean to west and large lateral limb to west
7. **Tree associates:** Ivy growing freely over tree; some evidence of historic bird nesting within ivy.
8. **Relationship to landscape features:** hedgerow tree
9. **Photographic record above.**
10. **Evidence of previous management works:** None evident
11. **Nil additional historic/ cultural value associated with tree.**
12. **Potential threats:** Nil biological observed other than general points noted in main text. Potential "sail" problem caused by ivy during strong winds.
13. **Management Recommendations:** Crown lift to approx. 6 metres, re-balance tree

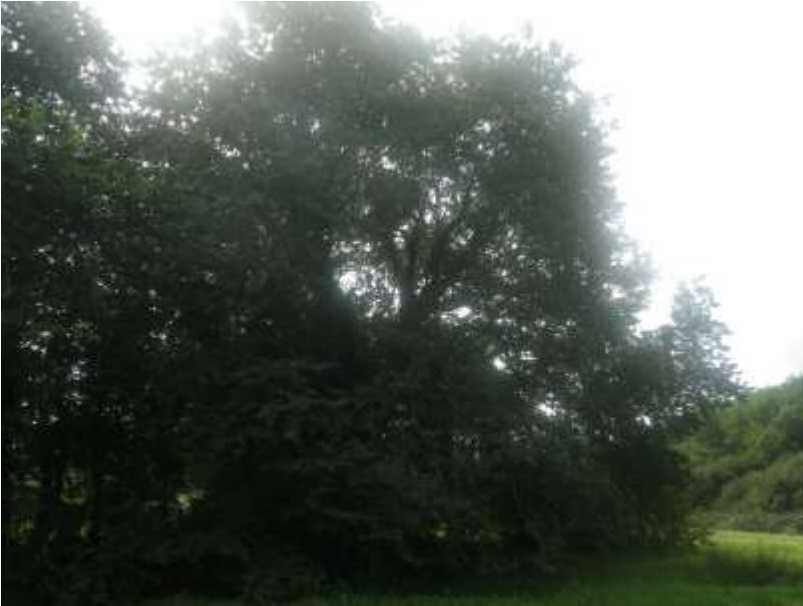
This is a number of mature, semi mature and saplings growing along a stone hedgerow in a corner of a field running approximately north west to south east and south west to north east and bordering fields on either side. The FEP identified five trees along this row which require major tree surgery. This row is surveyed from the north east sequentially.

One tree was identified as hosting *Bacidia incompta* and also having a medium potential for a bat roost.

Fig 2.3 Elm row G viewed from north looking south

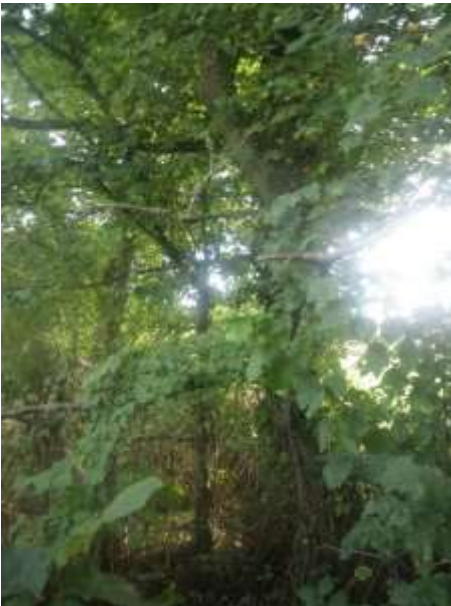
Tree 1G:

1. **Unique ref no:** 1G
2. **Grid Ref:**
3. **Measurements:** Diameter of stem 1.6m (measured); Height 16m (est.); Spread 12m(est.)
4. **Species:** Probably *Ulmus Procera*
5. **Estimated Age:** 50 years
6. **Tree Form and Vigour:** Appears to be maiden tree, single trunk, significant lateral limbs to north west
7. **Tree associates:** Ivy growing freely over tree; some evidence of historic bird nesting within ivy.
8. **Relationship to landscape features:** hedgerow tree
9. **Photographic record above.**
10. **Evidence of previous management works:** None evident

12. Potential threats: Nil biological observed other than general points noted in main text. Potential “sail” problem caused by ivy during strong winds.

13. Management Recommendations: Crown lift to approx. 4 metres, re-balance tree

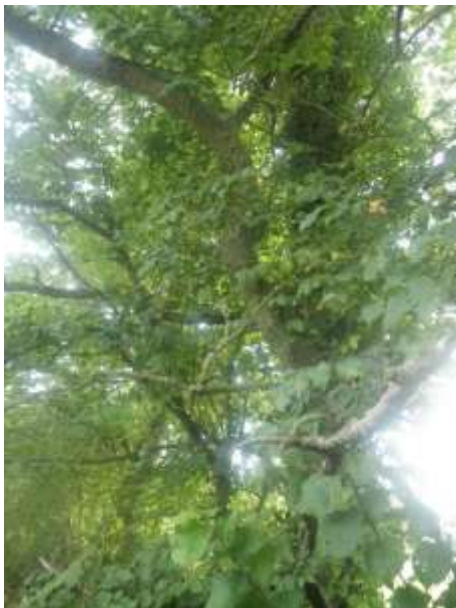
Tree 2G:

1. Unique ref no: 2G

12. Potential threats: Nil biological observed other than general points noted in main text. Potential “sail” problem caused by ivy during strong winds.

13. Management Recommendations: Crown lift to approx. 4 metres, re-balance tree

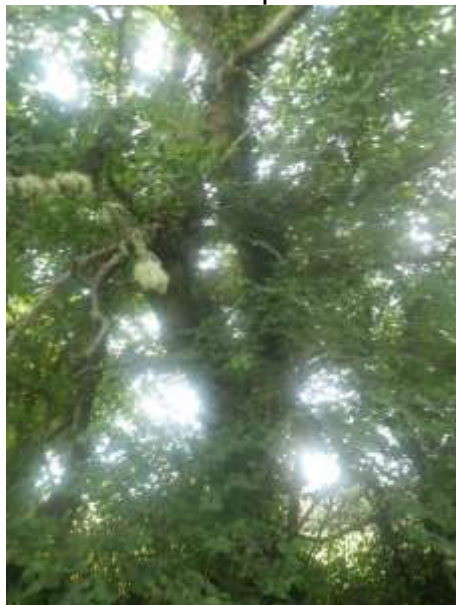
Tree 3G:

Bacidia incompta present
Medium bat roost potential

1. **Unique ref no:** 3G
2. **Grid Ref:**
3. **Measurements:** Diameter of stem 2.2m (measured); Height 18m (est.); Spread 20m(est.)
4. **Species:** Probably *Ulmus Procera*

5. **Estimated Age:** 90 years
6. **Tree Form and Vigour:** Appears to be maiden tree, single trunk, multiple lateral limbs particularly to west, some deadwood, active growth

7. **Tree associates:** Ivy growing freely over tree; some evidence of historic bird nesting within ivy. *Bacidia incompta* noted by lichen survey
8. **Relationship to landscape features:** hedgerow tree

12. **Potential threats:** Nil biological observed other than general points noted in main text. Potential "sail" problem caused by ivy during strong winds.

13. **Management Recommendations:** Minimal crown lift to approx. 4 metres, re-balance tree. Aim to preserve and increase colony of *Bacidia incompta* by carefully clearing ivy off this and adjacent trees and not to remove current dead branch that hosts *Bacidia incompta* unless it has already naturally fallen. Any works should take into consideration the recommendations for mitigating the risk to any potential bat roost.

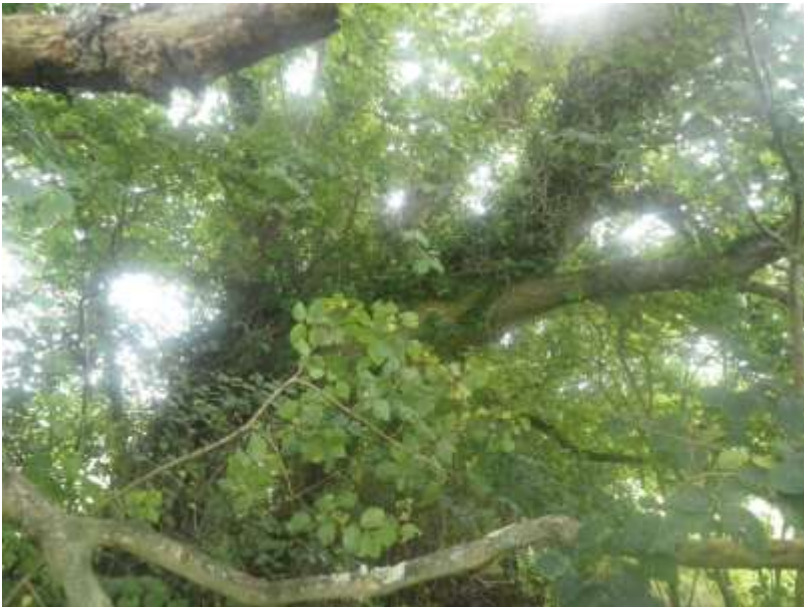
Tree 4G:

1. **Unique ref no:** 4G
2. **Grid Ref:**
3. **Measurements:** Diameter of stem 2.0m (measured); Height 16m (est.); Spread 16m(est.)
4. **Species:** Probably *Ulmus Procera*

5. **Estimated Age:** 90 years
6. **Tree Form and Vigour:** Appears to be maiden tree, single trunk, significant lateral limbs to west, significant lean to west

12. **Potential threats:** Nil biological observed other than general points noted in main text. Potential "sail" problem caused by ivy during strong winds.

13. **Management Recommendations:** Crown lift to approx. 4 metres, re-balance tree

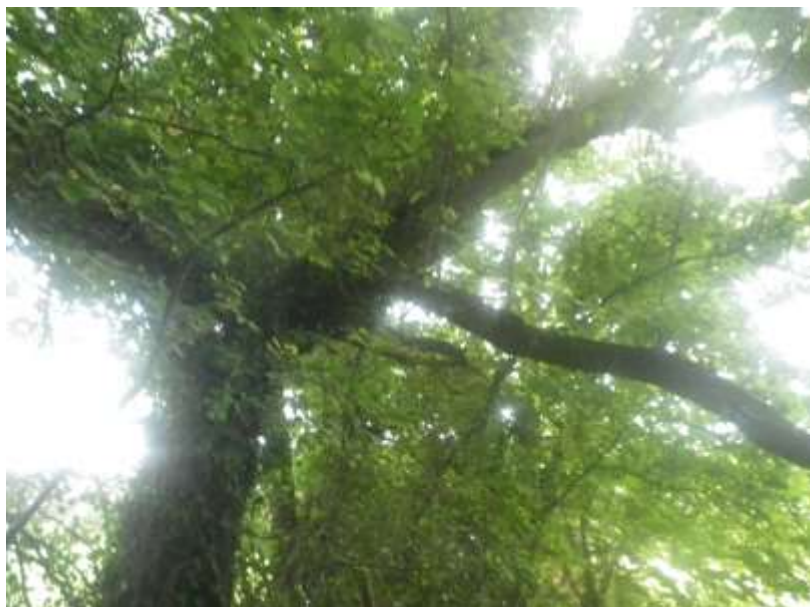
Tree 5G:

1. **Unique ref no:** 5G
2. **Grid Ref:**
3. **Measurements:** Diameter of stem 1.9m (measured); Height 18m (est.); Spread 16m(est.)
4. **Species:** Probably *Ulmus Procera*

5. **Estimated Age:** 80 years
6. **Tree Form and Vigour:** Appears to be maiden tree, single trunk, significant lateral limbs to west and significant lean to west

12. **Potential threats:** Nil biological observed other than general points noted in main text. Potential "sail" problem caused by ivy during strong winds.

13. **Management Recommendations:** Crown lift to approx. 4 metres, re-balance tree

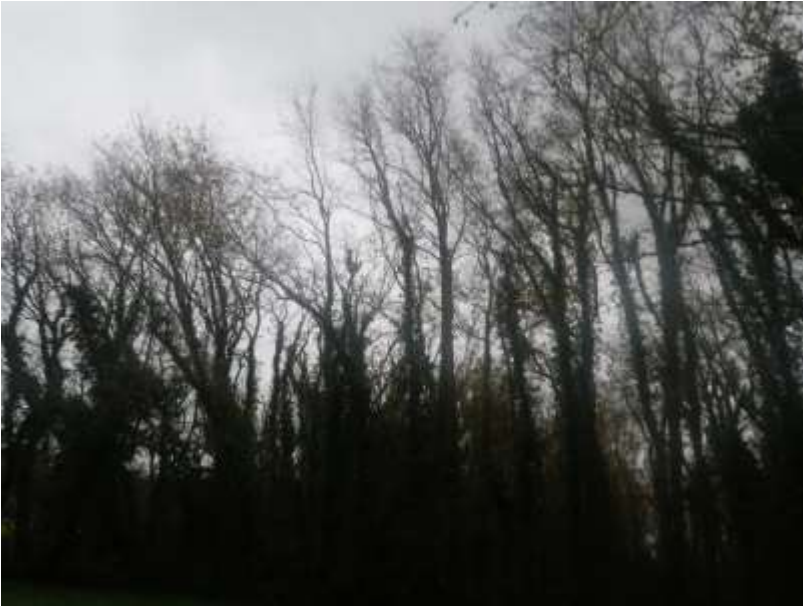
This is a number of mature, semi-mature and saplings (suckers) hedgerow specimens growing along a stone wall running east/ west and bordering two fields to the north and south. The trees have been surveyed from west to east sequentially, tree 1 being nearest to the western field boundary. The FEP identified four trees within this run which require major tree surgery.

Fig 2.4 Elm Row H looking south

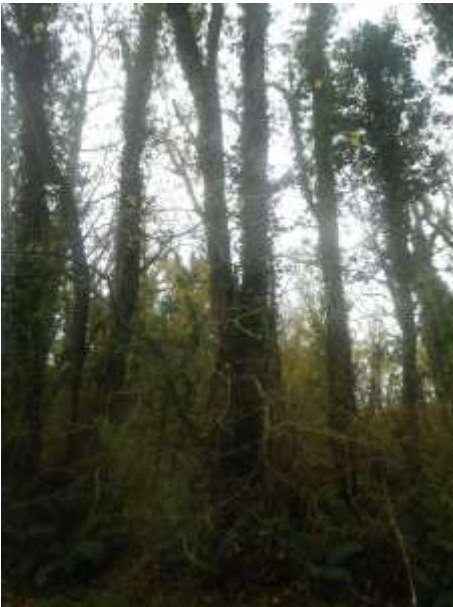
Tree 1H:

1. **Unique ref no:** 1H
2. **Grid Ref:**
3. **Measurements:** Diameter of stem 1.8m (measured); Height 24m (est.); Spread 14m(est.)
4. **Species:** Probably *Ulmus Procera*
5. **Estimated Age:** 80 years
6. **Tree Form and Vigour:** Appears to be previous lopped tree at approx. 1.5 metres from ground around 30 years ago, two co-dominant stems now growing from original cut, upright, active live growth, some lower deadwood, large limb to north
7. **Tree associates:** Ivy growing freely over tree; some evidence of historic bird nesting within ivy.
8. **Relationship to landscape features:** hedgerow tree
9. **Photographic record above.**

10. **Evidence of previous management works:** Previous pollard at approx. 1.5 metres
11. **Nil additional historic/ cultural value associated with tree.**
12. **Potential threats:** Some degradation of stem integrity around old pollard. Nil biological observed other than general points noted in main text. Potential “sail” problem caused by ivy during strong winds.
13. **Management Recommendations:** Crown lift to approx. 5 metres, deadwood lower areas and remove large limb to north.

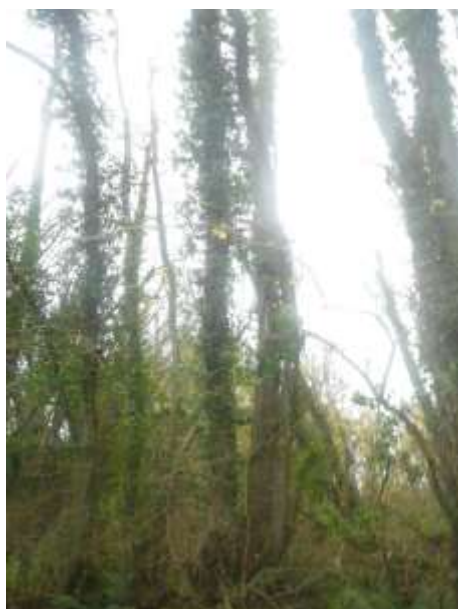
Tree 2H:

1. **Unique ref no:** 2H
2. **Grid Ref:**
3. **Measurements:** Diameter of stem 1.90m (measured); Height 24m (est.); Spread 14m(est.)
4. **Species:** Probably Ulmus Procera

5. **Estimated Age:** 80 years
6. **Tree Form and Vigour:** Appears to be previous lopped tree at approx. 1.5 metres from ground around 30 years ago, one thin straight stem now growing from original cut, upright, active live growth, some lower deadwood, large limb to north

12. **Potential threats:** Some degradation of stem integrity around old pollard. Nil biological observed other than general points noted in main text. Potential “sail” problem caused by ivy during strong winds.

13. **Management Recommendations:** Crown lift to approx. 5 metres, deadwood lower areas and remove large limb to north

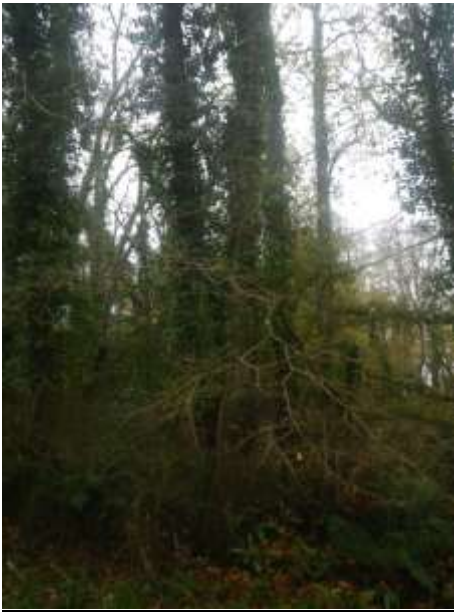
Tree 3H:

1. **Unique ref no:** 3H
2. **Grid Ref:**
3. **Measurements:** Diameter of stem 1.7m (measured); Height 24m (est.); Spread 14m(est.)
4. **Species:** Probably *Ulmus Procera*

5. **Estimated Age:** 70 years
6. **Tree Form and Vigour:** Appears to be previous lopped tree at approx. 1.5 metres from ground around 30 years ago, two co-dominant straight stems now growing from original cut, upright, active live growth, some lower deadwood, large limb to north

12. **Potential threats:** Some degradation of stem integrity around old pollard. Nil biological observed other than general points noted in main text. Potential "sail" problem caused by ivy during strong winds.

13. **Management Recommendations:** Crown lift to approx. 5 metres, deadwood lower areas and remove large limb to north

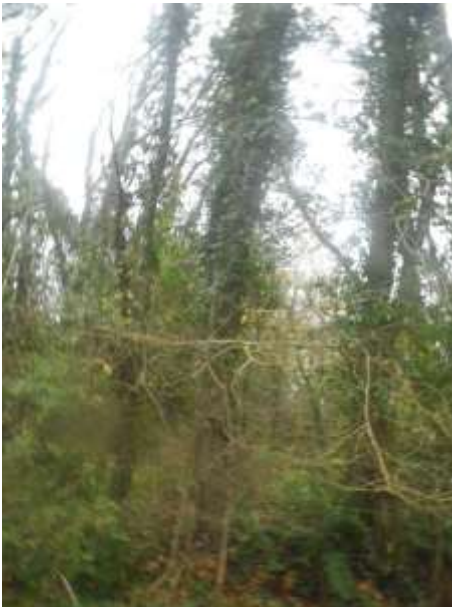
Tree 4H:

1. **Unique ref no:** 4H
2. **Grid Ref:**
3. **Measurements:** Diameter of stem 1.90m (measured); Height 24m (est.); Spread 14m(est.)
4. **Species:** Probably *Ulmus Procera*

5. **Estimated Age:** 80 years
6. **Tree Form and Vigour:** Appears to be previous lopped tree at approx. 1.5 metres from ground around 30 years ago, one large straight stem now growing from original cut, upright, active live growth, some lower deadwood, large limb to north

12. **Potential threats:** Some degradation of stem integrity around old pollard. Nil biological observed other than general points noted in main text. Potential “sail” problem caused by ivy during strong winds.

13. **Management Recommendations:** Crown lift to approx. 5 metres, deadwood lower areas and remove large limb to north
