Heritage Impact Statement

The Galley Takeaway

The Parade, St. Mary's, Isles of Scilly.

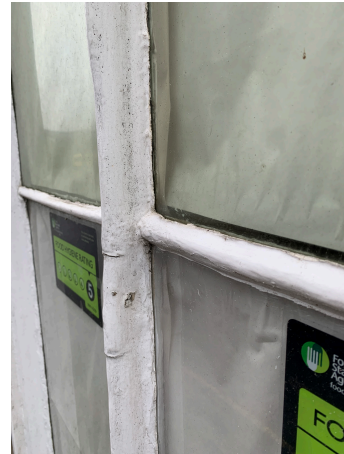
Existing Beading

On inspection of the large 6 pane glass windows it has been established that these windows were not made by a qualified carpenter and most likely constructed using cheap materials that would have been handy at the time. This can be easily noted as the windows are fitted with window putty on both inside and out; this should be a wooden transom with a bead or putty fixing to the outside only.

The replacement windows are identical in size to the existing windows, the original windows posts and door frame to remain. The only difference is the beading which will be made in the "Ovolo Moulding" traditional style, formed inside and out.
