Replacement Windows and Door

The Galley

Lower Parade, St. Mary's, Isles of Scilly.

Record of Existing Windows

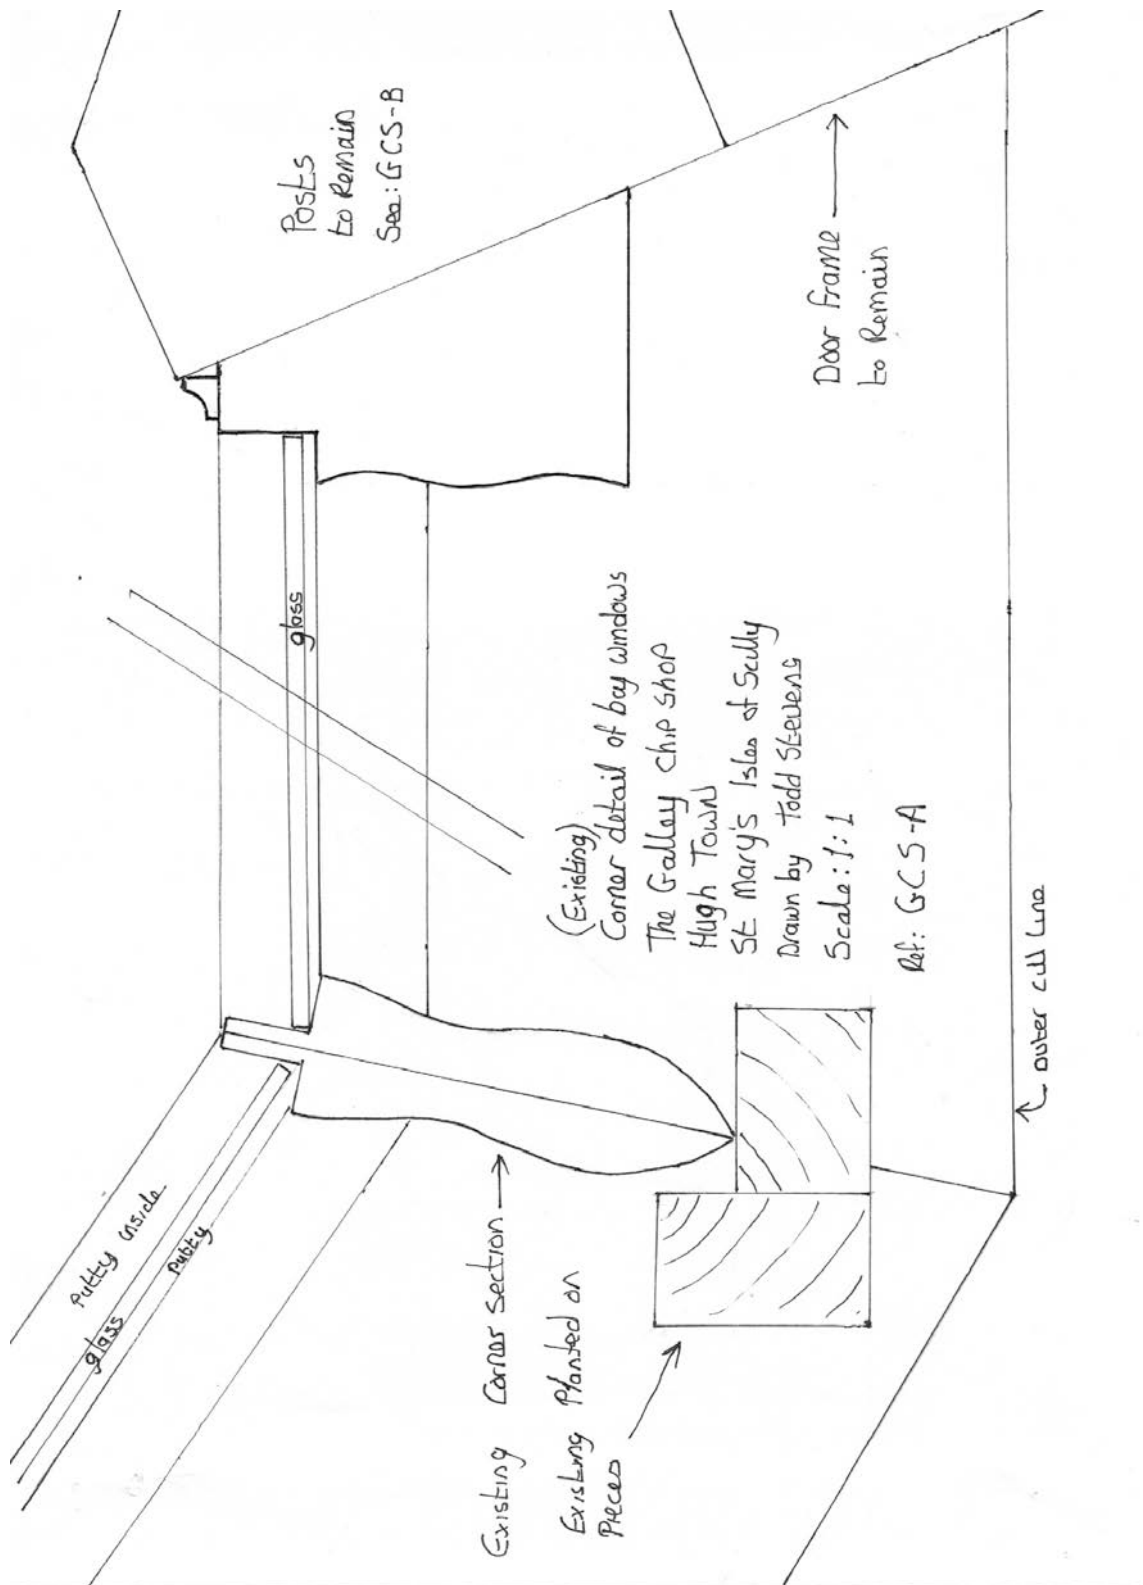
Firstly, it must be noted that the existing window frames are not original. What appears there currently is an oddity. The existing framing is made from softwood timber with a hardwood cill but it is made up of differing elements. There are four large heavily made solid wooden posts and a door frame which appear to be earlier than the actual frames that are to be replaced. These posts and door frame are set to remain. The existing windows being replaced appear to have been made up from either reworked lengths of weather boarding as that is the moulding that has been used in its construction, or that or a similar mould has been used. Its hard to say without taking it apart. The use of this mould in this way is something I have never seen before. The mould is machine made and not done by hand. Oddly, the existing frame is puttied from the inside and at the extreme ends of the frame the putty is all that shows from out of the wall reveals which is also not a correct or normal practice. There is also two uprights of square section softwood fixed over the corner joints on the outside of the frame, which I can only assume are a bodge to hide a poor joint on both corners or some kind of extra, if flimsy, support. The existing door frame has also been severely altered, rather poorly, at some point too. It is my opinion that a previous door frame is buried beneath the existing, and the existing shows signs of a previous door- so we must be on at least the third door hanging to this frame. The frontage leaks in places and is in desperate need of replacement. The glass to the existing frame is standard 4mm which also needs addressing. Some of the existing glass is currently in danger of falling out. In all my 40 years of working in bespoke joinery shops, which for the most part deal with old and indeed, listed building joinery replacement work, I have never seen the like of this construction before. Its appalling workmanship- something seen a lot over the years on Scilly as the islanders were often forced to make do and mend. I believe this is exactly what this existing frame to be- a make do and mend; which can in itself be a reflection and a part of local building history. This early 19th century building did not start life like this. One can see from what is to remain intact that this shop front has undergone at least 3 changes from the original. It is unclear exactly what that was. For what they are worth, I have produced some basic scaled section through drawings of the currently existing frame. With so much paint in evidence it is hard to determine some parts of this frame, which to me suggests it would make more sense to record the existing retrospectively once it has been removed. My drawings are therefore at best, educated guesswork.

The frame that is being proposed is to be a solid construction made locally of joinery quality timber with a hardwood cill. All to be painted. It is to be constructed in a traditional way using a sloped ovolo moulding the like of which can found at other properties at Scilly including this one. The shape of the cutters being used to form this shape were in fact taken from another similarly aged building nearby that still retained its original moulding. (*Madura- which is about 100 yards at most away from this property.*) I made the tooling to reproduce this same mould myself and think it prudent to use it again here at the Galley.

The glass will be 6mm toughened and beaded in externally using a bead to form the same ovolo moulding as employed on the interior. At the ends the frames will protrude from the wall reveals as they should and there will be no further need of any unnecessary square section timber on the outer corners as the joints on the new windows will be properly formed. When finished it will have a much more traditional look befitting the building. It will be fixed to the existing heavy posts which appear to be structural and look in good enough order to remain intact. However, I couldn't say if these existing posts are original but given the use of the chamfer mould upon them, which is more befitting of the 1930's, and this being an early 19th century building, I would guess at:- probably not!
