# PRELIMINARY ROOST ASSESSMENT (PRA)

## OUTBUILDING AT GREEN PASTURES, MCFARLAND'S DOWN, ST MARY'S, ISLES OF SCILLY

*Report date: 27<sup>th</sup> August 2021*

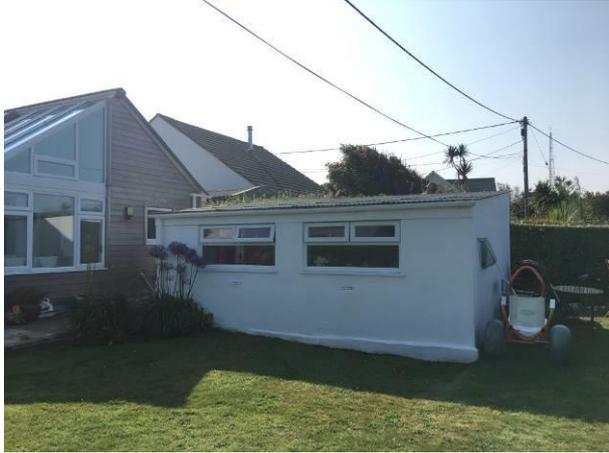
**Photograph 1:** Showing the outbuilding in context with the gable-end of the main residential property (Green Pastures) to the left.

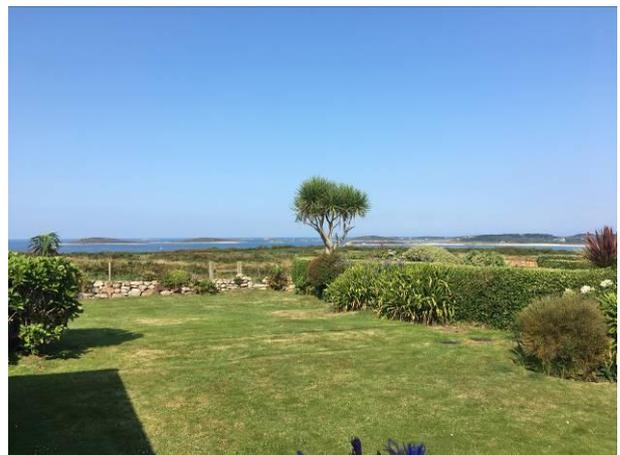
**Photograph 6:** Showing the landscape setting of the outbuilding (photograph taken from beside the building facing north-west across the residential garden).
