# PRELIMINARY ROOST ASSESSMENT (PRA)

## CHIMNEY REMOVAL AT FREESIA GUESTHOUSE HUGH TOWN, ST MARY'S, ISLES OF SCILLY

*Report date: 28<sup>th</sup> October 2021*

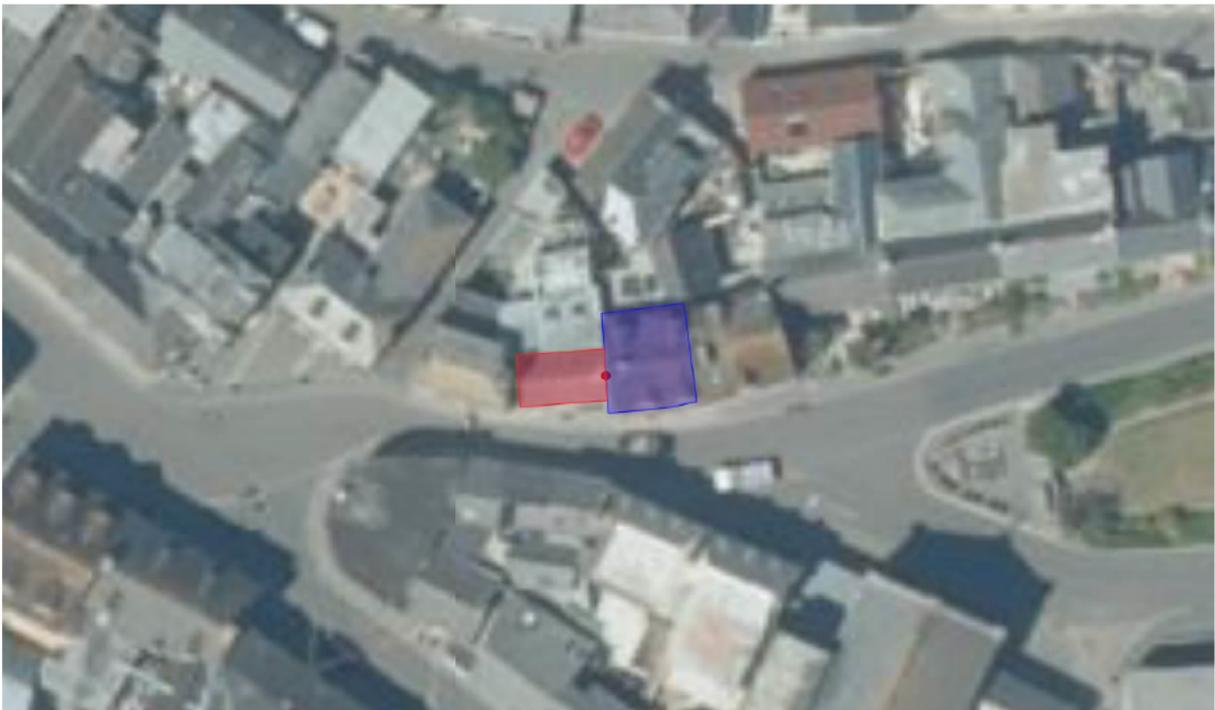
**Map 02** – Showing the chimney (indicated by the red dot) on the western gable end of Freesia Guesthouse (indicated in blue) with the adjacent Bordeaux property (indicated in red).
