PRELIMINARY ROOST ASSESSMENT (PRA)

1 BUZZA STREET
HUGH TOWN, ST MARY'S, ISLES OF SCILLY

Report date: 17th September 2021

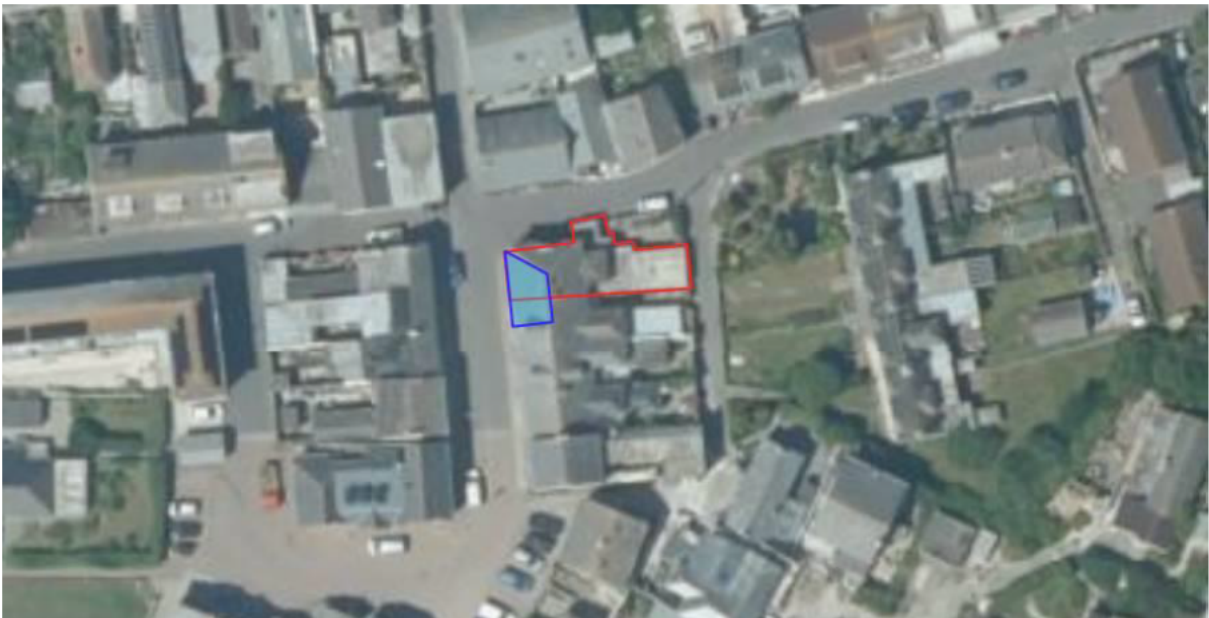
Map 02 – Showing the roof to be replaced (blue) which includes the western pitch of 1 Buzza Street and a portion of the neighbouring terraced property to the south – 2 Buzza Street. The footprint of the property 1 Buzza Street is indicated with the red line for reference.
