PRELIMINARY ROOST ASSESSMENT (PRA)

BISHOPS VIEW, ST MARY'S, ISLES OF SCILLY

Our reference: 23-7-1

Report date: 11th July 2023

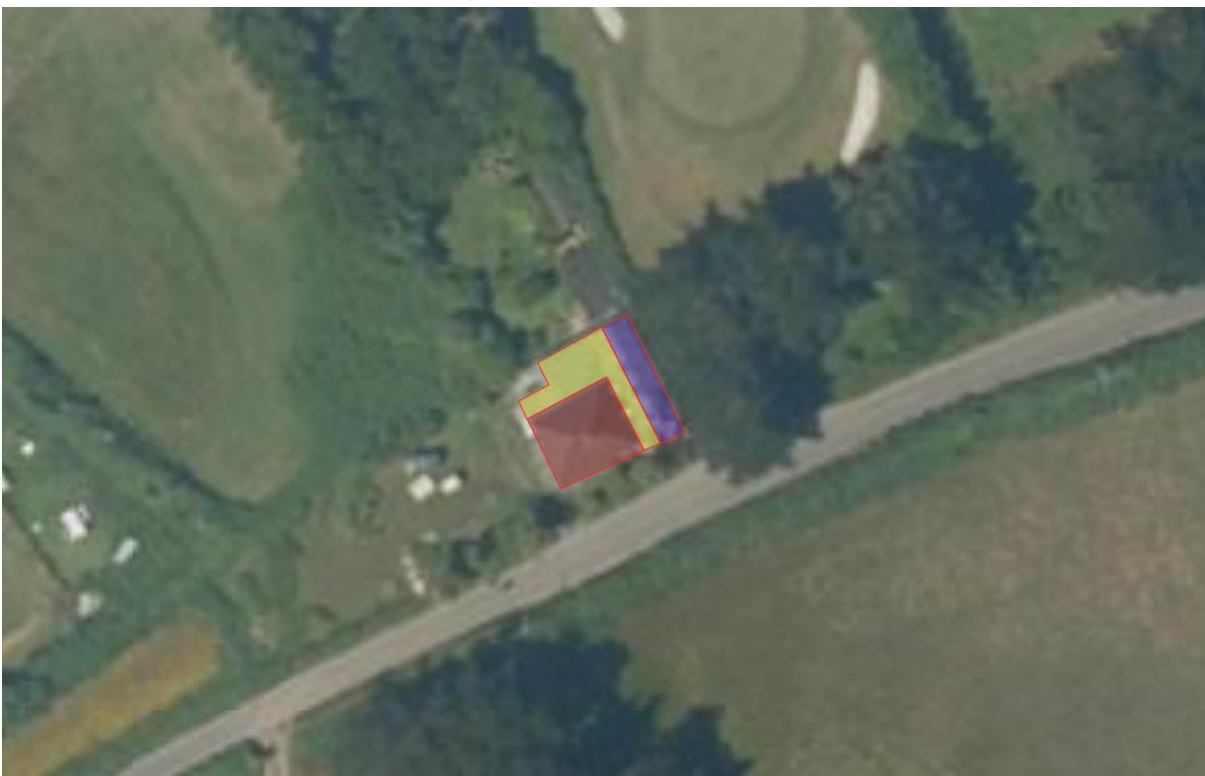
Map 02 – Showing the main hipped roof Section A (red wash) along with the pitched roof Section B (blue wash) and the connecting flat roof Section C (yellow wash). Reproduced in accordance with Google’s Fair Use Policy.
