HERITAGE APPRAISAL

PROJECT: REFURBISHMENT AND ALTERATIONS . BISHOP & WOLF . HUGH ST, ISLES OF SCILLY, TR21 0LL
PREPARED BY: SAM MAYOU PGDip Arch Cons

REPORT NO: 3258.HIA.01

VERSION: 1 ISSUED: APRIL 2024

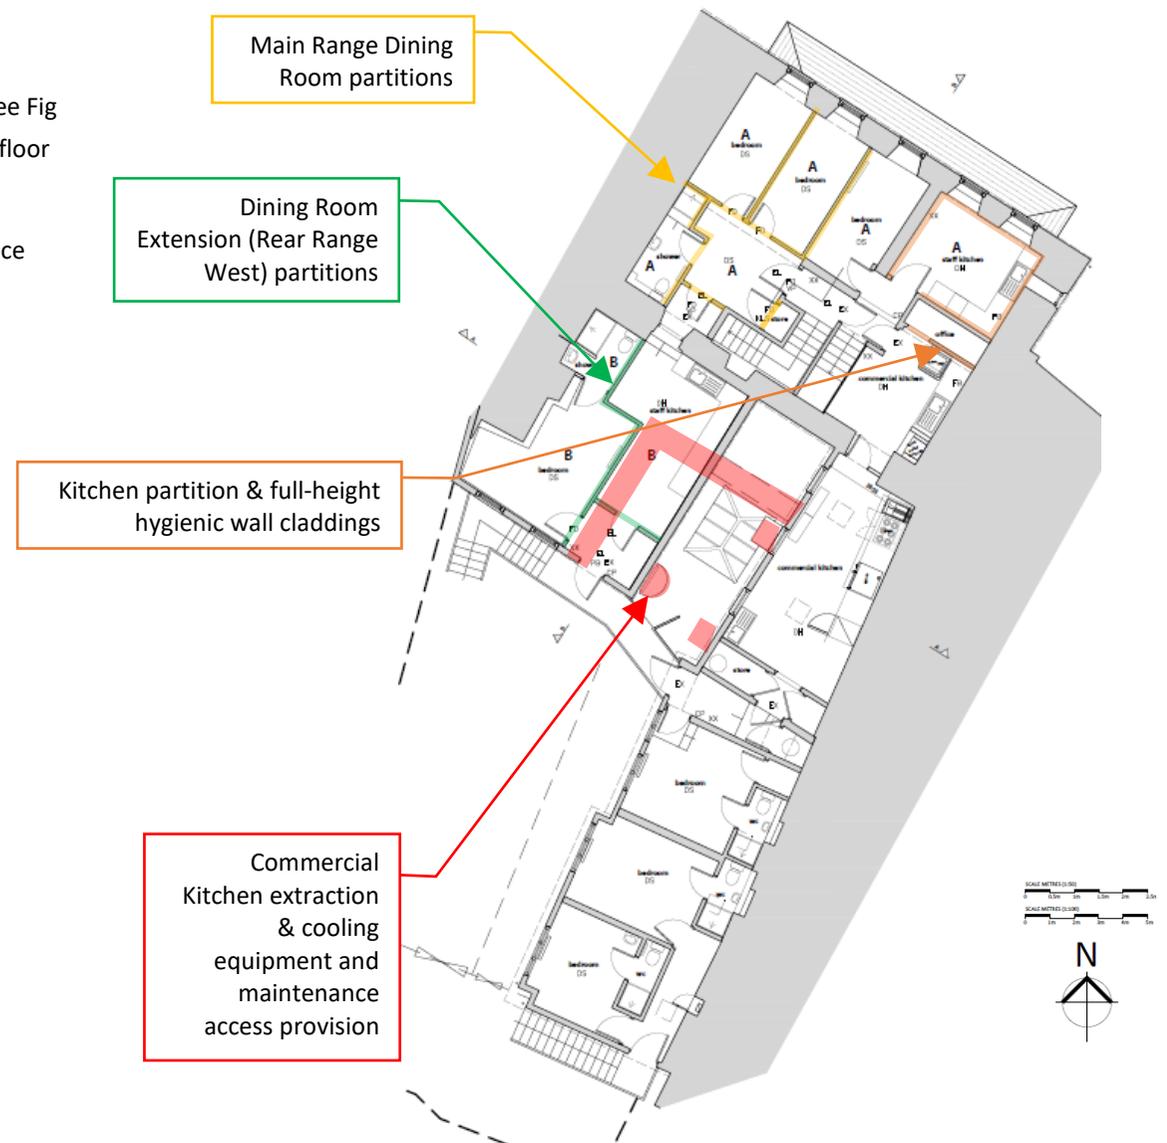
- 3.1.44. During 2023 a number of alterations were carried out to the first floor accommodation, namely the addition of partition walls.
- 3.1.45. The 2023 alteration works were recorded by a re-survey later in the year (see Fig 20) and are scheduled below, corresponding with notes applied to the first floor survey drawing (Fig 20).
- 3.1.46. External Commercial Kitchen extraction and cooling equipment, present since 2014 but missing from the earlier 2023 survey, was also recorded.

Fig 20 Bishop and Wolf First Floor Plan, with unauthorised works highlighted

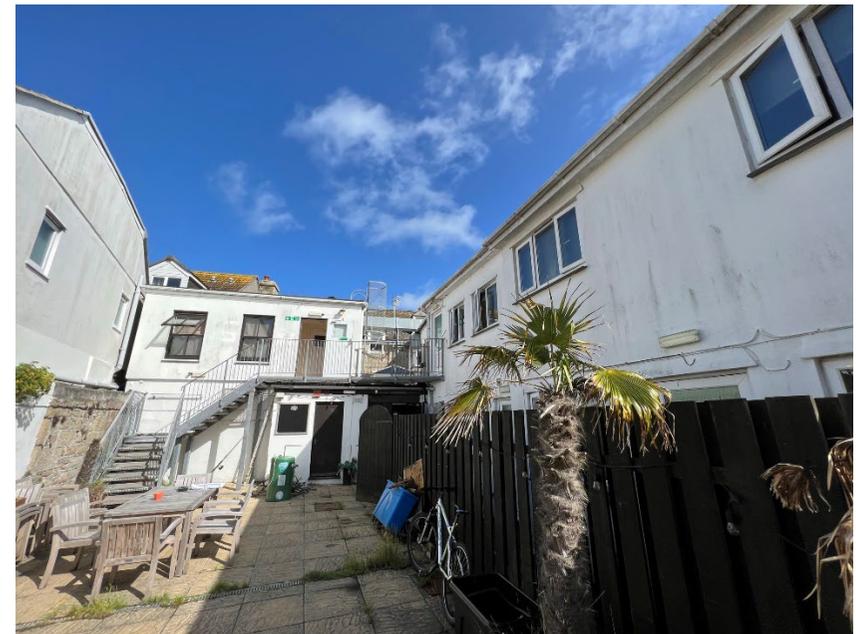
- 4.3.6. The site walkover confirmed that none of the rear extensions contained any fabric or features of special architectural or historic interest and thus could be largely discounted from future heritage impact assessments, save for any external changes potentially impacting the setting of, or views toward, the elements carrying such interest.

Fig 21: Rear Ranges of the Bishop & Wolf, viewed from rear of Beer Garden

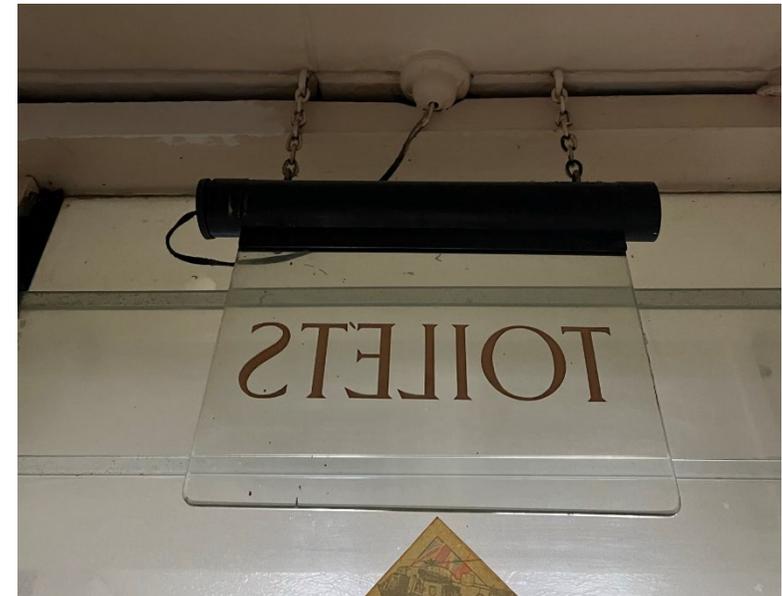
- 4.3.10. Original pub fittings, with the exception of an illuminated glass WC sign of that period, were also notably absent – presumably lost during a series a comprehensive refurbishments.
- 4.3.11. The architecturally jarring shopfront extension has itself been slowly rebuilt over time, through substantial repair and replacement of original elements.

Fig 23 Rear view of illuminated Toilet sign, set behind a louvered glass fanlight – likely the only remaining original fixture of the c1958 pub conversion

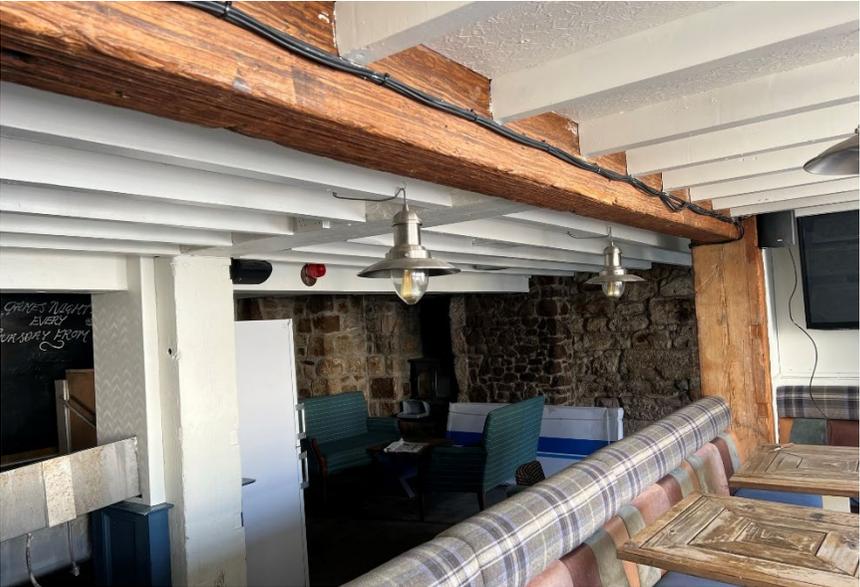
Fig 24 View toward western gable from c.1958 'shopfront' extension

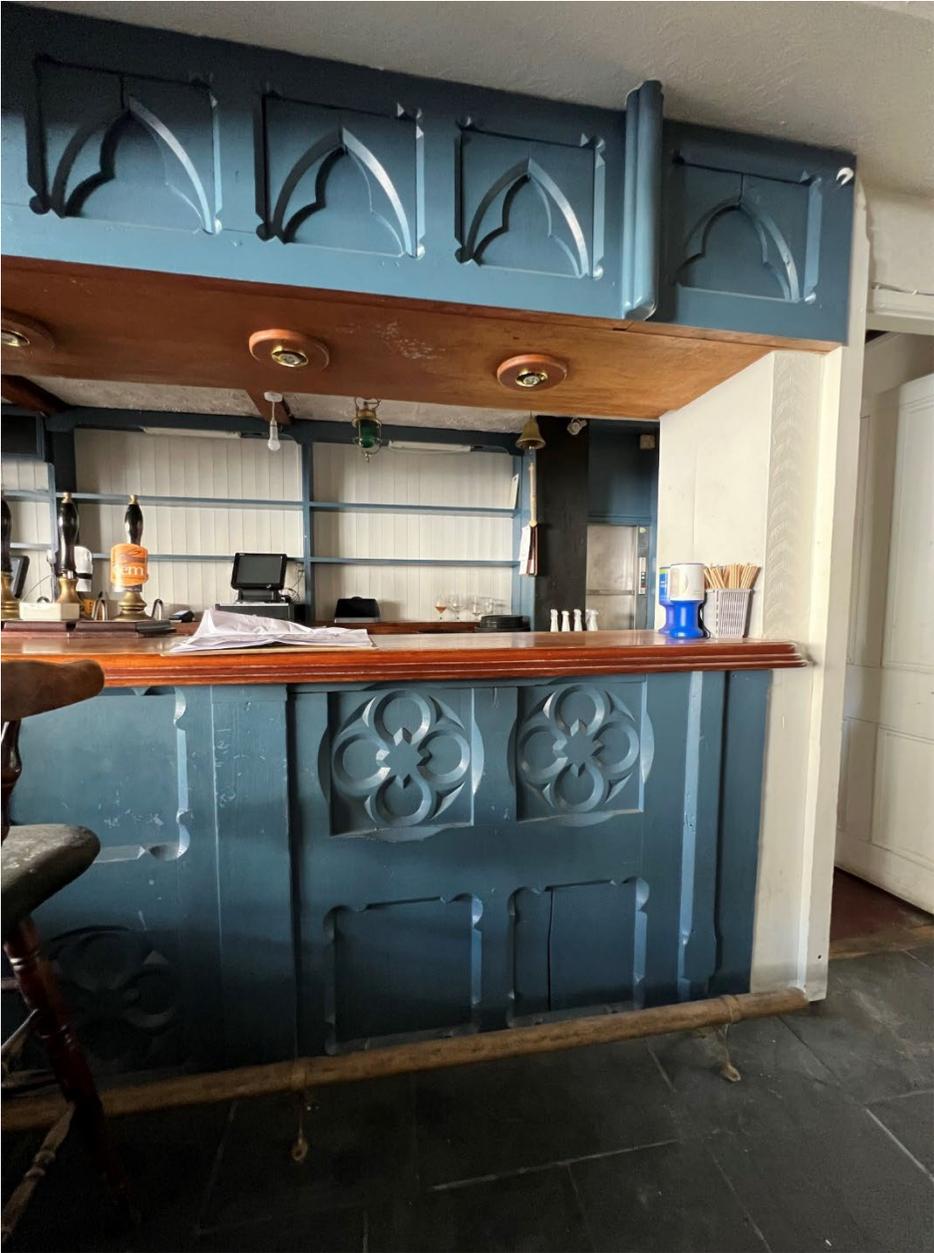
Fig 26 Ecclesiastical carved timber components to bar front to celebrate 'Bishop' element of venue name

- 4.3.12. Plasterboard ceilings, with textured plaster finishes, were found to be adorned with false timber joists supported by heavy timber posts which, together with reclaimed items from other sites, including two four panel doors and features playing on the 'Bishop' element of the name, such as ornate carved timber screens to the bar front and remnants of hammer beam trusses to frame the opening into the Pool Room extension, have been used to inject historic character into the main trade area.

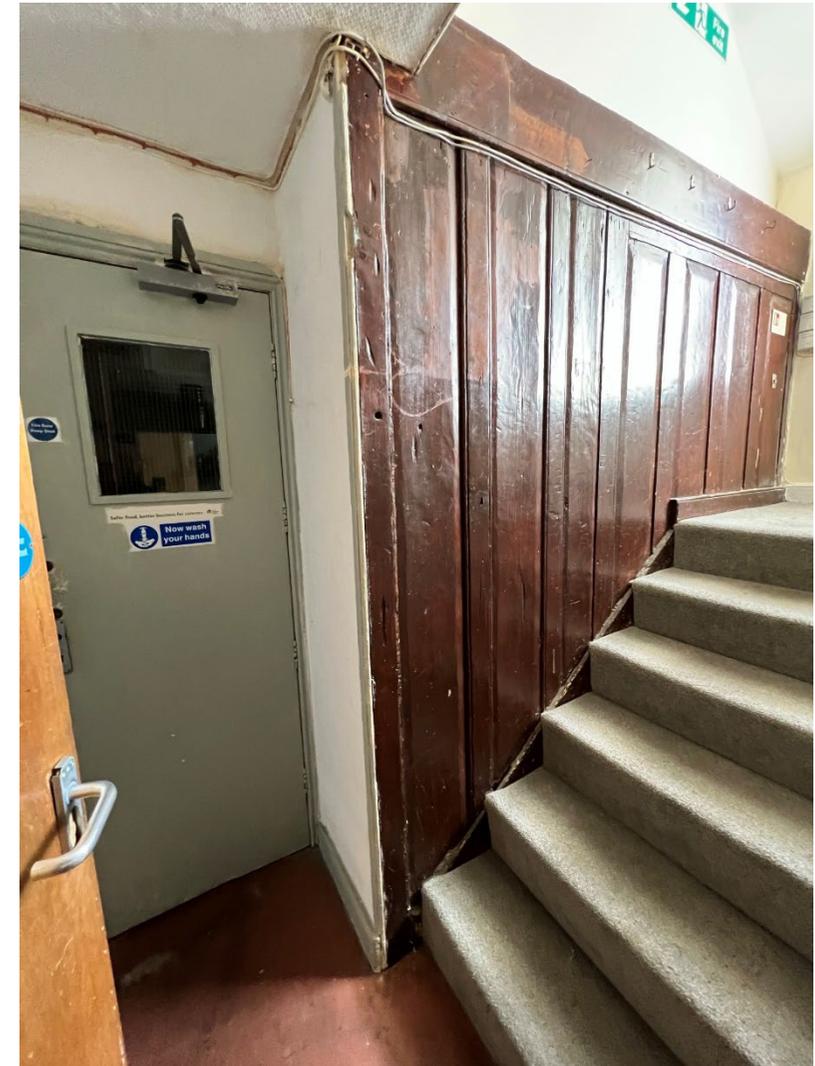
Fig 31 Main Range, First Floor centre, rear (view from northwest) showing lower leg of stair up to second floor level

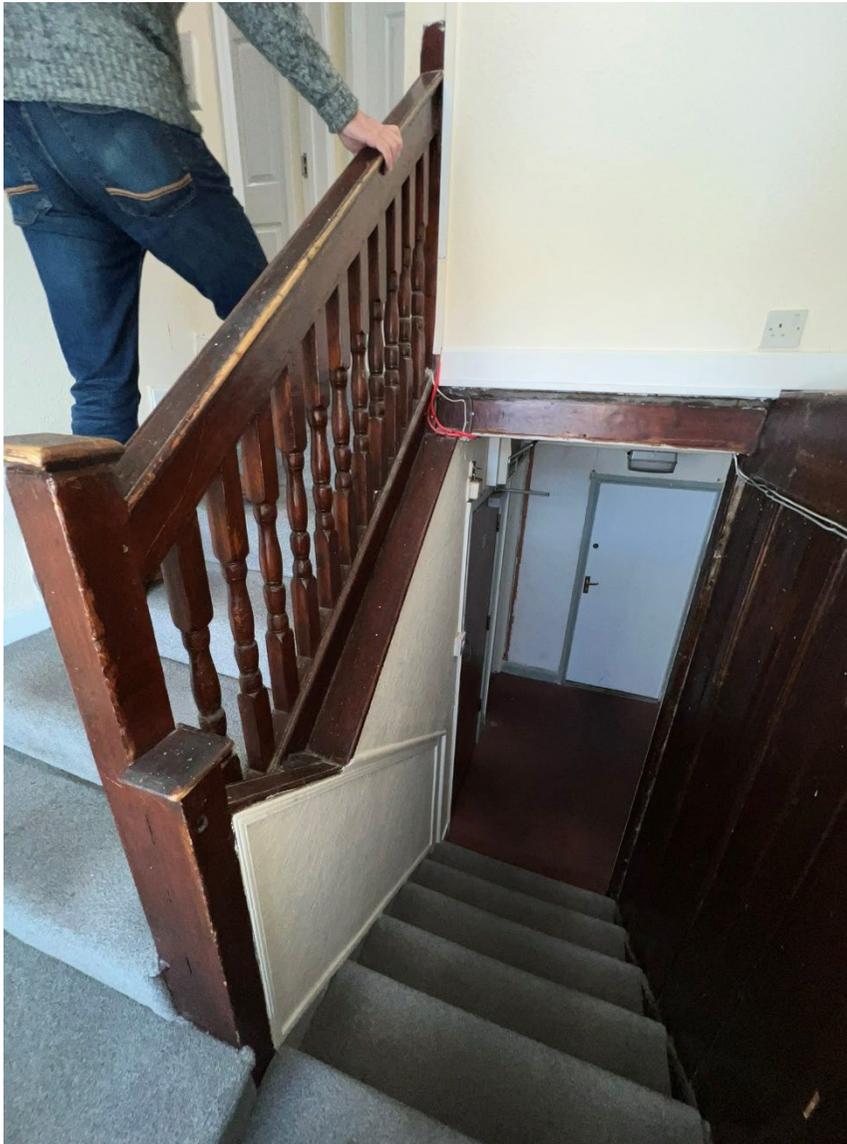
Fig 32 Main Range, First Floor/Second Floor half landing, centre, rear (view from south) showing general arrangement and separation of lower leg from stairwell down to ground floor pub (left)

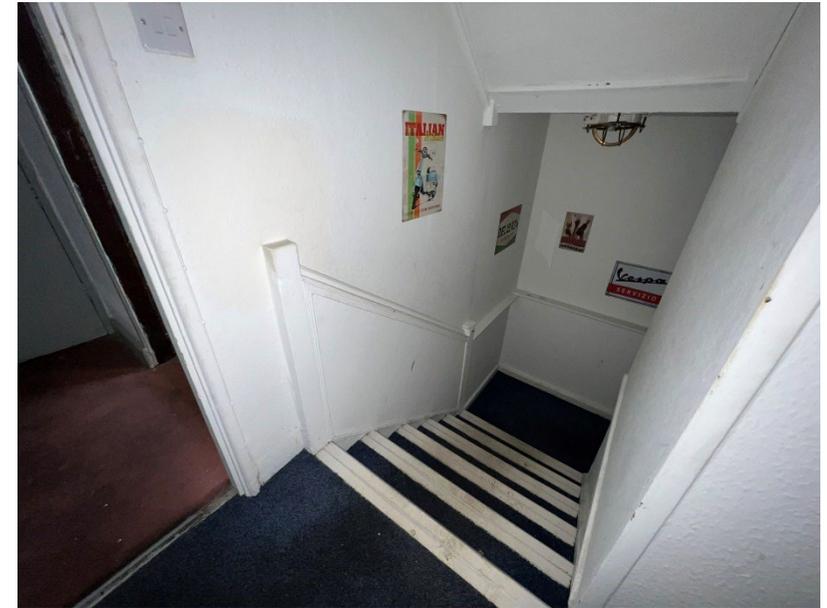
Fig 33 Main Range, First Floor centre, rear. Landing/stairwell down to pub showing enclosure of presumed originally open handrail (left). Stair rises to second floor behind this

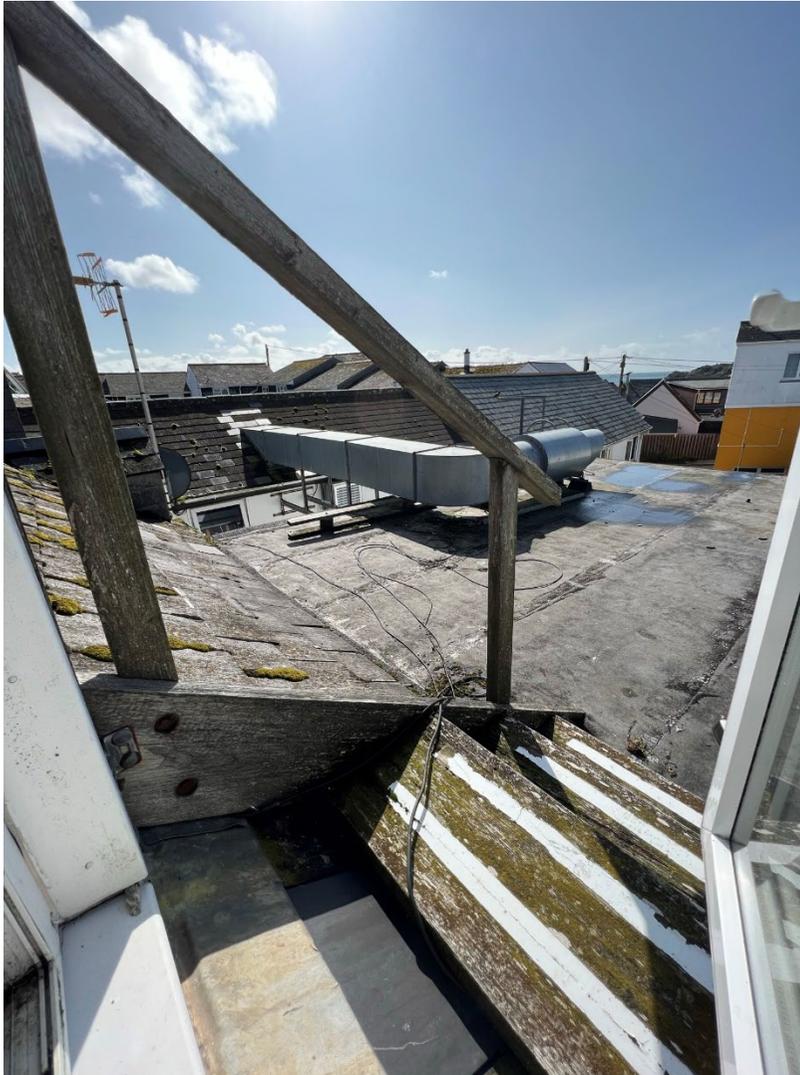
- 4.3.31. The flat roof of the first floor former dining room extension is also utilised for supporting kitchen extraction ductwork, and specifically for ensuring its exhaust is as far from opening windows as possible.

Fig 34 Main Range, Second Floor level – view across flat roof from western dormer

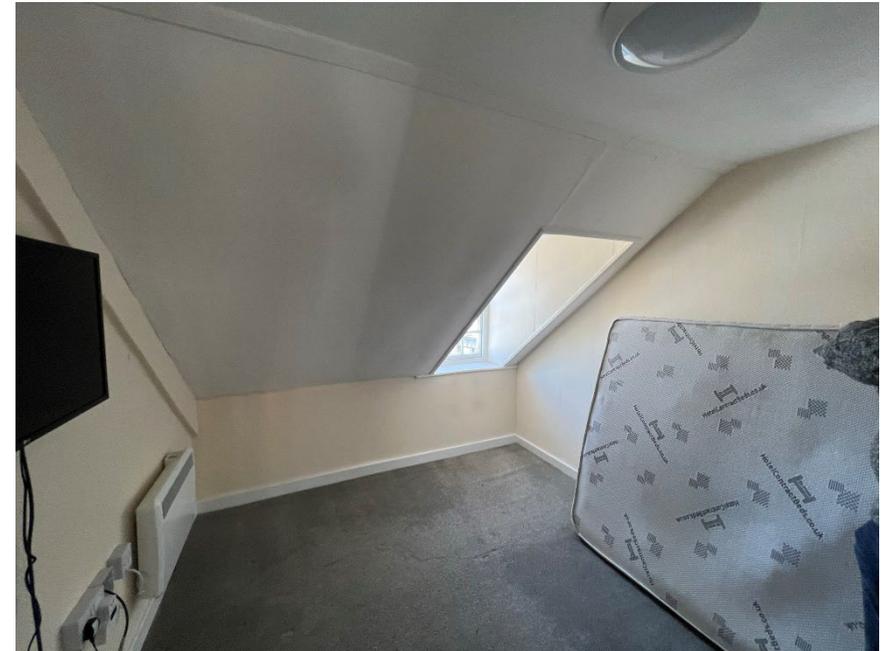
Fig 35 Main Range, Second Floor – typical bedroom accommodation to front, showing limited headroom and relationships with front elevation dormer and roof truss structure sandwiched in partition wall structure (left). Note high-level purlin set into the junction of pitched and flat ceilings. Low level purlins are absent or concealed behind sloping ceilings, except over the stairwell and adjoining landing/bedroom lobby.

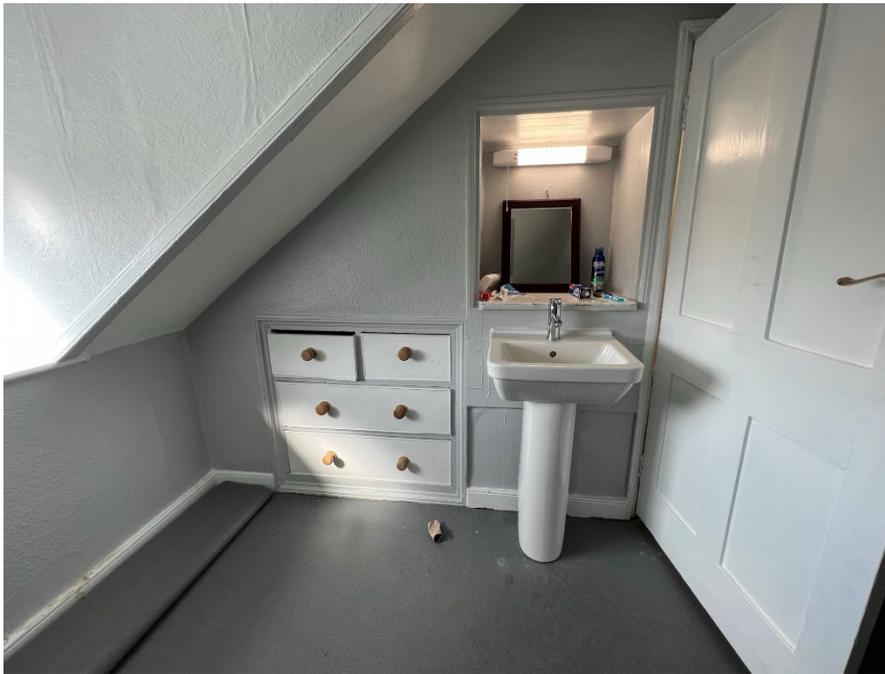
- 4.3.35. The current bathroom, against the eastern gable, appears to have been in use as such for this timeframe at least. The Bathroom is also the location of the oldest internal door left in the property – a simple and unremarkable 4 panel unit without decorative moulding, of the type expected for private accommodation in the second half of the C19 – although its originality to this position, and indeed the building, is unclear.
- 4.3.36. Doors, and architraves and skirtings generally around the second floor are late C20 with evidence of earlier skirtings and architraves having been salvaged and recycled as the layout has evolved or refurbishments have taken place.

Fig 36 Second Floor bathroom including storage recesses framed by salvaged architraves

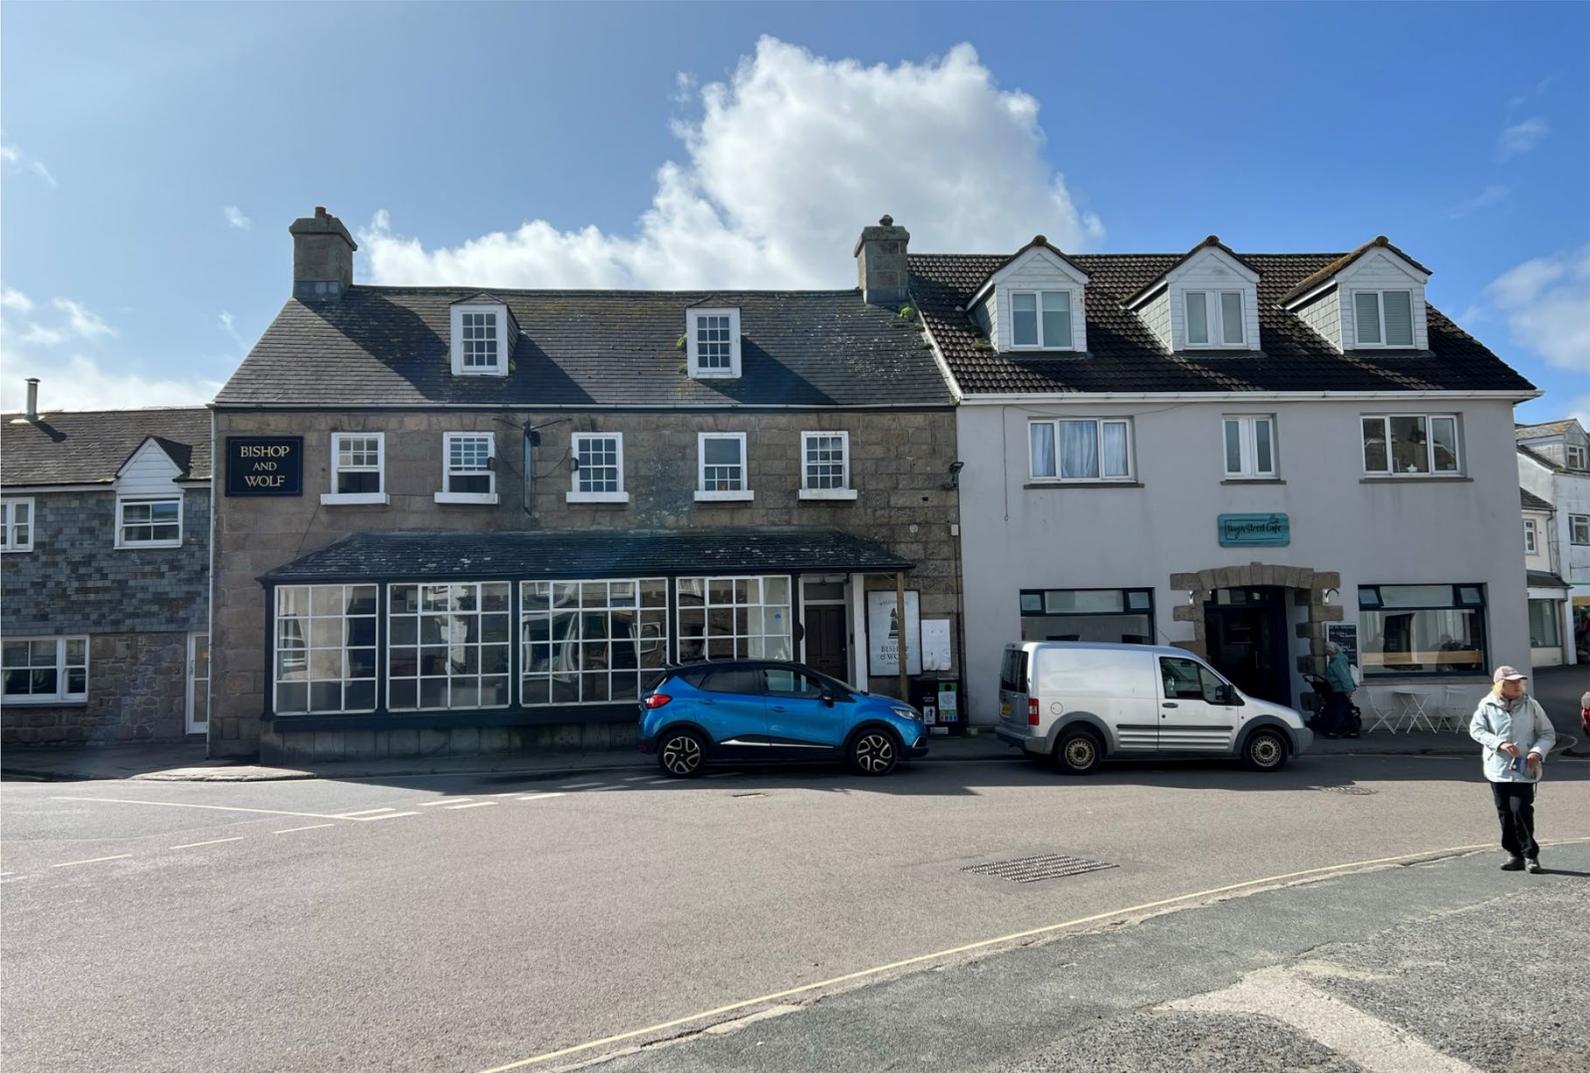
- 4.3.58. The C20 redevelopment of the premises to the east was particularly unfortunate for the way it overtook the street scene primacy of the Bishop & Wolf in terms of height and general scale, emphasised by a bland modern material palette of cement render and profiled concrete roof tiles and horizontally-emphasised window openings.

- 4.3.59. The later addition of three large gabled dormers, dwarfing the smaller, hipped structures of the Bishop and Wolf exaggerated the dominance of the neighbour.

Fig 41 Main Range front elevation within streetscene context.
