PRELIMINARY ROOST ASSESSMENT (PRA)

ROCKY HILL COTTAGE, ST MARY'S, ISLES OF SCILLY

Report date: 27th August 2024

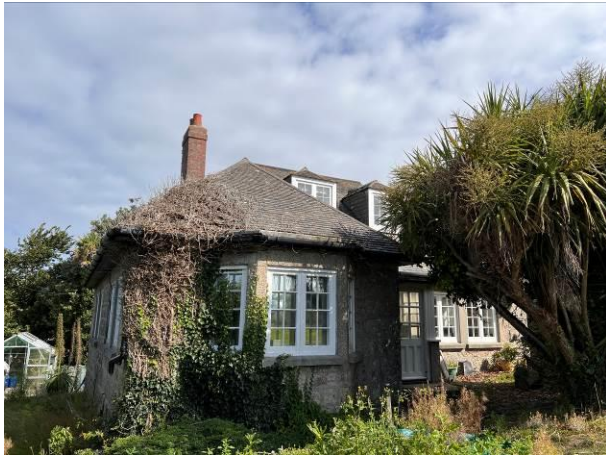
There is dense ivy cladding on the south-western corner of the property – this has been cut back at the base and appears to be mostly dead but the stems remain clad to the walls. The size and structure of the stems would make it unlikely to provide a roosting opportunity in its own right in the current condition.

Photograph 1: Showing the property viewed from the south-western corner – the flat-roof bay window is visible.

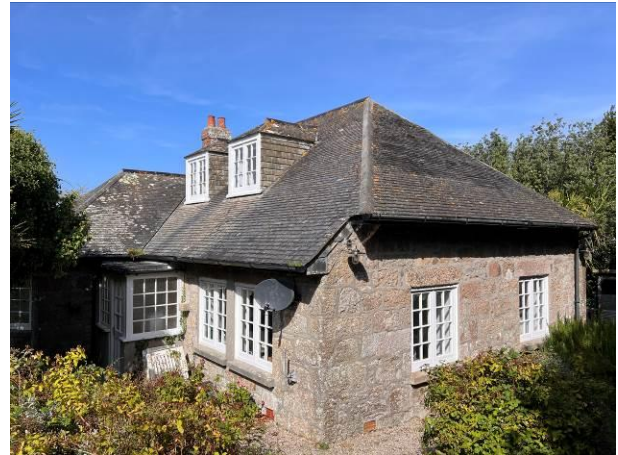
The boxed soffits around the edge of the roof are generally very well-fitted with minor gaps noted around the front porch and adjacent to the rear extension on the north-east corner of the property.

Photograph 2: Showing the property viewed from the north-eastern corner.
