PRELIMINARY ROOST ASSESSMENT (PRA)

PARK HOUSE,
HUGH TOWN, ST MARY'S, ISLES OF SCILLY

Report date: 9th February 2025

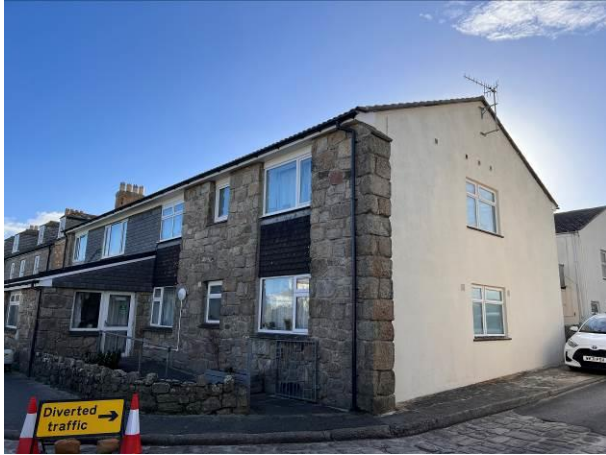
Photograph 1: Showing northern frontage and western gable of the property.

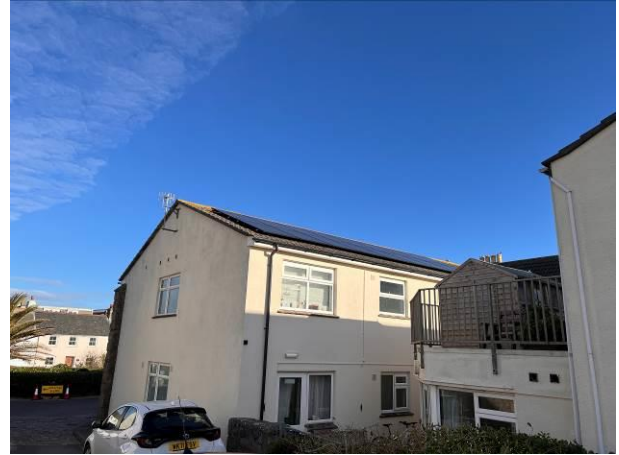
Photograph 2: Showing the southern aspect and western gable of the property.

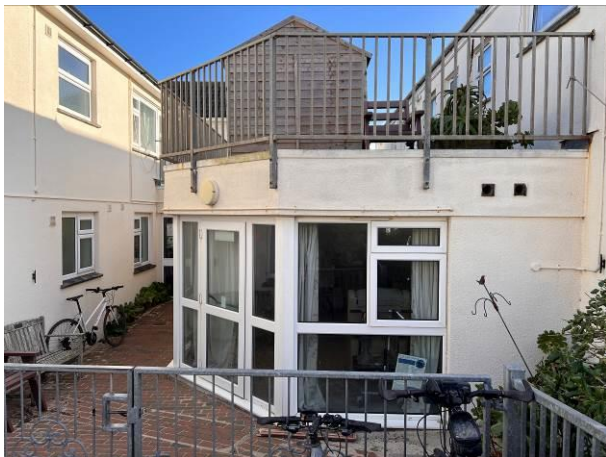
The single-storey flat-roof component of the property on the southern aspect is well-rendered throughout with well-fitted windows and a well-sealed roof with no gaps or other roosting opportunities noted.

Photograph 3: Showing the flat roof component present on the southern aspect of the property.

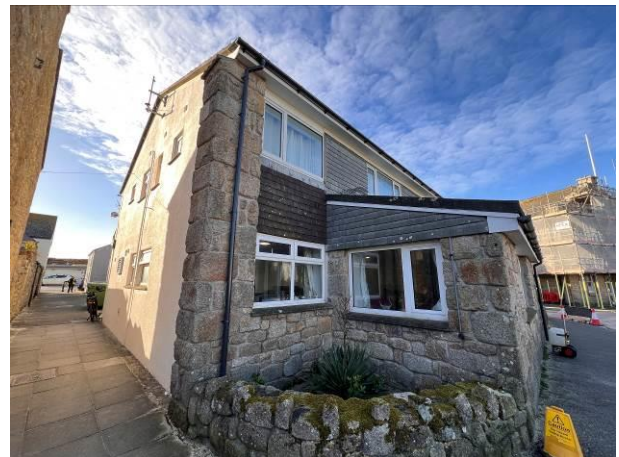
Photograph 4: Showing the eastern gable of the property with the mono-pitch roof structure visible on the northern frontage.
