Arboricultural Management Plan: St Mary's Airport Construction Compound

January 2014

Prepared for: Lagan Construction

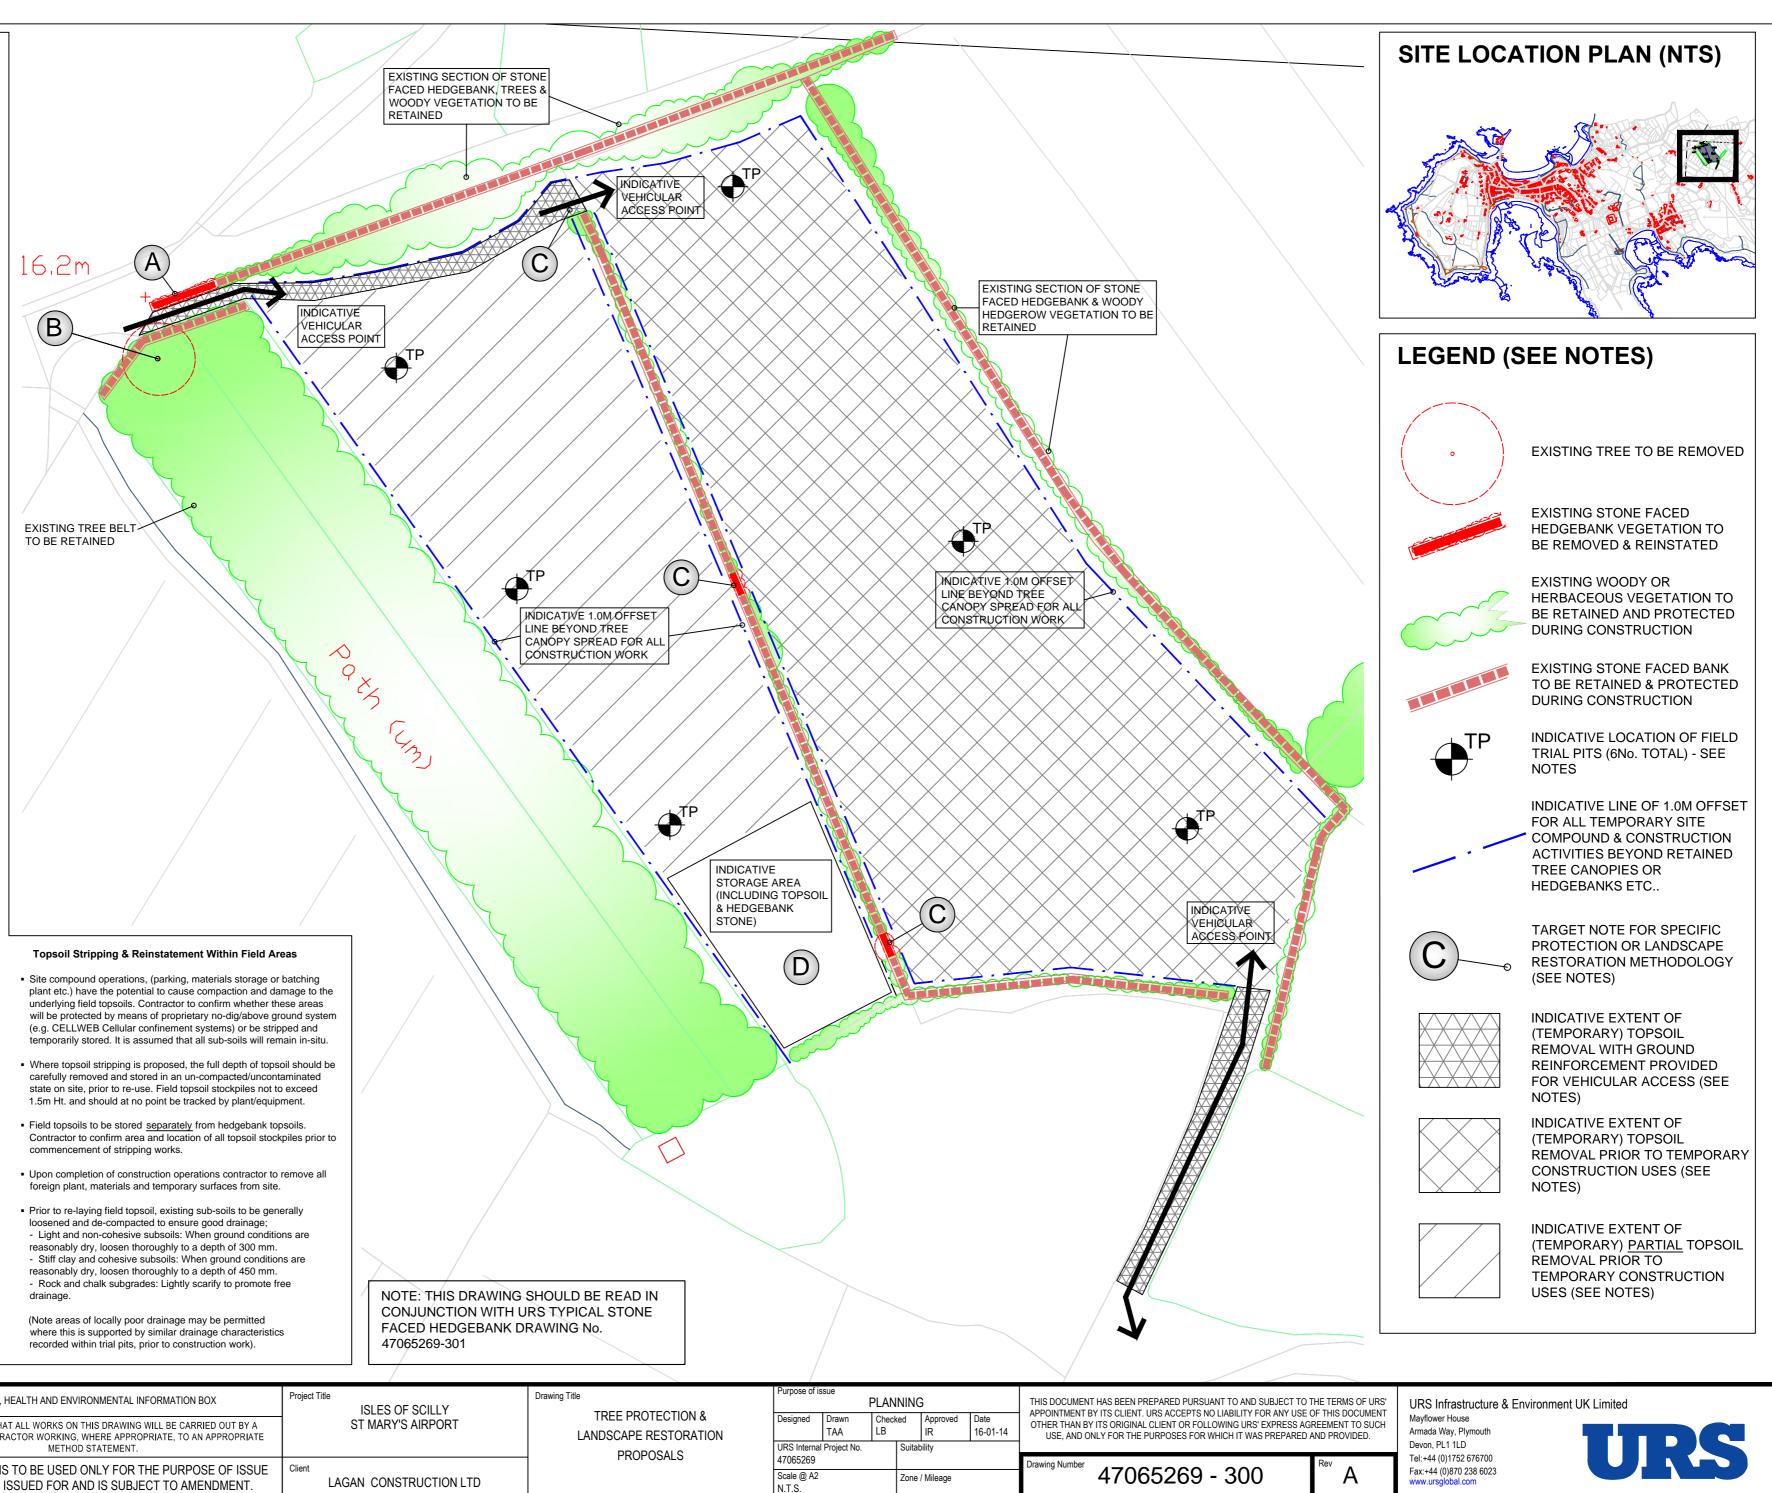
TREE PROTECTION AND LANDSCAPE RESTORATION - OUTLINE SPECIFICATION

- A)Existing Stone Faced Hedgebank & Stone Gatepost Bounding A3111 Telegraph Road
- End section of stone faced hedgebank proposed for temporary removal to facilitate construction access - contractor to confirm exact length to be removed.

B)Existing Monterey Pine Tree (Pinus radiata) overhanging field access point

C)Existing Stone Faced Hedgebanks Internal to Site

D)Site Compound Storage Area

Trial Pits (6No.)

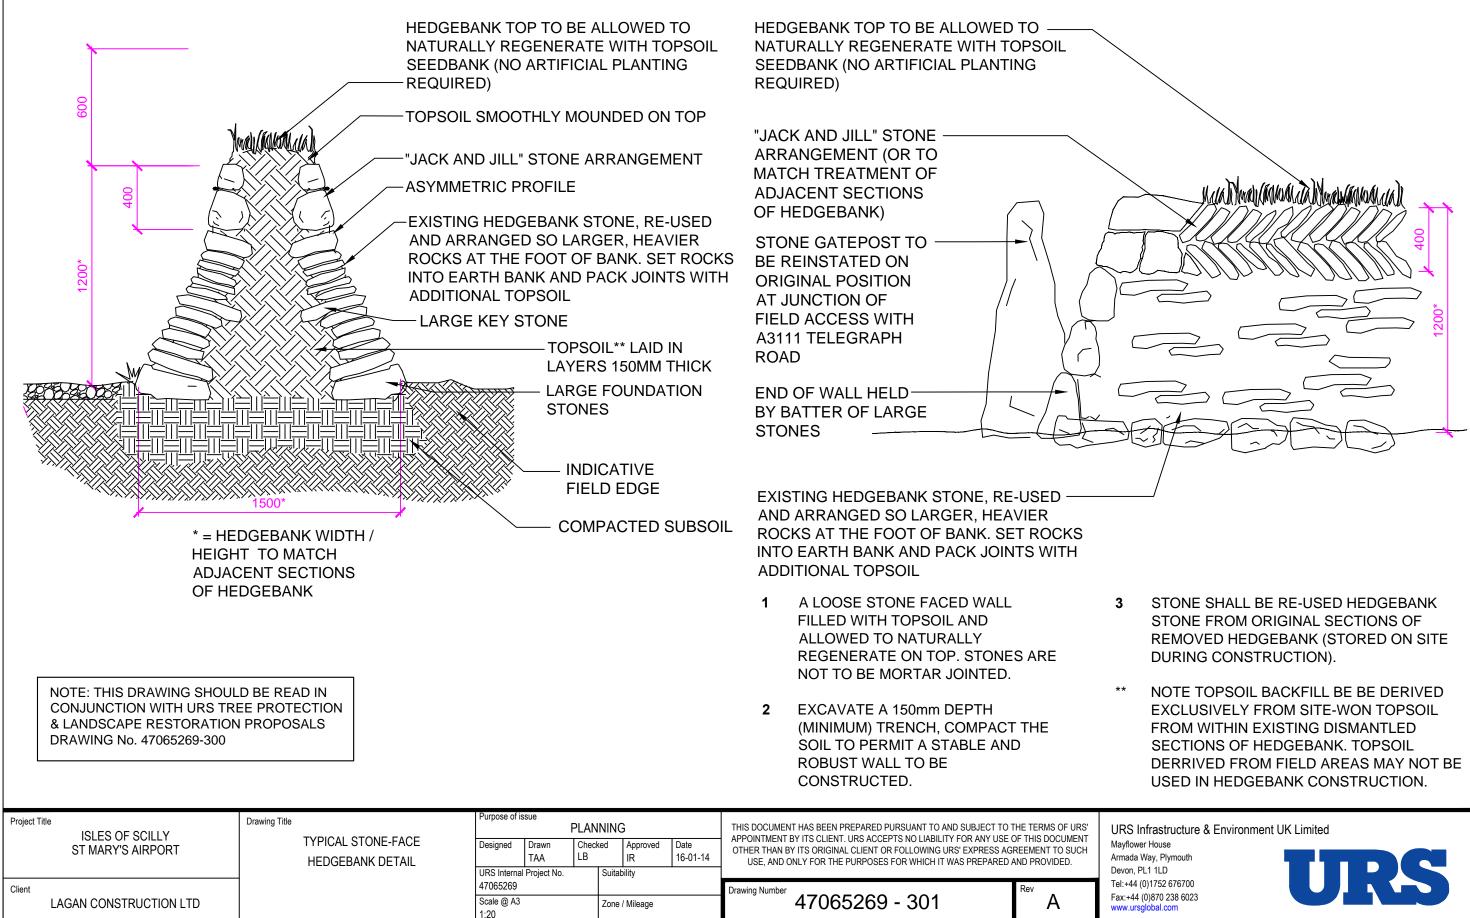
TYPICAL ELEVATION / END OF WALL DETAIL @ 1:20

TYPICAL SECTION THROUGH REINSTATED SECTION OF STONE FACED HEDGEBANK @ 1:20

- Upon completion of the works, hedgebank to be reinstated in accordance with URS Typical Stone Faced Hedgebank Detail drawing 47065269-301 and to match dimensions and style of adjacent section of hedgebank. Reinstatement to include installation of stone gate post.
