## DOLPHIN HOUSE

### DESIGN, ACCESS, & HERITAGE STATEMENT

#### Dolphin House, Dolphin, Tresco, Isles of Scilly, TR24 0QD Listing Entry Number: 1376770

This document has been prepared to support a Planning and Listed Building application for alterations to Dolphin House, which is grade II listed. The proposed modifications would involve limited internal alterations to original house, a two storey rear extension to replace a C20th service tower, and enlargement of the existing southeastern wing.

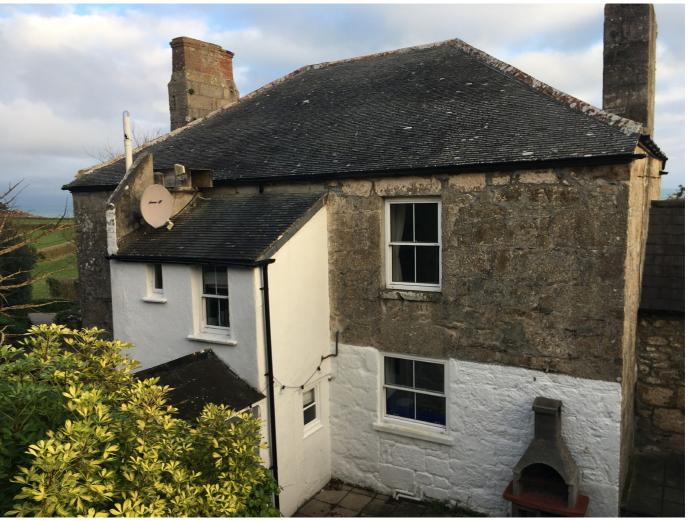
SOUTH ELEVATION - Note; blocked in door, uPVC windows & later masonry on rear face east wing.

The rear and side elevations are formed in random coursed roughly squared granite, and have been painted in some areas. There are no windows in the side elevations. Each features a substantial chimney breast that occupies much of the elevation. These terminate in granite stacks that have subsequently extended with red brick, presumably to improve the draw.

The rear elevation has asymmetrically placed sash window openings. Joinery in these openings has been replaced with uPVC imitation sashes.

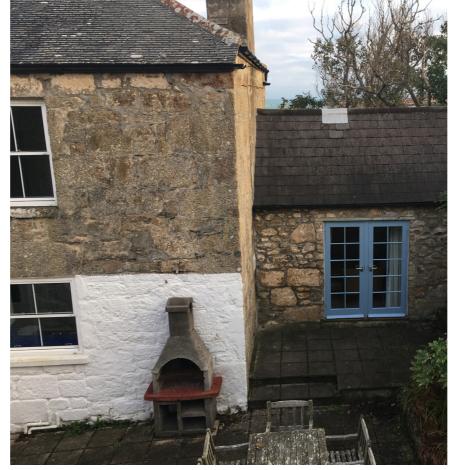
Part Rear Elevation. Note; Later granite masonry to the rear of the eastern wing (uncoursed with Grey cement pointing); GLF rear window is an infilled door.

The gable and rear elevation (which has later poor-quality granite work and a 1980s timber french door) would be demolished and rebuilt to enlarge the size of the enclosed space. Material salvaged from the demolition would be used in reconstuction of the new masonry walls. The C20th roof would also have to be replaced and rebuilt to suit the new footprint.

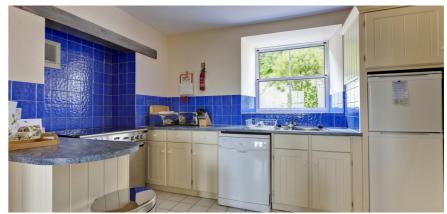
Kitchen, Note; uPVC window; C20th fitting and finishes; alterations to chimney breast

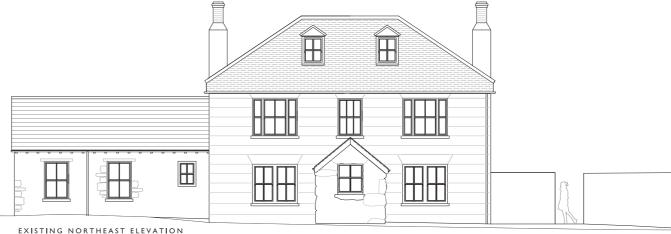
EXISTING NORTHEAST ELEVATION

The primary northeast elevation is granite ashlar, the peripheral bays have large double width windows with voussoir granite flat arch heads. These are infilled with 2-2 pane double sashes at ground floor level and at first floor level with 2-2 central sashes with fixed half-width side lights. The pane sizes and horns indicate that these are CI9th replacements not the original joinery.

A porch in the romantic style has been added to this elevation. It incorporates large rounded granite boulders and raked back pointing to achieve a rusticated appearance. This addition is consistent in style with other mid-CI9th architectural additions made around the island, under the auspices of Augustus Smith (Lord Proprietor of the Scillies 1834 - 1872).

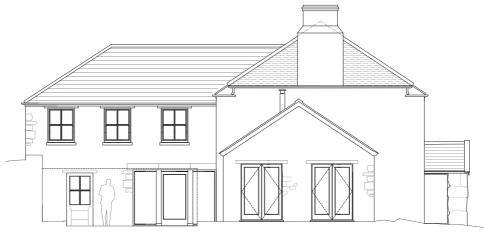
EXISTING SOUTHEAST ELEVATION

The building has also been extended on the SE side elevation, with a small single storey masonry wing with double pitched slated roof (not scantle). This wing is identifiably

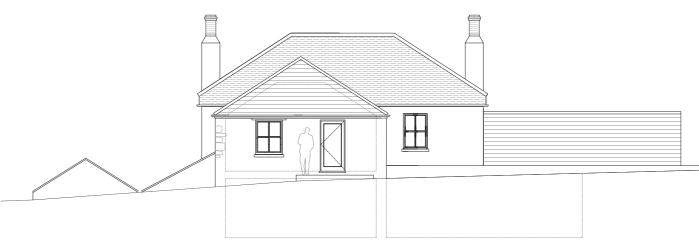
EXISTING SOUTHWEST ELEVATION

The house has been extended on the rear southwest elevation with a C20th service tower containing WC and first floor bathroom. This is finished in render and painted. An asymmetric projecting parapet on one side houses satellite + TV equipment. Openings are meagre and placed at random. Joint lines in the masonry indicate alterations to this section of building. However, there is not sufficient evidence available to ascertain what form this previous incarnation took (possibly extended from single to two storey).

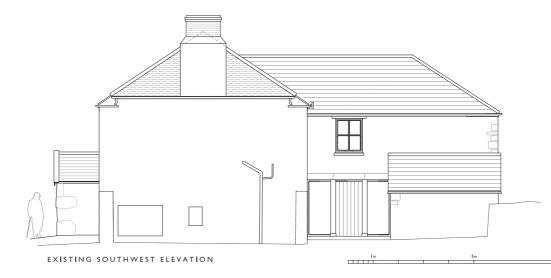
The roof extension would be pitched and hipped to complement the existing roof. It would be slated in blue-grey slate, to aid legiblity between old and new. The first floor would be skinned with coursed granite rubble masonry. Eaves and ridgeline would be lower than the existing roof to ensure subservience to the main body of the dwelling. Windows take their proportion from the front facing sashes, but are of a reduced scale, again to maintain the heiarchy of the various elements of the building. New windows would be painted timber sashes with slim double glazed units.

The unattractive existing two-storey rear extension and covered porch would be demolished and replaced with a larger two-storey extension that takes its architectural cues from the original house. This would span over the existing outbuildings to connect to the upper garden at first floor level.
