Design and Heritage Statement

**The Downs and Little Downs
Higher Trenoweth
St Mary's
Isles of Scilly
TR21 0NS**

30 AUGUST 2024 **REV A**

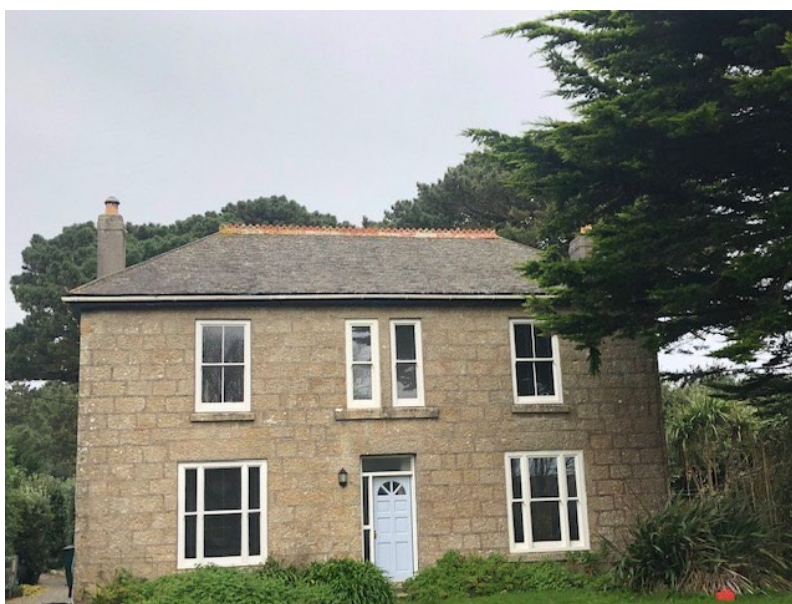
The Downs is a 3 bedroom dwelling with self contained ground floor Annex used as holiday accommodation found in a cluster of dwellings and agricultural buildings at Higher Trenoweth. The property is constructed of coursed granite with a Cornish scantling wet bedded roof finish of slate with clay cockscomb ridge tiles, lead valleys and shaped in situ cement mortar as a caping to hips.

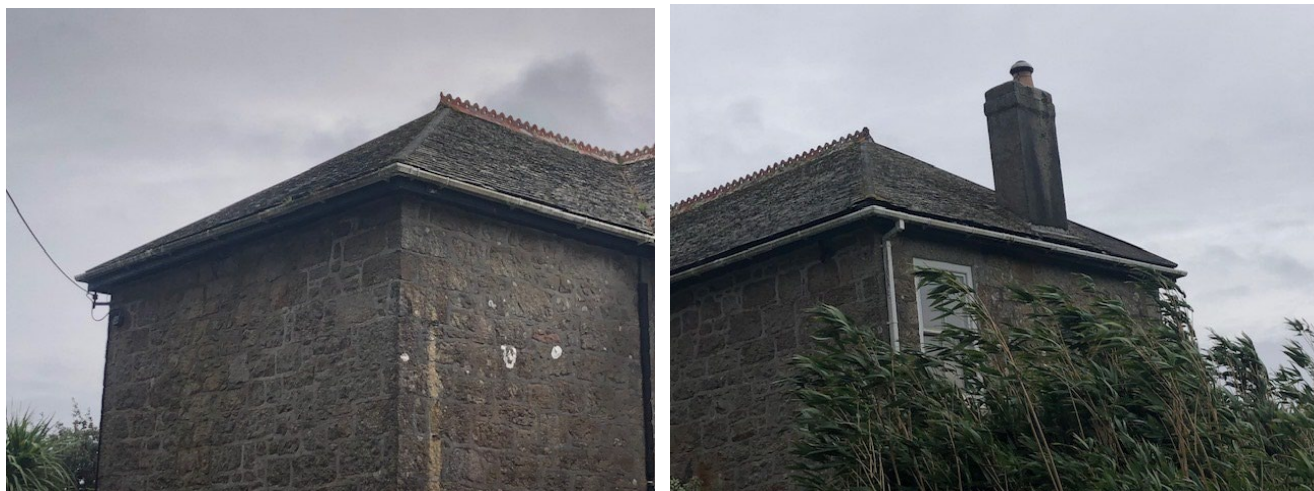
The proposal is to remove the defective existing slate roof covering, carry out repairs as found necessary and provide a new natural slate roof covering using natural Trevilletts from the Tintagel quarry in either 400 x 250 with the addition of a continuous roofing membrane that is suited to the roosting of bats but will act as a secondary defence against water ingress. The opportunity is being taken as part of the roof recovering works to install three number Velux Heritage Conservation rooflights of size 550 x 978 mm.

The cockscomb ridge tiles will have been removed with care and will be rebedded on the new slate coverings. Valleys will be relined with lead and the mortar hip finishes will not be reinstated but the hips will be finished with a mop stick roll and lead capping.
