From: Marcus Fylan-Smith [REDACTED]
Sent: 19 August 2024 16:57
To: Paul Marino
Cc: [REDACTED]
Subject: 21185 Carn Thomas - Response to drainage comments
Attachments: Surface Water Drainage Porthmellon Carn Thomas Hill.png; 21185 Infodrainage Rev.C.pdf; 21185 Civils Transmittal 19.08.24.pdf; 21185-200P2.pdf; 21185 Flood Risk Assessment Rev.A.pdf

The drainage proposals have been revised following the information provided by Eddie Williams regarding the existing surface water network and outfall position. All surface water drainage has now been directed to the new outfall pipe location. This has meant the addition of 2 extra inspection chambers, 2 extra manholes and associated pipework.

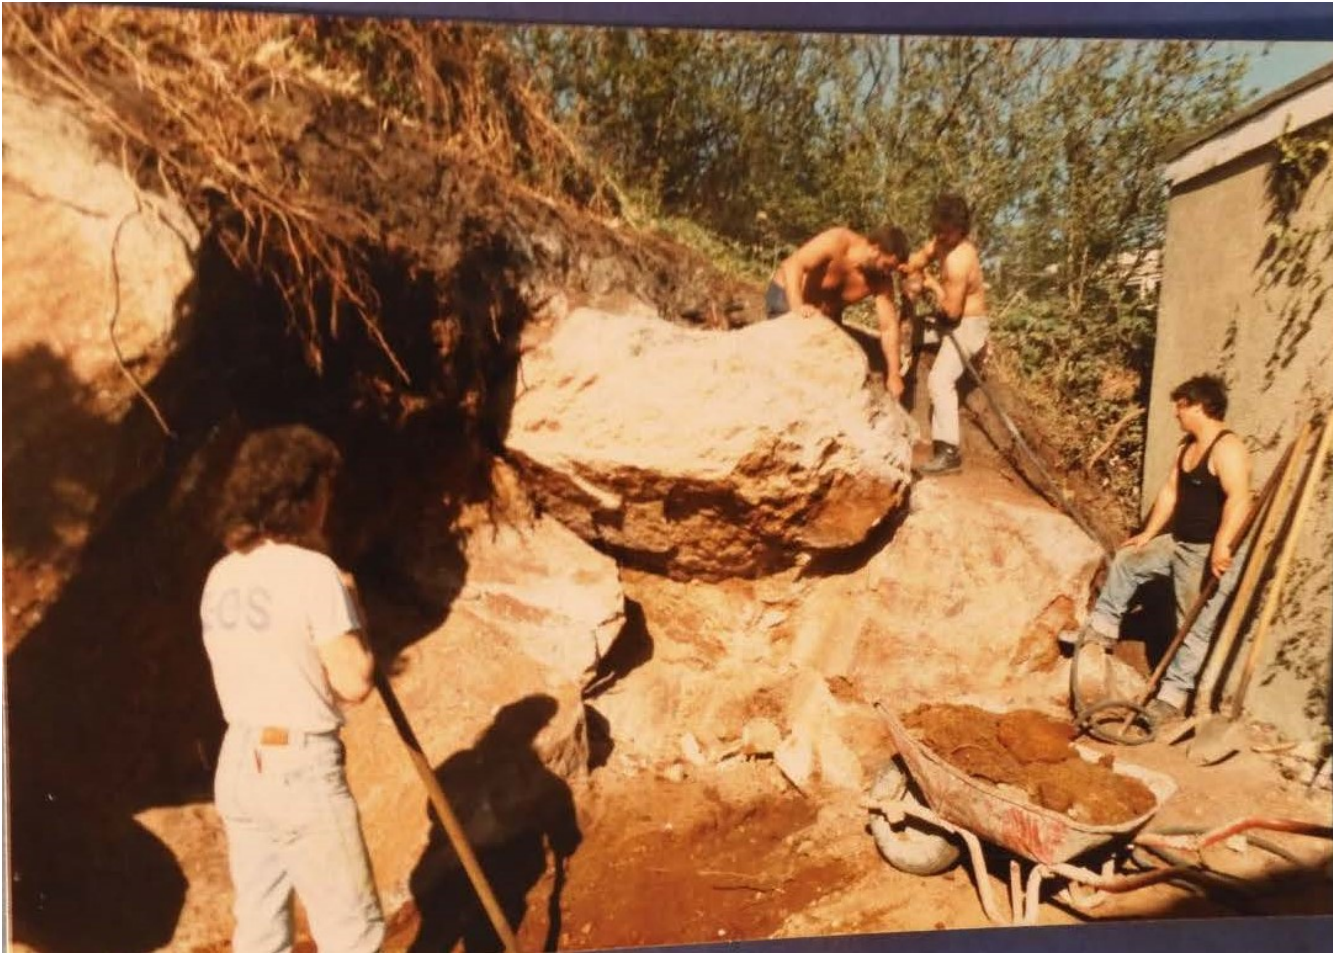
Further to questions on if the surface water drainage hierarchy has been followed, this ultimately relates to ground conditions. As much of IoS, the site is generally underlain by granite. This manifests itself as large granite boulders that gradually become solid granite at depth. The photograph below shows this. The weathering of the granite increases towards the surface and this mixture of silt, sand, gravel, and boulders is known locally as "Rab".

As is the case with much of the IOS, infiltration discharge techniques, such as soakaways, are not appropriate for the site as the weathered granite doesn't offer good percolation, the underlain boulder material can become unstable, and there is a risk of uncontrolled breakout on steeper slopes. As previously discussed, we can explore the use of swales / bioretention systems but these would need to be positively drained so we would question the appropriateness of use here where not really required.

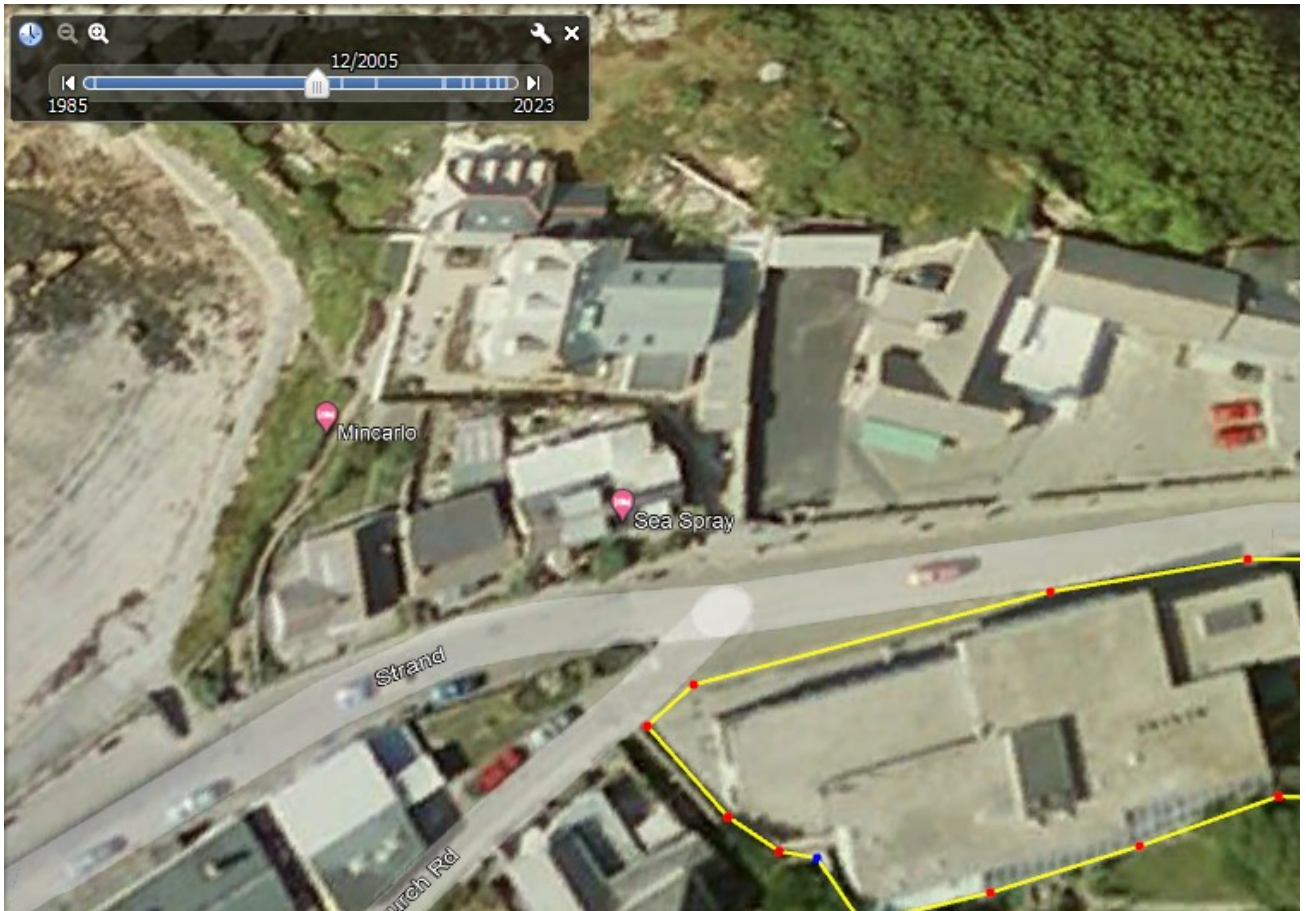
We don't have any historic records to interrogate. However, an estimate using Google Maps suggests a minimum 1900.00m². See extract below from Google Maps 2005 prior to demolition of school.

The proposed impermeable area is less at 1690.00m², which also includes the 10% urban creep (future development) allowance. Please see attached InfoDrainage Calculations (Rev. C).
