Site Ref: Carn Thomas IOS

Karn Geoservices Ltd (KGL) has been commissioned to undertake an intrusive investigation of the existing slopes at Carn Thomas, Telegraph Road, Hugh Town, St Marys, Isles of Scilly. This report provides additional information on the stability of the existing ground conditions and follows on from the previous investigation reports detailed in the following section.

It is understood that the site is to be redeveloped for residential purposes and the existing slopes must be cut to facilitate the construction.

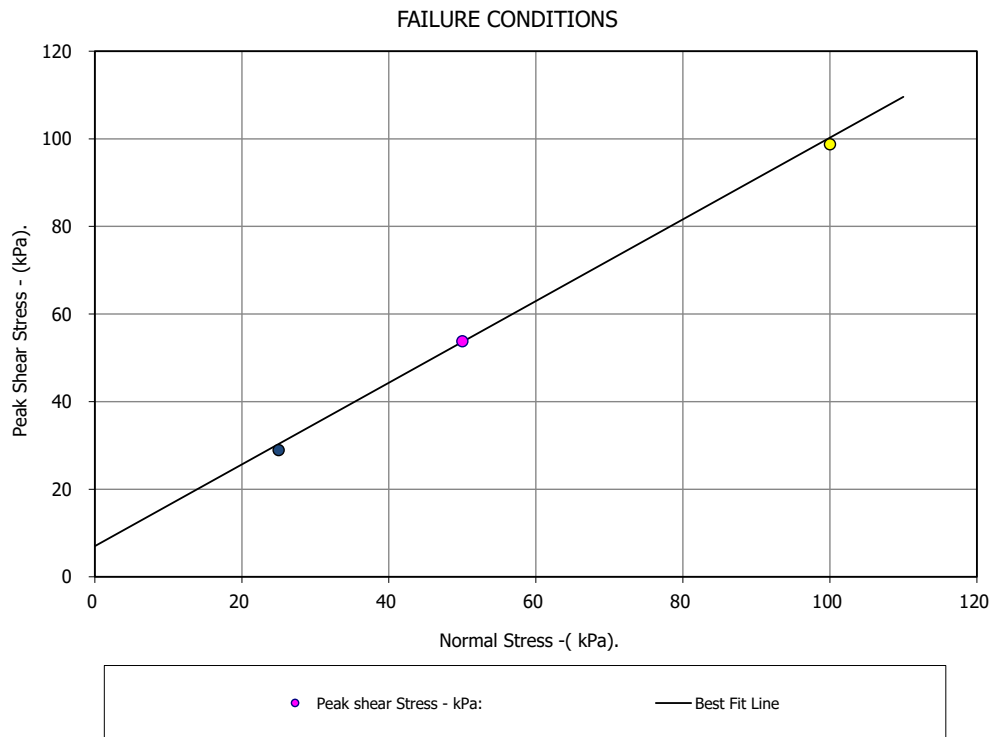
Borehole Number:	TP01	Depth from (m):	0.00	
Sample Number :		Depth to (m):		
Sample Type:	B			
Particle Density - Mg/m3:	2.65 (Assumed)			
Specimen Tested:	Submerged, Remoulded (Light Tamping) Material above 2mm removed.			
Sample Description:				
Brown silty SAND				
STAGE	1	2	3	
Initial Conditions				
Height - mm:	24.98	24.98	24.98	
Length - mm:	60.00	60.00	60.00	
Moisture Content - %:	19	19	19	
Bulk Density - Mg/m3:	1.91	1.91	1.91	
Dry Density - Mg/m3:	1.61	1.61	1.61	
Voids Ratio:	0.6509	0.6499	0.6504	
Degree of Saturation - %:	76.94	77.07	77.00	
Normal Pressure- kPa	25	50	100	
Consolidation				
Consolidated Height - mm:	24.93	24.74	24.20	
Shear				
Rate of Horizontal Displacement (mm/min)	0.500	0.500	0.500	
Horizontal Displacement at Peak Shear Stress (mm)	2.61	3.25	4.24	
Peak shear Stress - kPa:	29	54	99	
PEAK				
Angle of Shearing Resistance:(θ)				43.0
Effective Cohesion - kPa:				7.0

The laboratory testing undertaken as part of this investigation identified angles of shearing resistance between 35° and 43° whereas the existing slopes are stood at 60° to 90°. The test results are a reflection of the finer material only and the soils are noted to be predominantly granular; however, it is considered that the results are reflective of the ground conditions. The results show the existing slopes to be significantly over steepened and are therefore likely to continue spalling until remedial work is undertaken.
