REV	DATE	DESCRIPTION
P2	31/05/24	Updated Tender Documents
P1	22/12/23	STAGE 4 ISSUE

TITLE
Conservation Repairs - External - Outbuilding

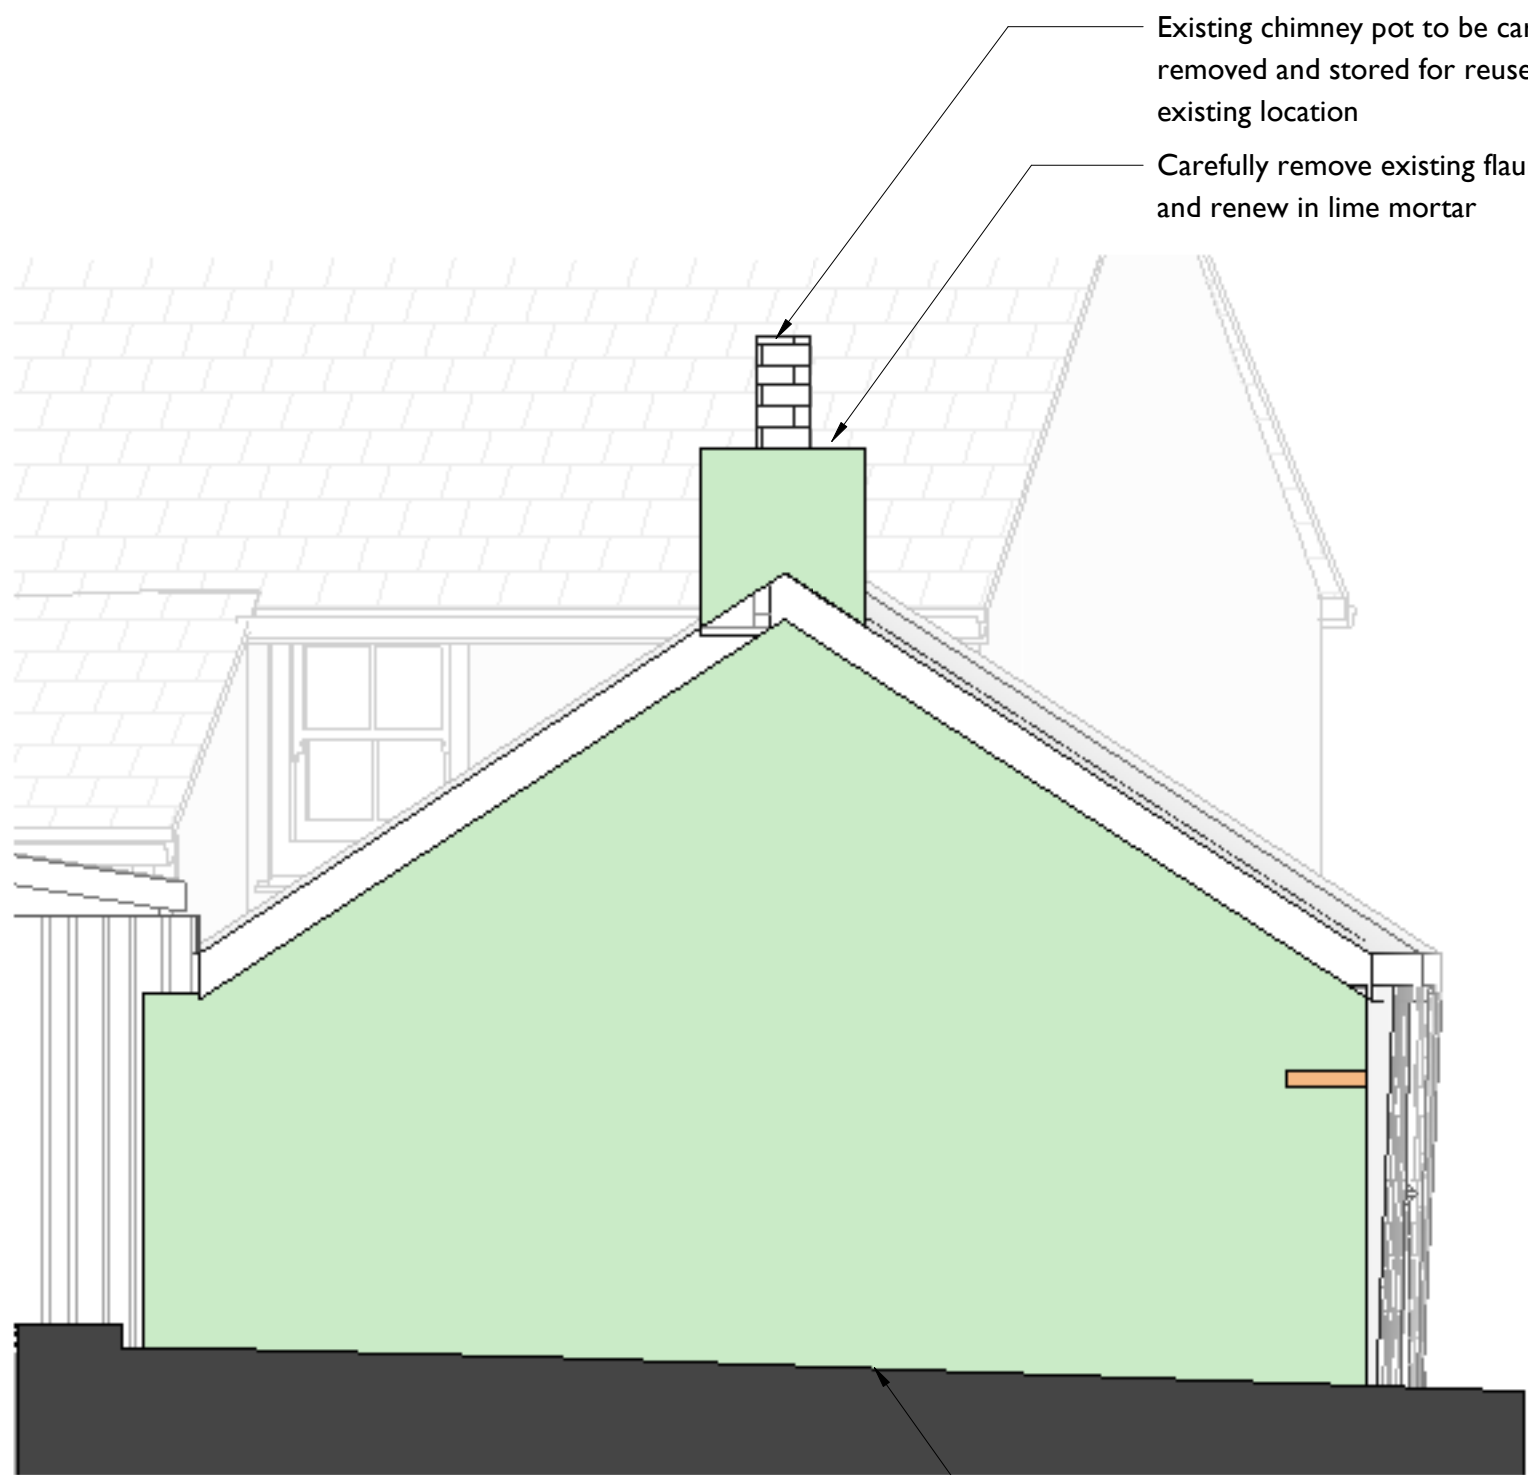
2 Outbuilding - NW Elevation Repairs
1 : 25

Carefully remove all vegetation to the base of the building, taking care to ensure that all roots are removed
