Porthmellon Waste Site, St Mary's

Isles of Scilly

# **Quality Management**

1.1.1 RPS has been commissioned by the Isles of Scilly Council to undertake an ecological review of the Porthmellon Waste Site and adjoining land with specific reference to compliance with wildlife legislation to inform the proposed redevelopment of part of the site as a Household Waste Recycling Centre (HWRC) and to inform actions that will need to be taken to ensure that the demolition of the disused incinerator complies with wildlife legislation.

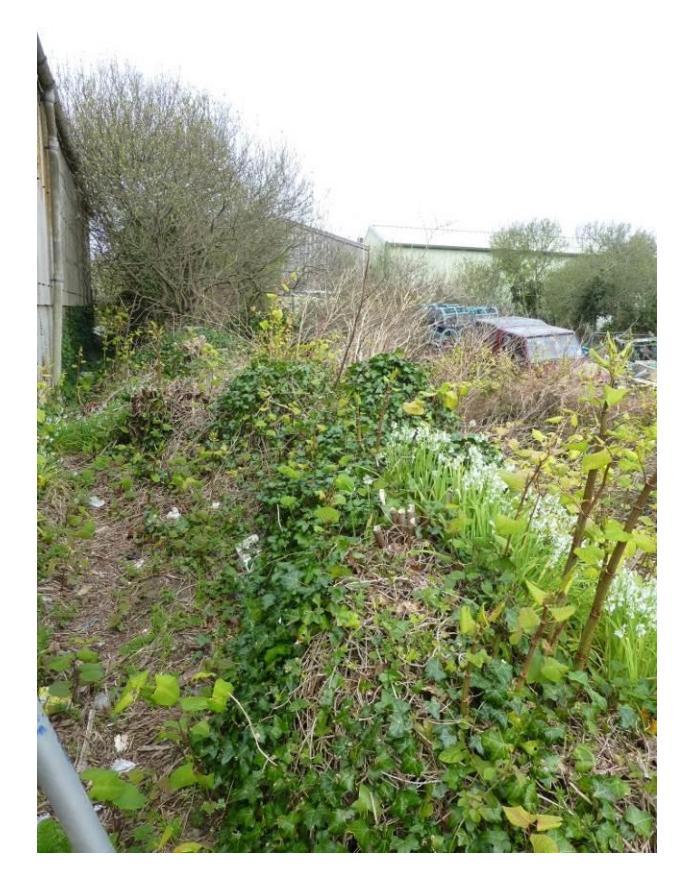
Plate 3-1 Northern part of Stand A

3.1.6 This is an established stand of Japanese knotweed on a low bund on the eastern boundary of the operational site growing between the workshop and the offsite ditch. (*Plate 3-1*).

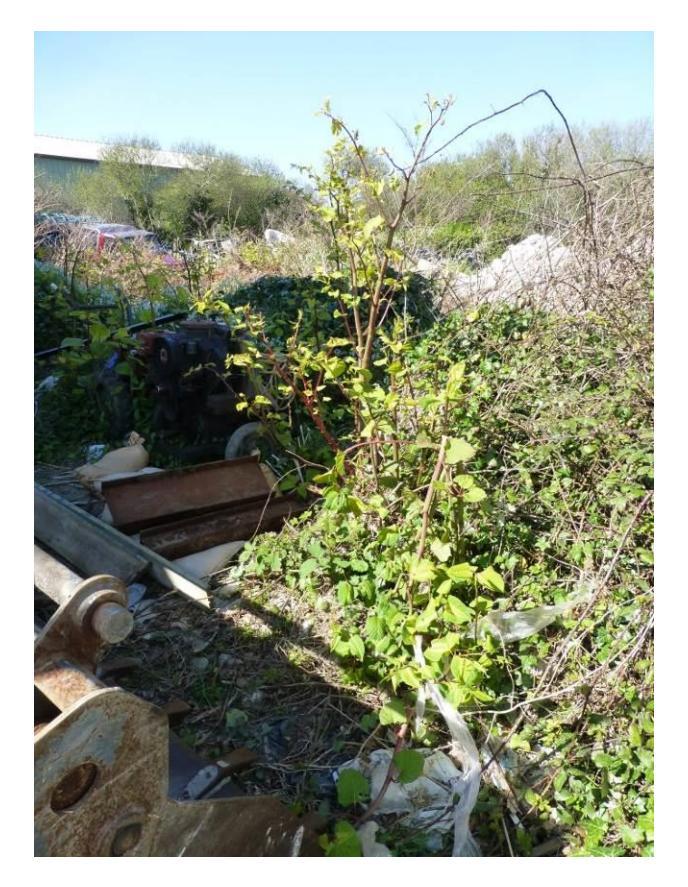
Plate 3-2 Stand A and site materials

- 3.1.7 Old growth with large crowns and wide diameter stems was evident on the bank at the southern end of the workshop indicating that the plant has been present in this location for a number of years. Infrequently used equipment on this boundary on the site boundary bund has young shoots of Japanese knotweed growing amongst them.
- 3.1.8 Several small young shoots are coming up into the operational site in and around the location where the JCB was being parked at the time of the survey (*Plate 3-2*). This part of the site will be expected to have Japanese knotweed roots below the surface of the working area. The roots would also be expected to extend beneath the workshop.

3.1.9 Importantly there is not yet any evidence of spread onto the historic refuse mound in this location and only slow spread southwards along the length of the ditch.

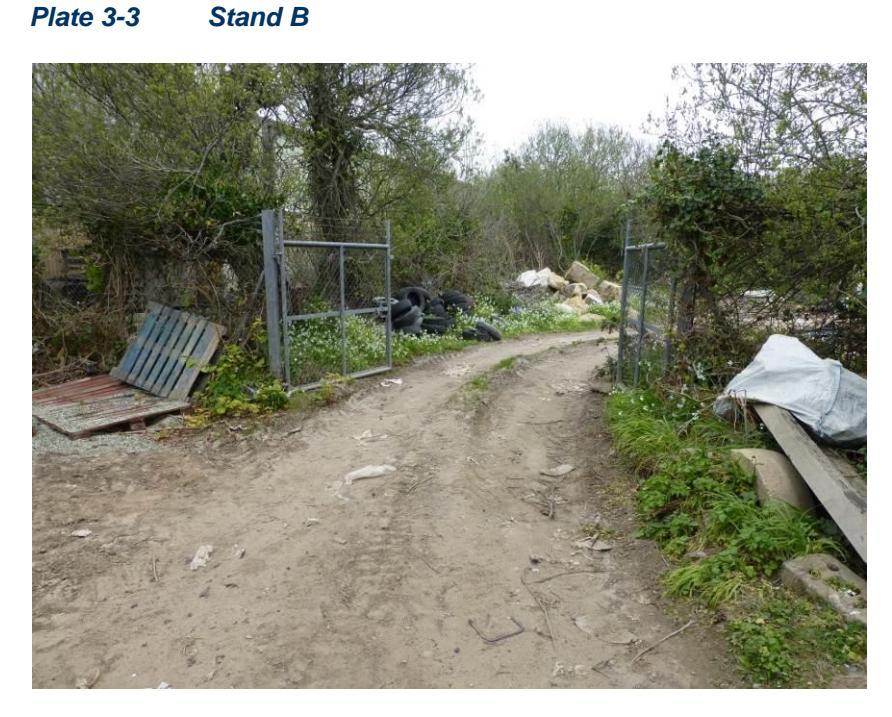
3.1.10 Numerous small shoots are appearing on the edge of the track into the Duchy of Cornwall site. Some very young shoots are coming up through compacted soils in the trackway and with more likely to appear in the coming weeks (*Plate 3-3* and *Plate 3-4*). In comparison, there are only scattered plants on the north-eastern boundary adjoining the northern ditch with more substantial stands beyond the site boundary.

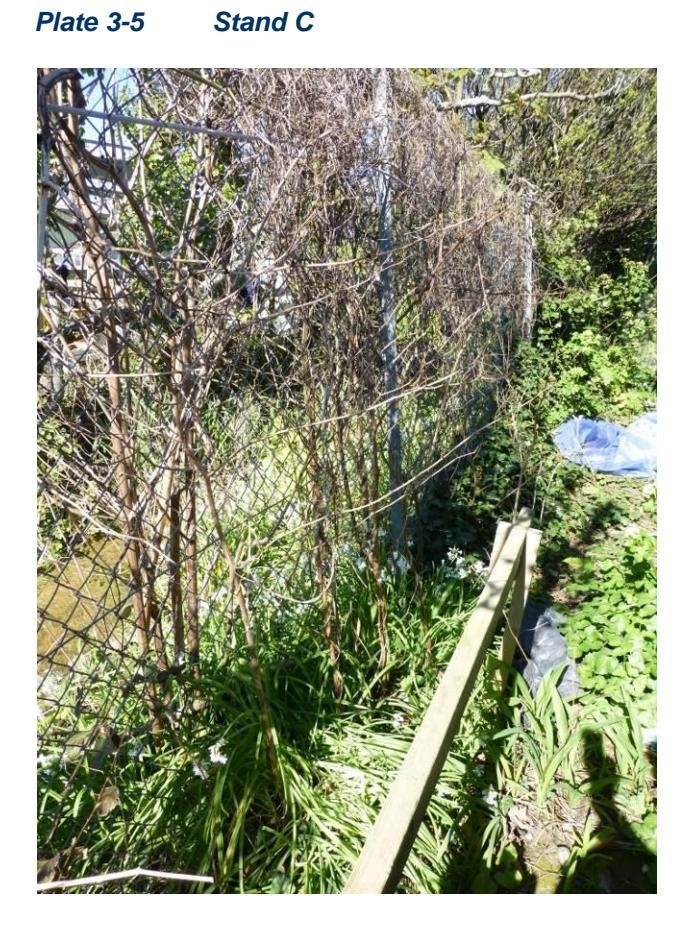
3.1.11 Japanese knotweed shoots are appearing in ground disturbed where a cable was installed by trenching in 2014 (*Plate 3-5*). The work undertaken by Western Power Distribution will have spread Japanese knotweed and machinery used in the works could have spread the plant to other locations on the Scilly Isles or on the UK mainland.

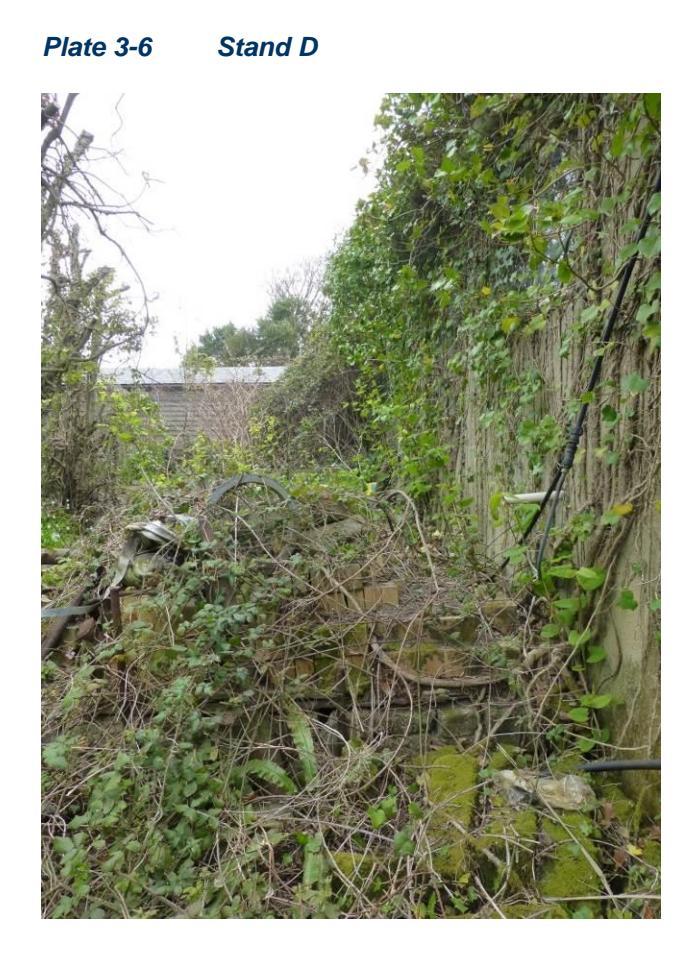
3.1.14 There are also a few shoots of Japanese knotweed emerging in bare ground behind the site office portacabin. The growth to the north was associated with the roots present beneath the off-site workshop/garages. Off-site Japanese knotweed was also seen growing from the base of the eastern elevation of the garages with an adjacent long established stand on the bank of the ditch (*Plate 3-6*).

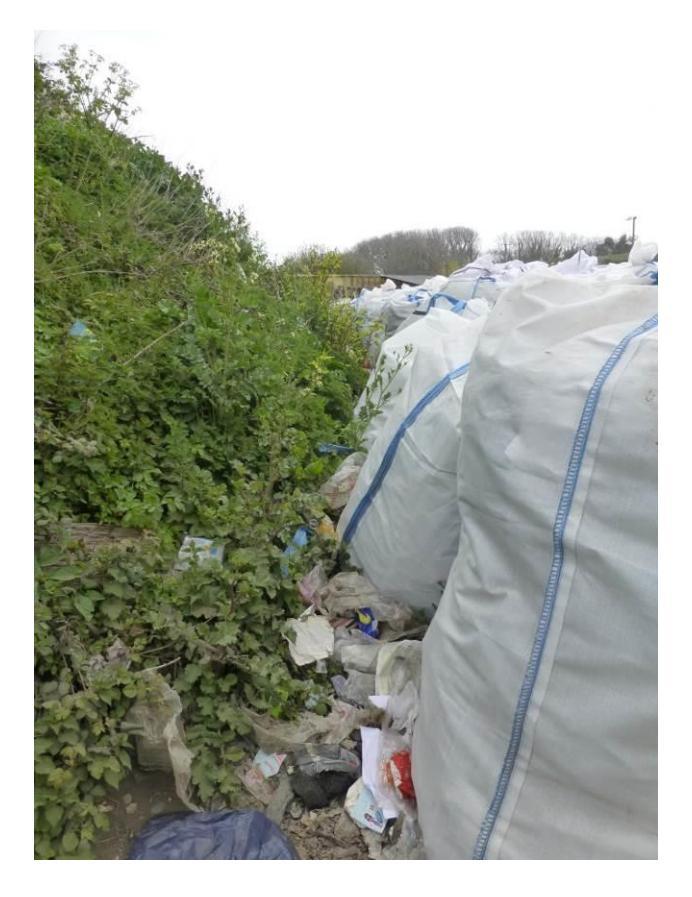
3.1.15 A small stand of Japanese knotweed is growing on the edge of the working area for current site operations at the base of the historic waste bund. The stand is approximately 10m long is growing next to white hessian bags used to temporarily store black bag bin waste (*Plate 3-7*). Young shoots were growing up around the base of a few white bags but the extent of young growth was not fully assessed as there was not safe access to the stand. The small dense stand will have established from plant material inadvertently spread by people or machinery during site operations.

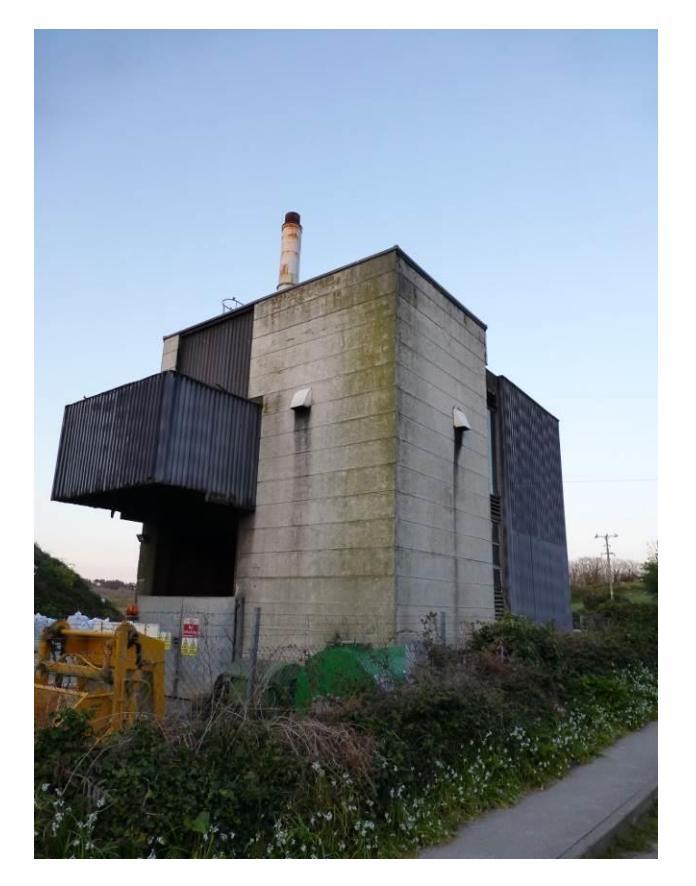
Plate 3-8 Incinerator building viewed from adjoining road

3.1.18 The disused incinerator building is located in the southern part of the site, adjoining the surface public path. It comprises the main waste reception and incinerator block, a fan and tower and two gas cleaning plants. The buildings are primarily constructed from sheet metal but the main incinerator block is partially constructed from concrete blocks (*Plate 3-8*). There are connecting metal flues supported by stanchions linking the built structures. The roofs are flat with the stack located on a central gas cleaning plant.

- 3.1.19 The concrete blockwork was tightly sealed with no significant deterioration in the structure. The metal sheeting was also in reasonable condition but the upper part overhangs the lower section of the building with the potential for there to be accessible internal cavities. However, roosting bats are rarely associated with metal materials due to the very wide temperature variations created by this material and in this context the likelihood of bats using of this part of the building is negligible.
- 3.1.20 Two areas of the building were identified has having some potential for use by roosting bats.

- 4.1.9 Overall the incinerator building is considered to have low potential value for roosting bats but there are small enclosed cavity features in its structure with the potential to be used by roosting bats.

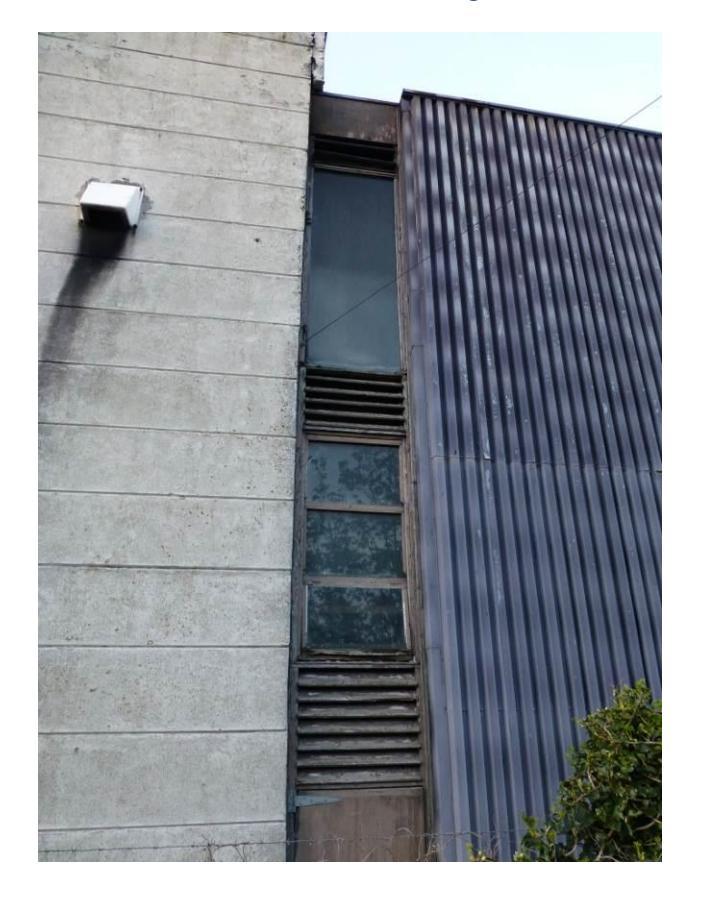
Plate 3-9 Louvred ventilation grilles

3.1.21 Externally, there are narrow connecting sections between the parts of the building that of concrete block and sheet metal construction (*Plate 3-9*). These are present on three sides of the incinerator black and have wooden louvred vents creating points of access into cavities on all three elevations.

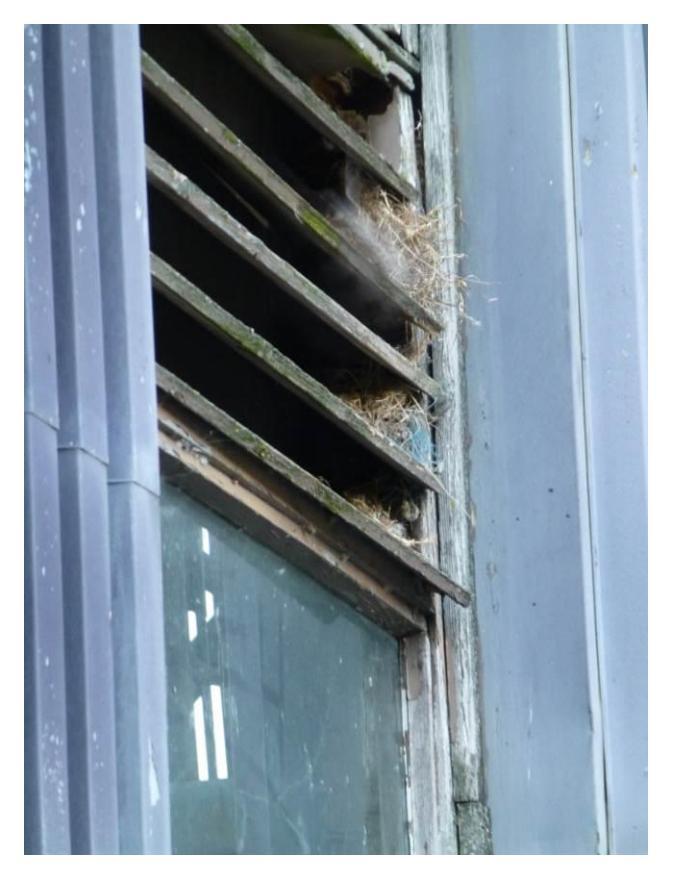
- 3.1.24 During the walkover surveys, bird activity around the incinerator building was recorded. House sparrow *Passer domesticus* and starling *Sturna vulgaris* was observed around the buildings during both of the daytime walkover surveys and in the evening at the start of the bat activity survey.
- 3.1.25 Nesting material was visible in many of the louvred vents on the south-east and north-west elevations (*Plate 3-10*). Adult house sparrows were seen flying from and entering these areas

during the surveys and males were territorial calling from the structure during the daytime surveys. House sparrows nest semi-colonially and there will be a number of pairs using the louvred features on two sides of the building.

4.2.4 Programming the dismantling and demolition of the incinerator block and associated buildings in autumn (September onwards) would avoid the main nesting season. Given the mild weather conditions on the islands confirmation that nests are no longer active (i.e. an absence of birds flying in and out of the building) should be addressed prior to the start of demolition.

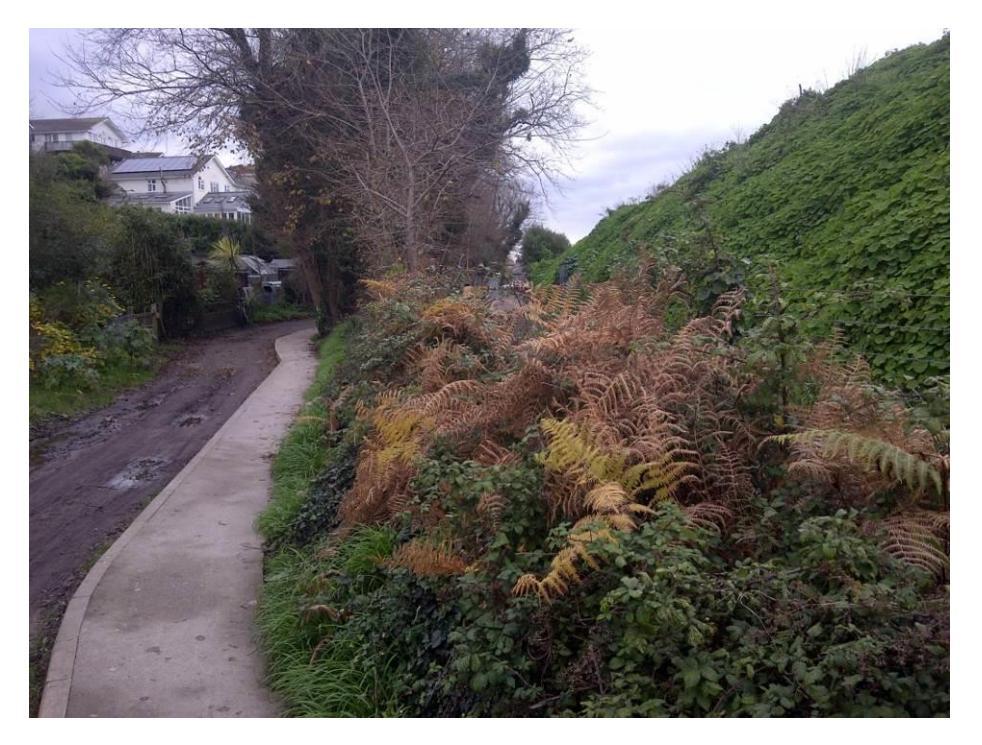
## Plate 3-11 Road north-west of incinerator

- 3.1.32 The first bat recorded flying along the road in the vicinity of the incinerator was at 20:49 with three bats seen together at this location at 20:50. This location is shown on *Plate 3-11*. At this time foraging passes extended further up and down the road and were frequently over the adjacent field/allotment. The light level of the sky remained relatively high during the first half of the survey and there were regularly passes of two bats flying together.

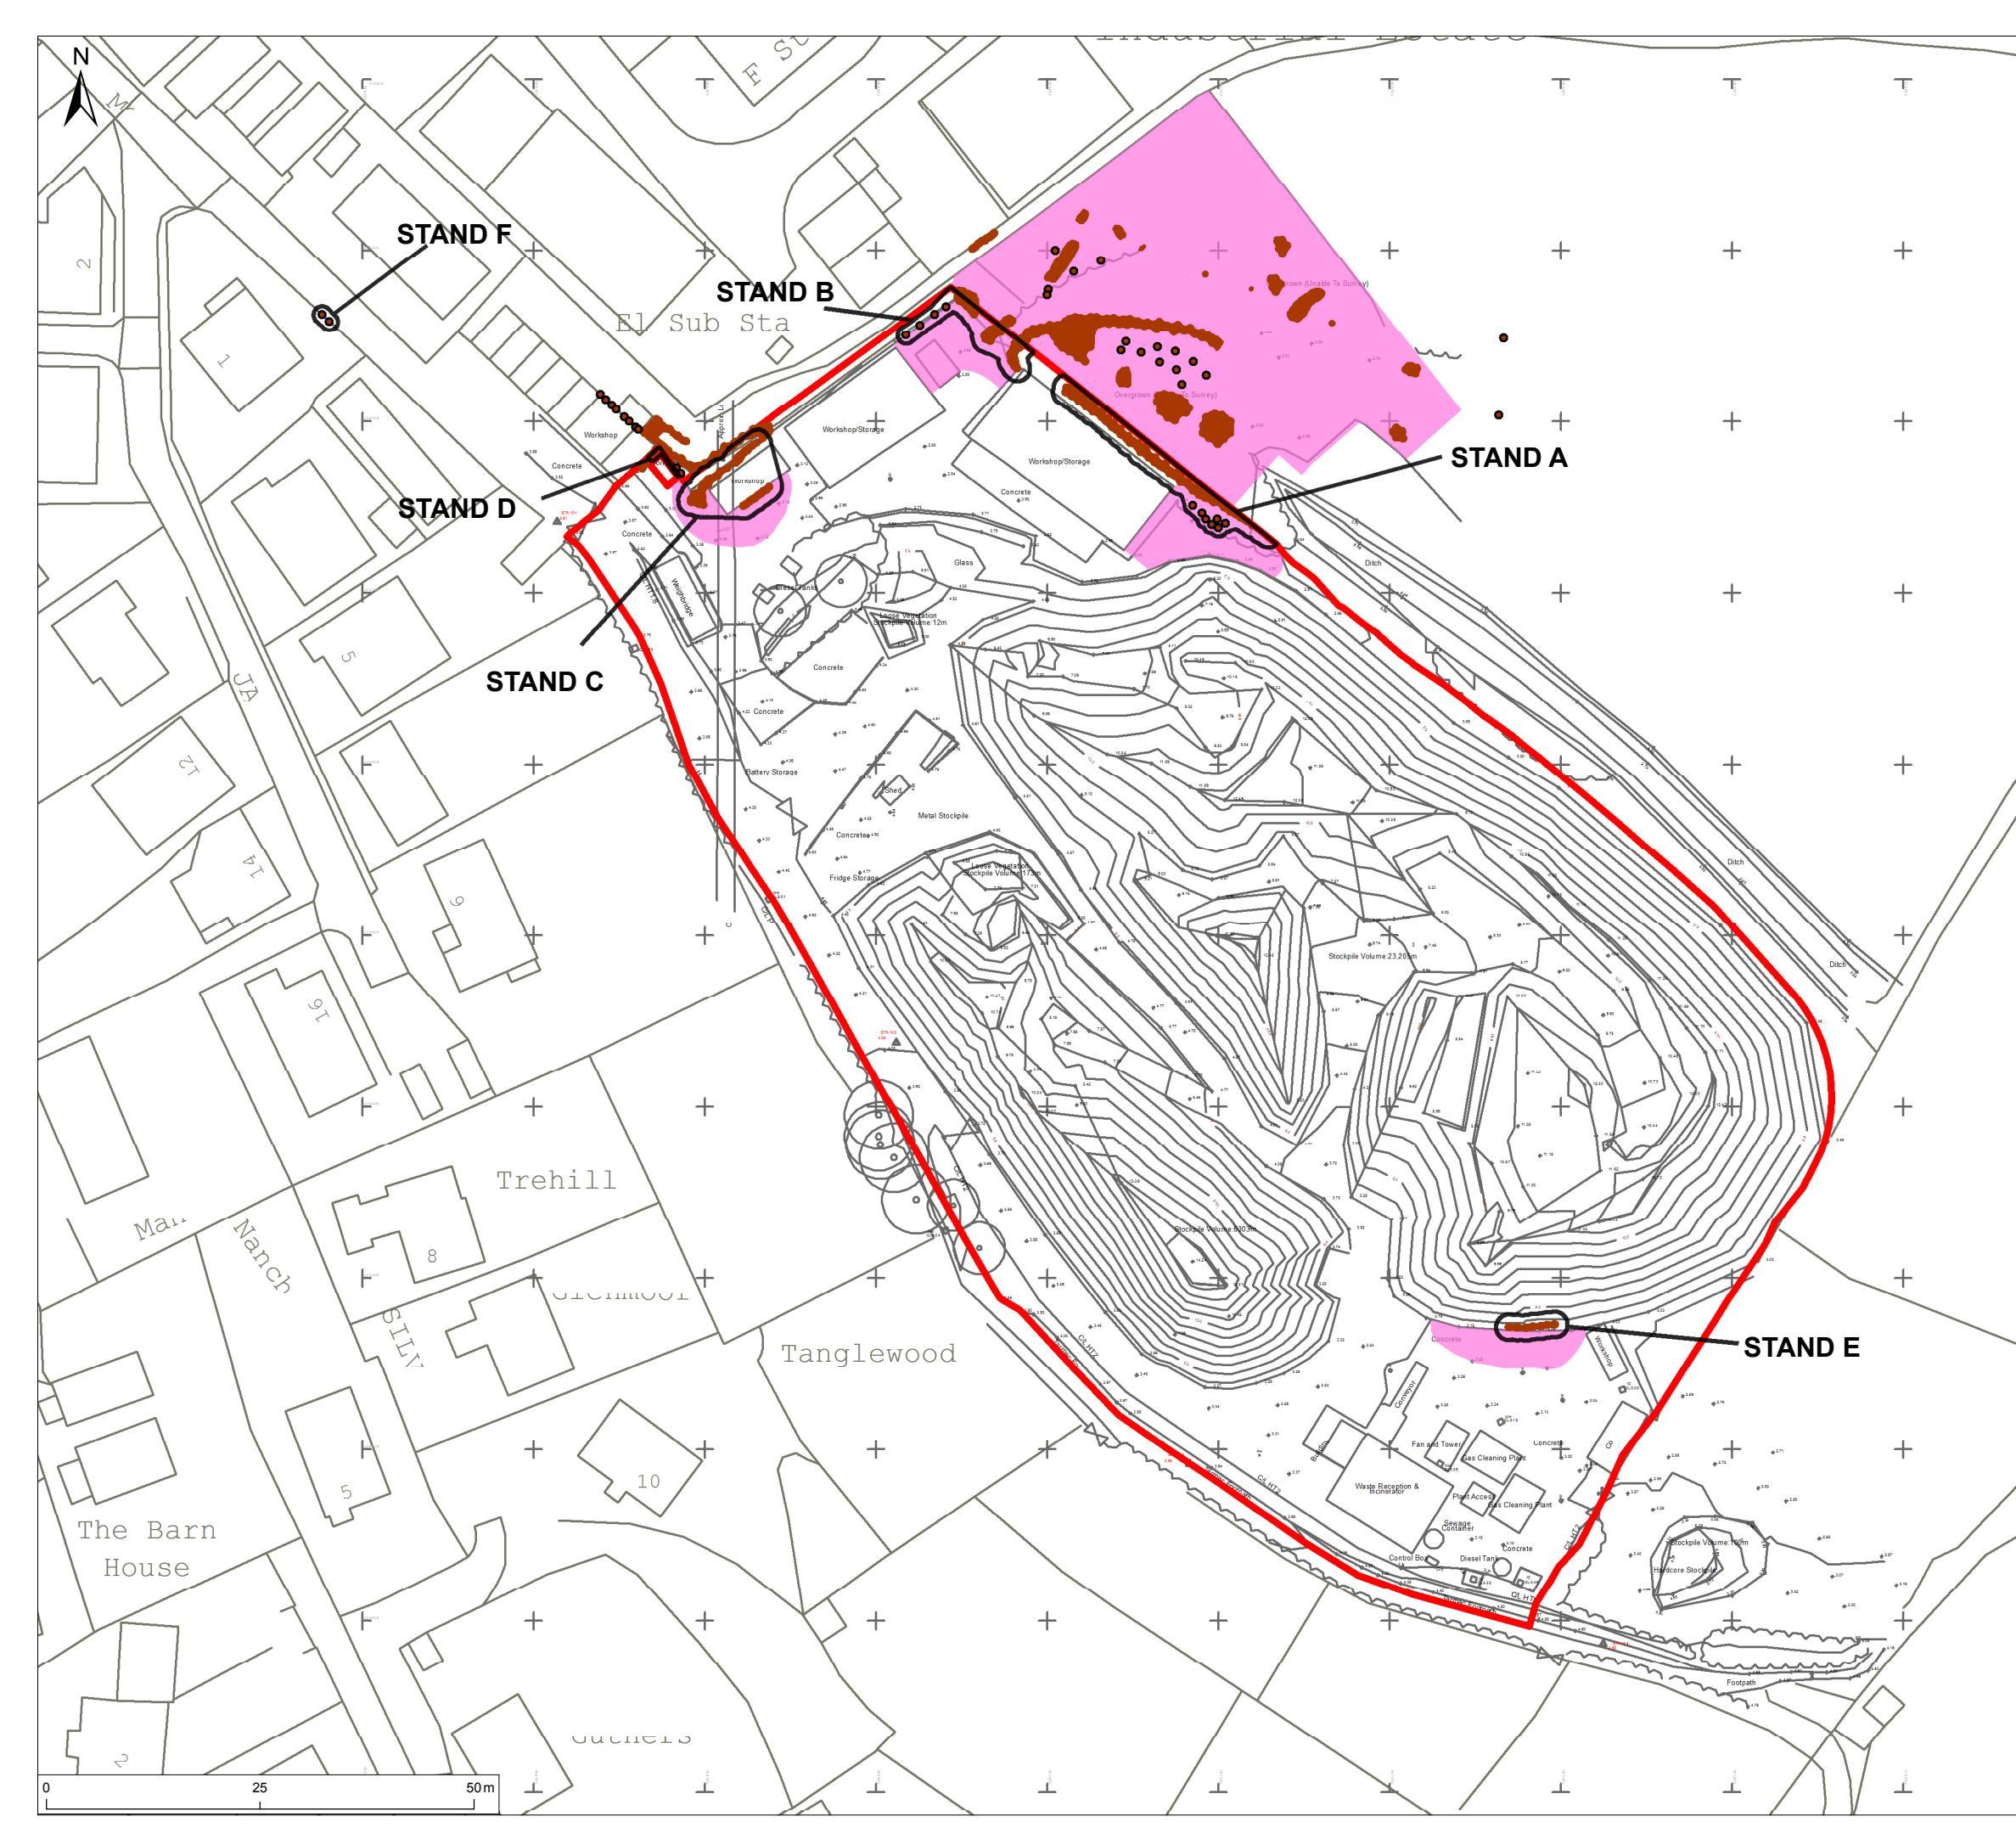
Drawing JER6282-ECO-003

- 3.1.1 The distribution of Japanese knotweed within the site is mapped on *Drawing JER6282-ECO-*003. The majority of plants within the municipal site occur on the northern and north-eastern boundaries of the site. The Japanese knotweed growth within the site has been divided into three main areas of infestation Stand A to E. The presence of Japanese knotweed on the northern boundary of the municipal site is likely to relate to the spread of the plant from off-site locations. Outside the site boundary there are groups of Japanese knotweed plants on the banks of the wooded northern ditch directly (adjoining the site boundary) and is widely distributed on the adjoining Duchy of Cornwall landholding where is growing on at the main access gate, along the edges of the central access track, on the banks of the ditch, amongst stored materials and under vehicles as well as on perimeter mounds.

- Ensure that Japanese knotweed plant fragments are not transported within or outside the site
- Implement herbicide control strategy on all stands (within and directly adjacent to the site)
- Build control measures into the design of the new HWRC to eliminate the potential for Japanese knotweed to affect structures in the redeveloped site
- 4.2.2 There is a risk of new Japanese knotweed stands being established in the municipal site from plant fragments transported on the wheels of vehicles. The Duchy of Cornwall will also need to urgently implement JK controls and eradication on adjoining land alongside control measures in the municipal site. Importantly vehicle movements of the tenants using the Duchy of Cornwall land could bring new plant fragments into the municipal site and around the island. The extent

- 4.2.3 The following actions should be implemented at the site as an urgent priority in advance of the development of the HWRC.
  - Establish a stand-off between were people are working and equipment is stored. This would ideally be 7m from the base of the established stand.
  - Separate operational areas from visible Japanese knotweed with barrier fencing to visually define stands.
  - Where Japanese knotweed is growing adjacent to equipment or stored materials do not disturb.
  - Equipment that will be essential for site operation can only be moved following a controlled method to ensure that plant fragments are not disturbed, transported or buried within the site.
