PROJECT  
**Mytle Cottage**  
Structural Refurbishment

DRAWING TITLE  
Existing Plans

SCALE	DATE	NO.	REV.
1:50 @A1	08.02.2016	10/0852-01	0

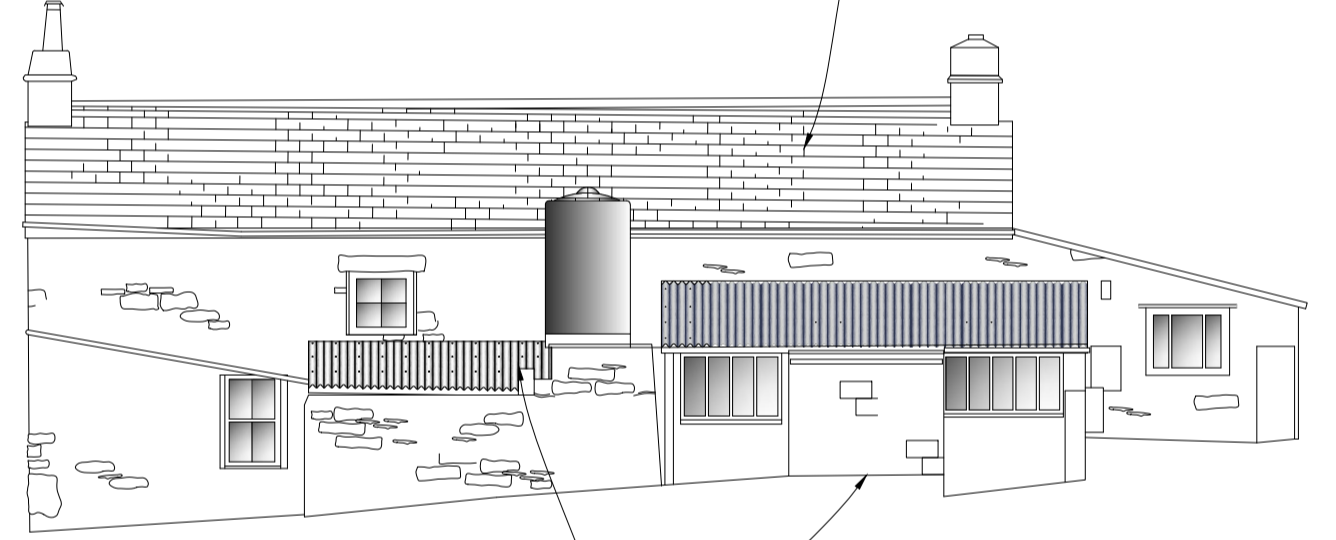
Elevation 1

**WATER STORAGE**  
Profiled compressed fibre and bitumen sheet roofing and rubble stonework mass and walls.

**SUN ROOM**  
Profiled plastic sheet roofing with concrete blockwork single skin walls.

**MAIN ROOF**  
Man made fibre cement with bitumen based membrane beneath. Relatively new timber roof structure.

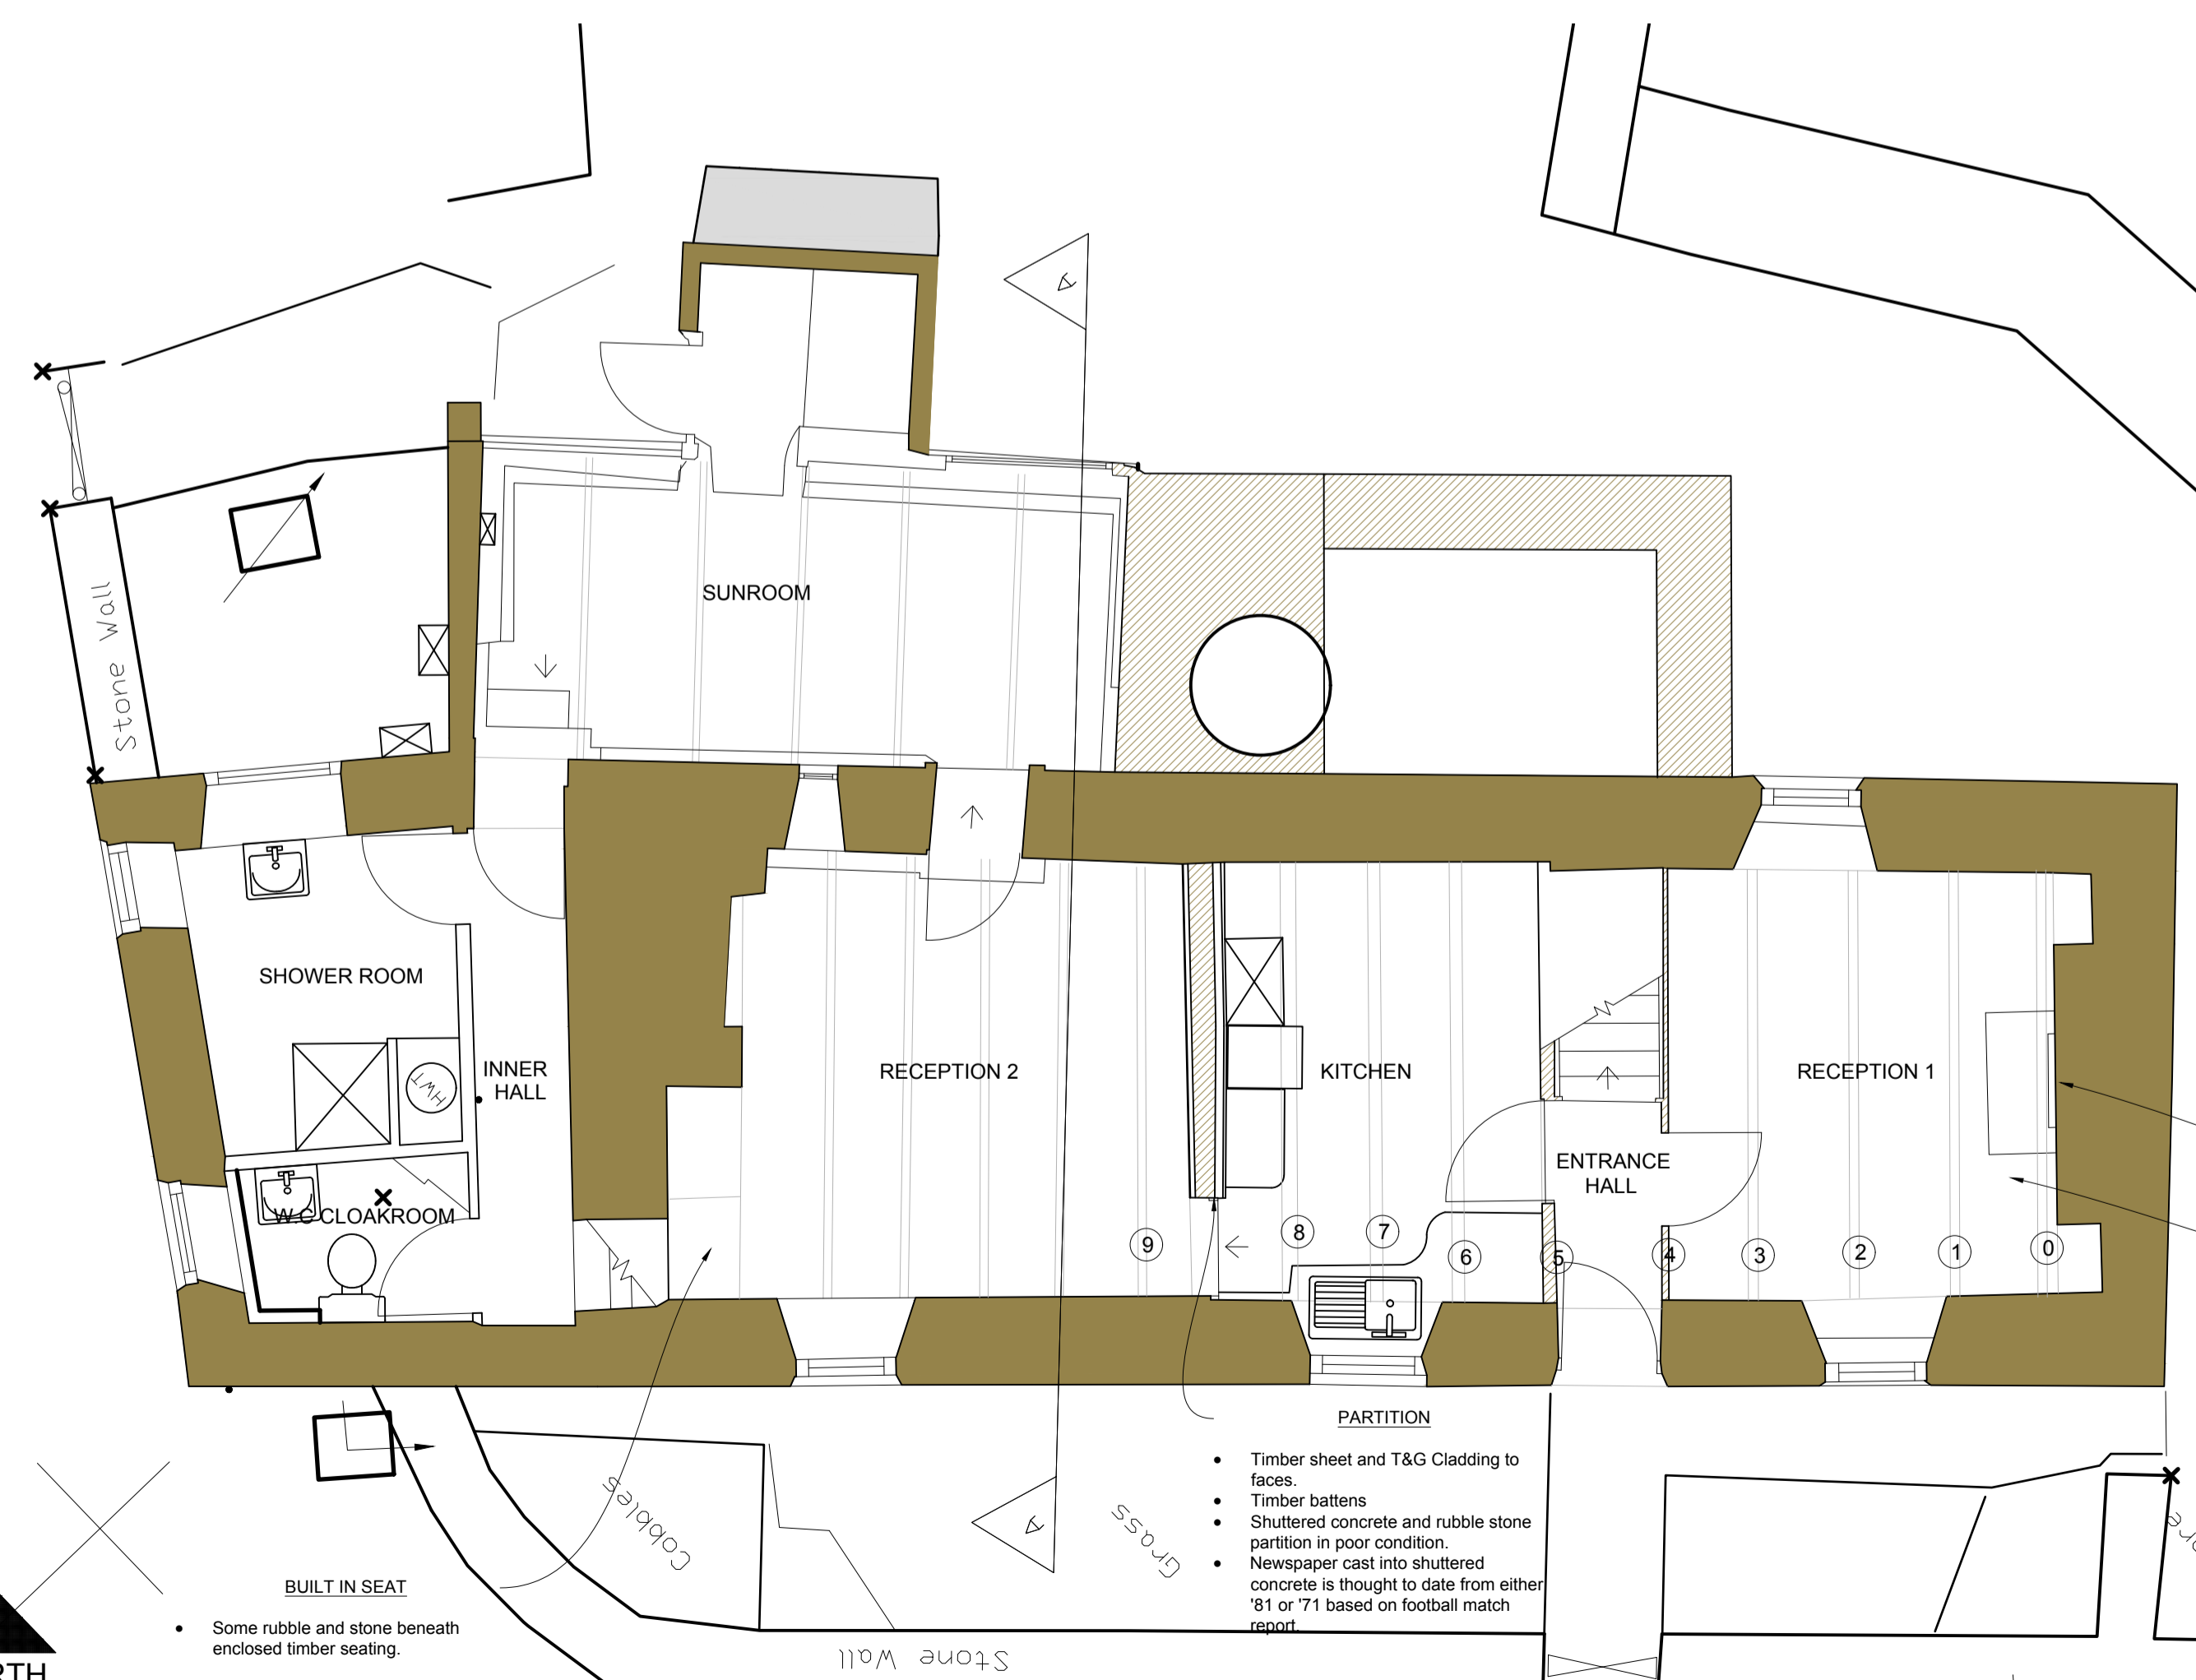
GROUND FLOOR PLAN

- PARTITION**
- Timber sheet and T&G Cladding to faces.
  - Timber battens
  - Shuttered concrete and rubble stone partition in poor condition.
  - Newspaper cast into shuttered concrete is thought to date from either '81 or '71 based on football match report.

**BUILT IN SEAT**  
• Some rubble and stone beneath enclosed timber seating.

- FIRST FLOOR JOISTS**
- 0 76x125mm
  - 1 80x125mm D shape
  - 2 76x125mm
  - 3 80x125mm
  - 4 95 x??mm
  - 5 Not inspected. Suspect 76 x125mm
  - 6 100x 110mm D shape
  - 7 100x 110mm L shape
  - 8 Ø125mm O shape
  - 9 70x125mm - All reception 2 Joists
