Design & Access Statement

Hildrop – Store

Lower Town, St Martins

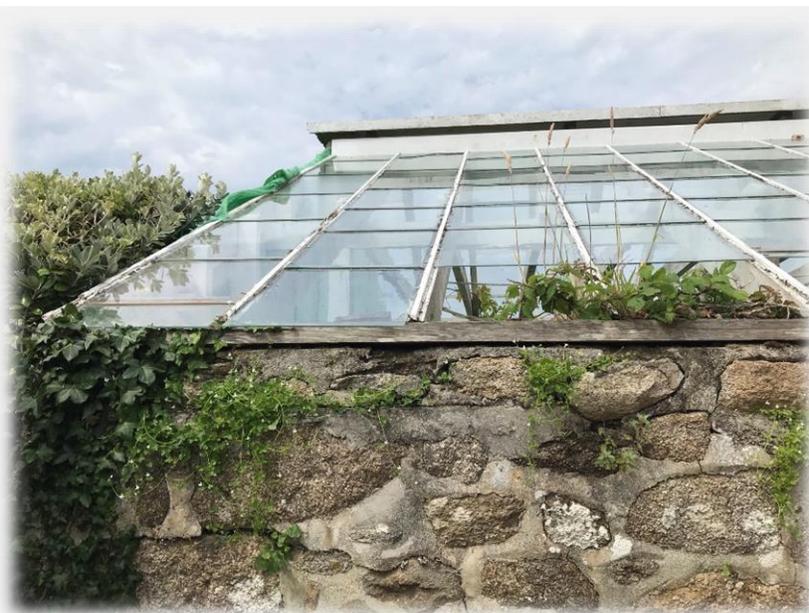
The glass currently used is not safety glass and is between 2mm and 4mm in thickness. The tops of the rafters need painting on a regular basis and to do this in a safety conscious way it is necessary to remove the glass panes to give access, which in itself is a hazardous process.

“...maintenance is difficult and hazardous...”

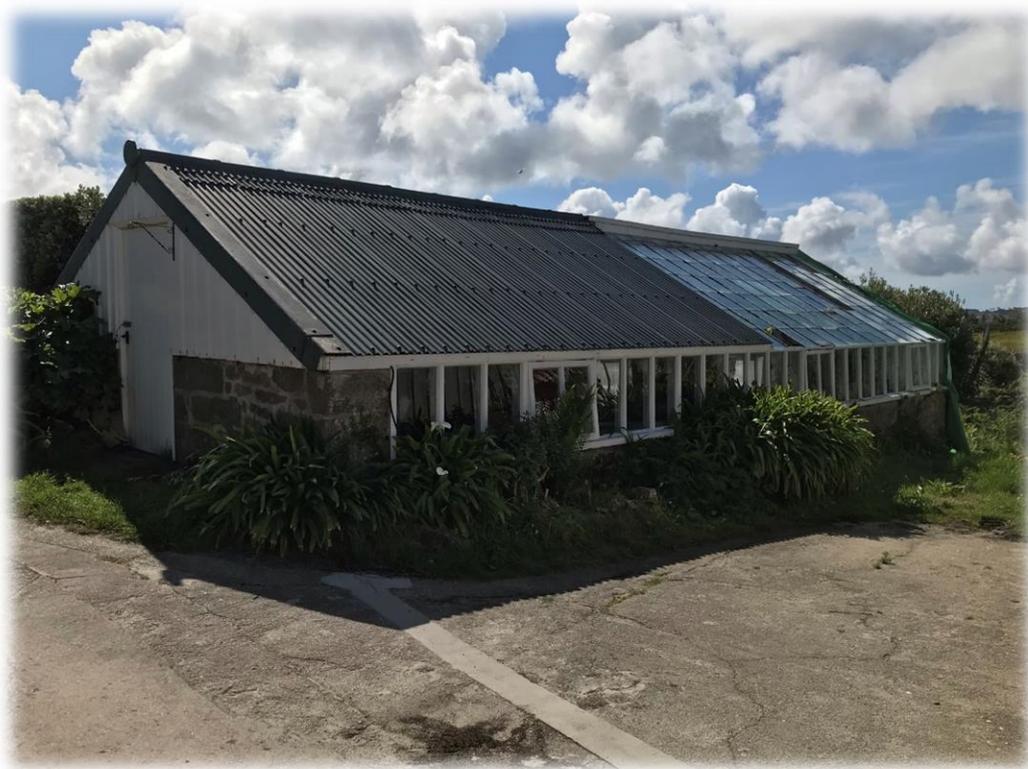
The proposed roof line will follow closely that of the existing roof covering.

There may be a variation of up to 20mm from the existing roof line. The proposed roof covering will be cement profile sheeting to match the existing. Proprietary accessories will be used to close off the eaves and ridge in a similar way to the existing system.

The internal roofing structure will be renewed where required. The wall plates will largely be replaced on a like for like basis. It will be possible to revert to a glass roof covering in the future should there be demand for this type of use for the building.

By carrying out this work we are able to preserve the structure from further decay whilst being sympathetic to, and retaining evidence of, its previous use as a glass house.
