P/21/079/TWA Old Town Churchyard

Brian has asked me to write, in support of the above tree works application.

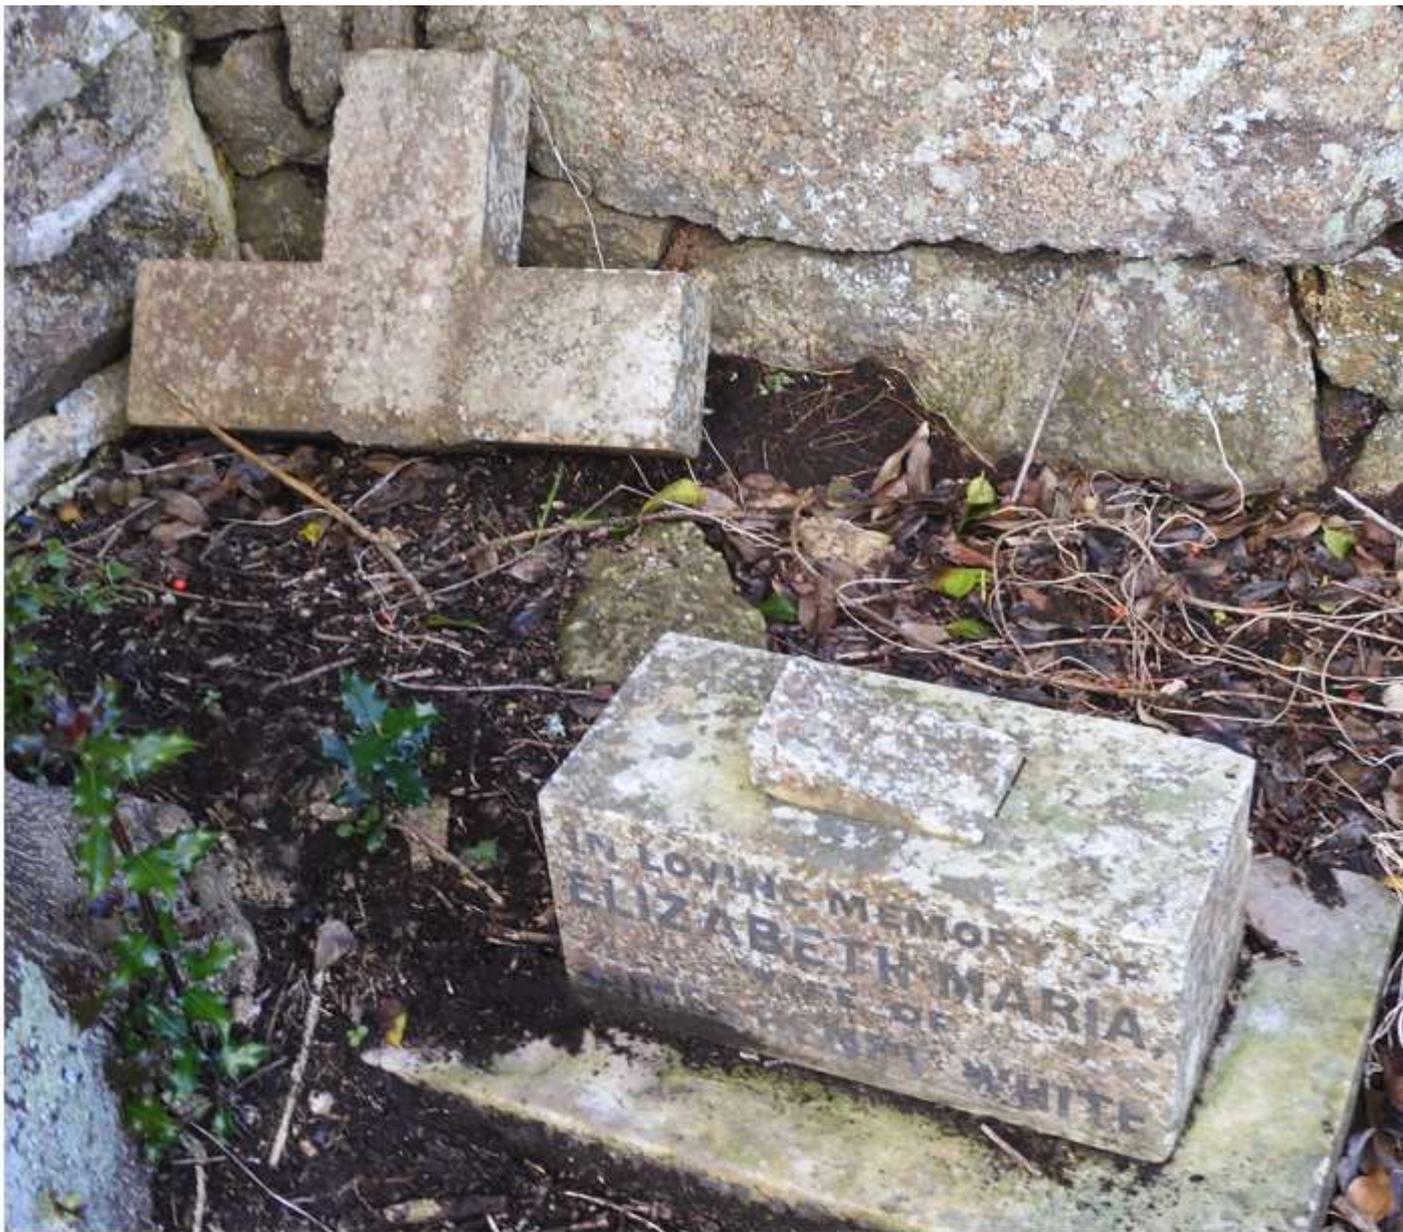
We have had conversations with Ned Rogers about the Holly tree. It is dying around its crown, many of the limbs are dead or in very poor condition. The trunk is shooting out new growth, but this is to be expected of Holly trees, they have a strong survival instinct. Aesthetically the tree is in a dire state, its removal would help in Brian's repair works. The overbearing size of the tree means that the side area is permanently damp and dark, its removal would bring light into the left hand side of the terraces, allowing the more sympathetic and appropriate planting to thrive and Brian would more easily be able to access the walls to rebuild them, currently this is not possible.

The tree has caused, in Brian's professional opinion, untold damage to the adjacent terrace walls, the roots themselves have badly undermined the stonework and the side wall is in a state of collapse. One cross, has been shattered by falling limbs. The cross belongs to Elizabeth Maria White, who died in 1884, she was the wife of Rev. James Henry White, who died later the same year in tragic circumstances. The nearby graves are all showing signs of root damage, the grave on the low walled area by the tree is particularly vulnerable.

We should like to support the tree's entire removal, as it is hard to see how a tree of that age would ever look presentable again, at the cost of the destruction of people's graves. After all it is a churchyard.
