Extension to The Turk's Head Pub, St Agnes, Isles of Scilly

Planning Application Design & Heritage Impact Statement

1st September 2023 | Revision E - 20/02/24

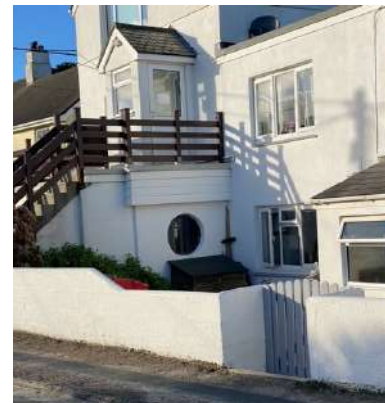
Image 13. Examples of round windows in Hugh town.

The extension's front (east) elevation provides a feature round window, other examples of which can also be found around the islands, especially in Hugh Town (see images below). Also on the front elevation is the entrance lobby, with glazed sidelight to the door, allowing the sun's warmth to dry the coats and shoes.

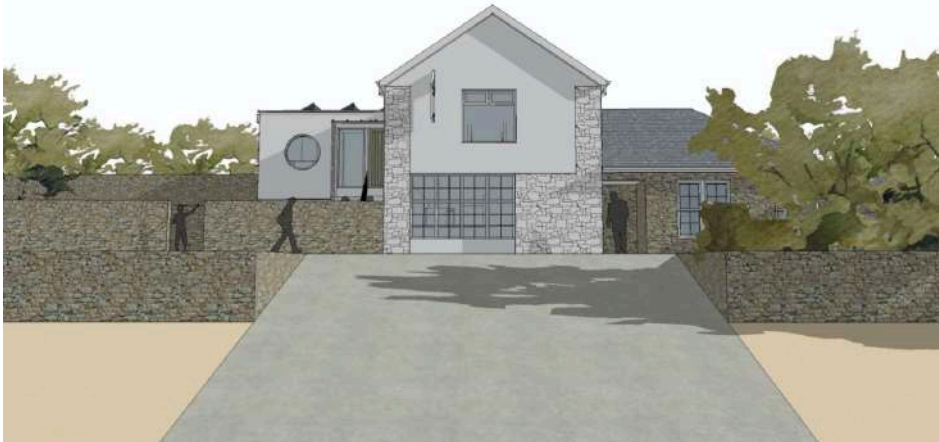
Image 13. Proposed view from the Slipway.

The extension is set back from the main building's front elevation, as well as its roof being much lower, almost level with the eaves. These elements help to emphasise the original building and minimise the impact on the Designated Area. When viewed from the north east, from the harbour, it will be largely out of view (see submitted 3D Views). The removal of the glazed conservatory will also greatly reduce sunlight reflection into the landscape.
