Extension to The Turk's Head Pub, St Agnes, Isles of Scilly

Planning Application Design & Heritage Impact Statement

HUGO
DAVIES
ARCHITECT

1st September 2023 | Revision F - 23/05/24

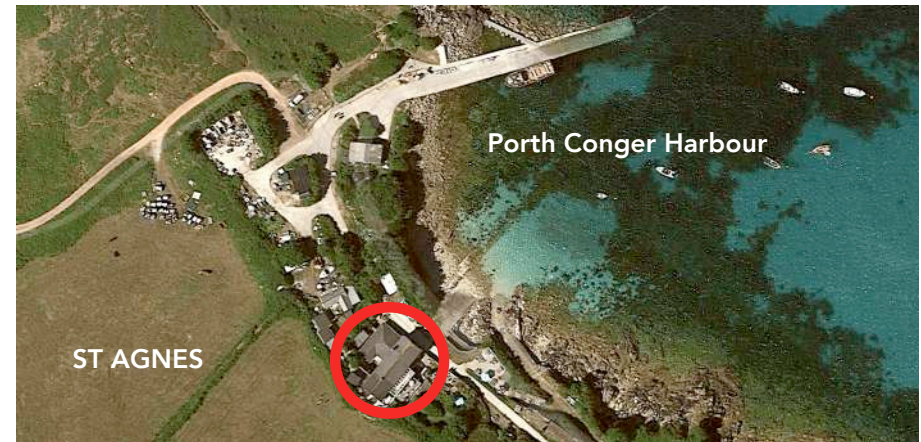
Image 1. Site location. Existing conservatory on south side of the building. Source: Google.

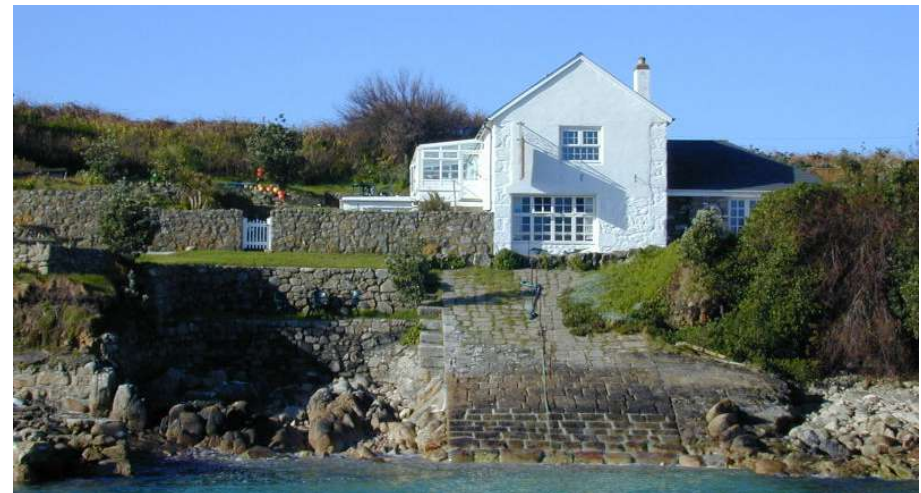
Image 2. Existing east / front view.

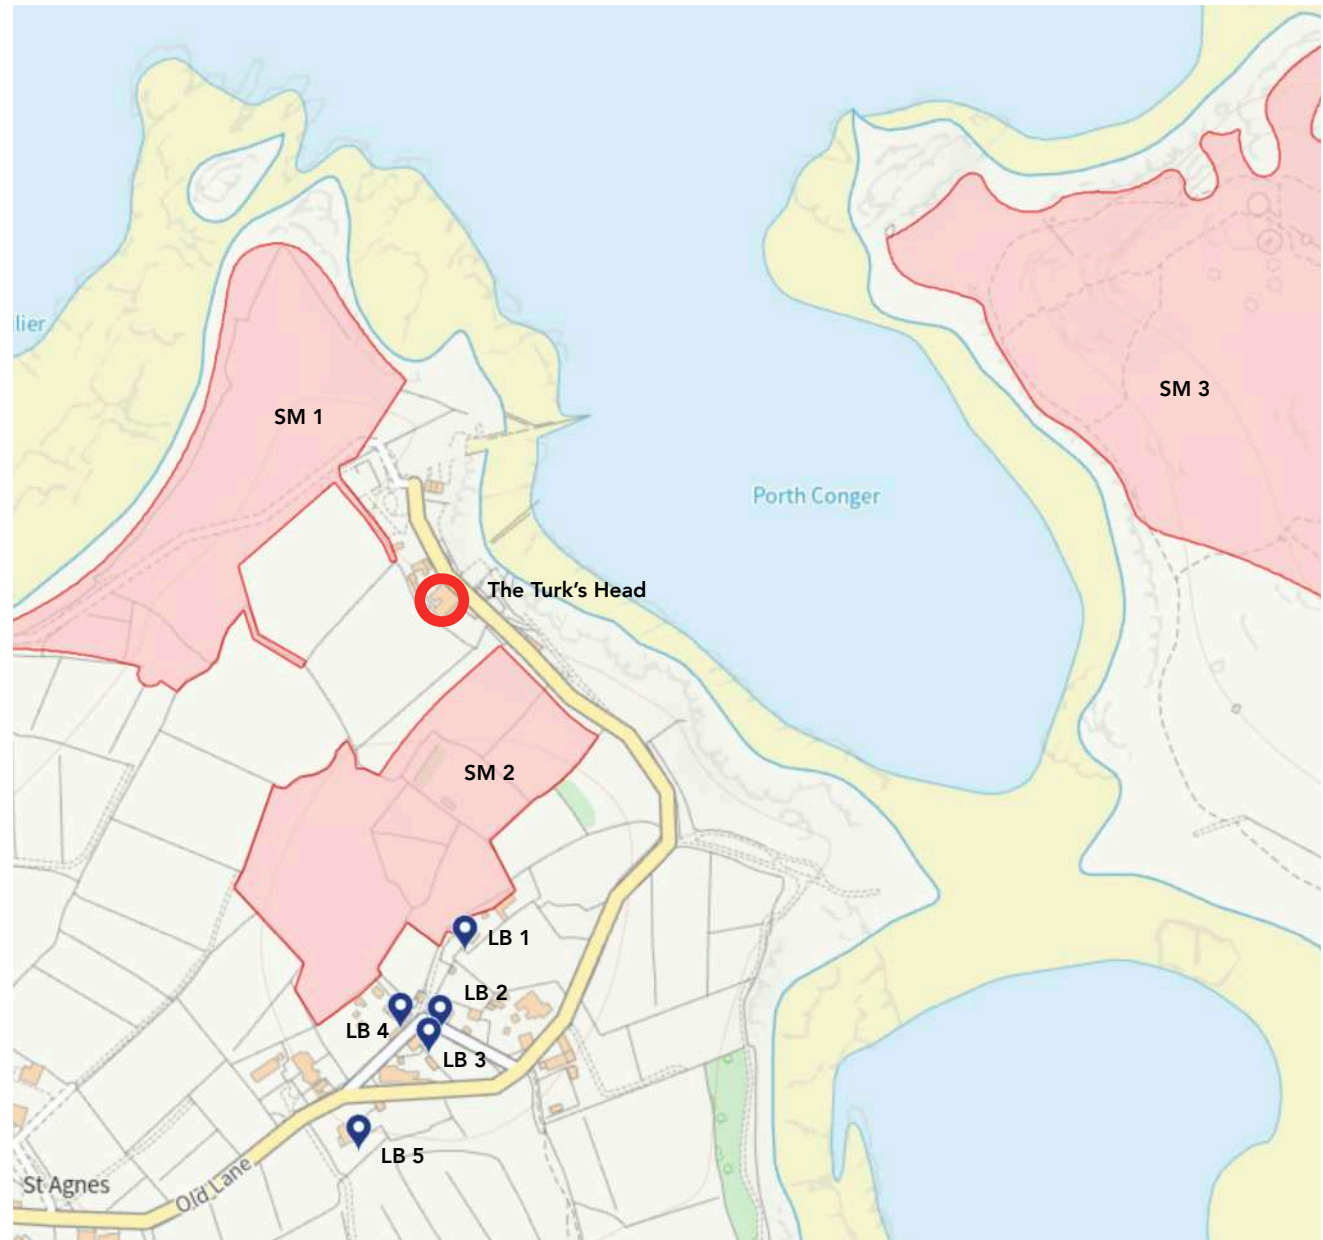
Image 3. Map showing listed buildings / scheduled monuments. Source: www.historicengland.org.uk.

To the north and south of the site area two areas designated as Scheduled Monuments, labelled on the image right as SM 1 and SM 2. To the east, across Porth Congor bay is another, labelled SM 3.

- LB1: Rosenhill, Grade II, list number 1141202.
- LB2: Rose Cottage, Grade II, list number 1328852.
- LB3: Myrtle Cottage, Cottage, Grade II, list number 1328836.
- LB4: Atlantic Cottage, Grade II, list number 1218318.
- LB5: Outbuilding at SV 8831 0819, Grade II, list number 1141201.

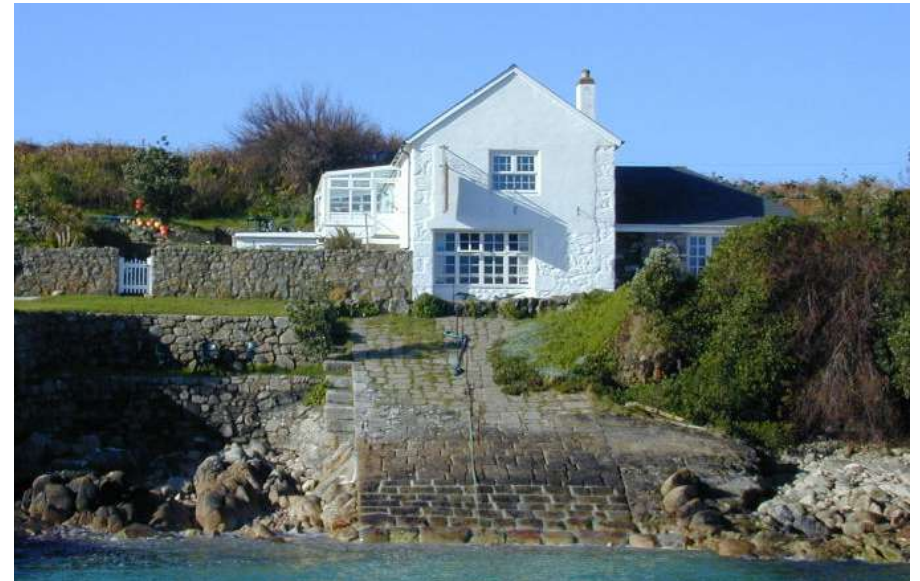
Image 4. Existing east / front elevation.

It is mainly a stone building painted white. Its first floor east gable is rendered and painted white. The roof finish is artificial slate. Windows are white PVCu. The conservatory is a combination of wood and PVCu but is in poor condition. The kitchen walls, at lower level and beneath the conservatory, are block work with imitation stone cladding, painted white.

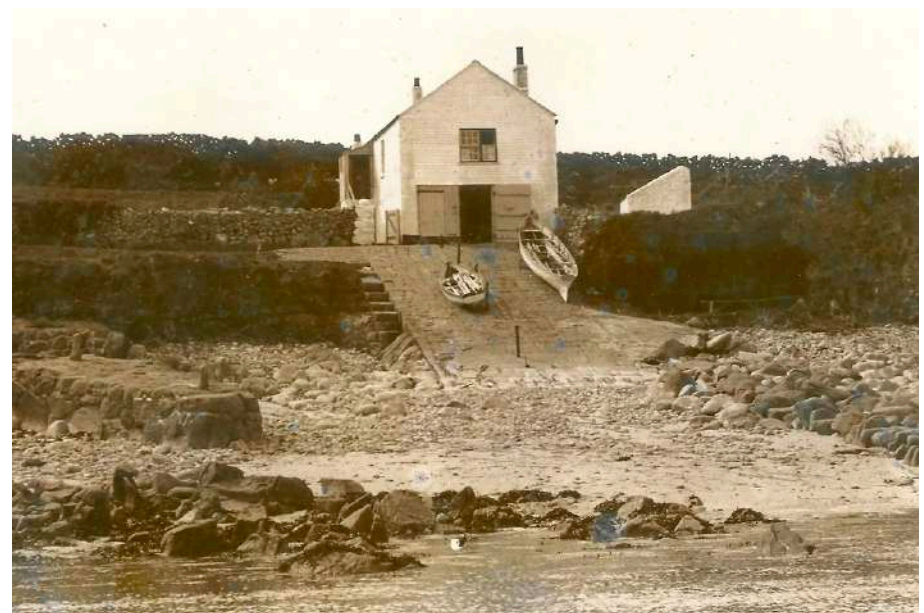
The building's original use was the coast guard and customs boat shed, as shown in the image on the left. In 1972 it became a pub and the building's external appearance remains largely the same, with the the same openings and chimney. The original building had a small lean-to on its south west side, as a porch to the first floor entrance. This was replaced by the existing conservatory in the 1990s. This sits above the pub's kitchen at the lower level.

Image 5. Historic image of the building.

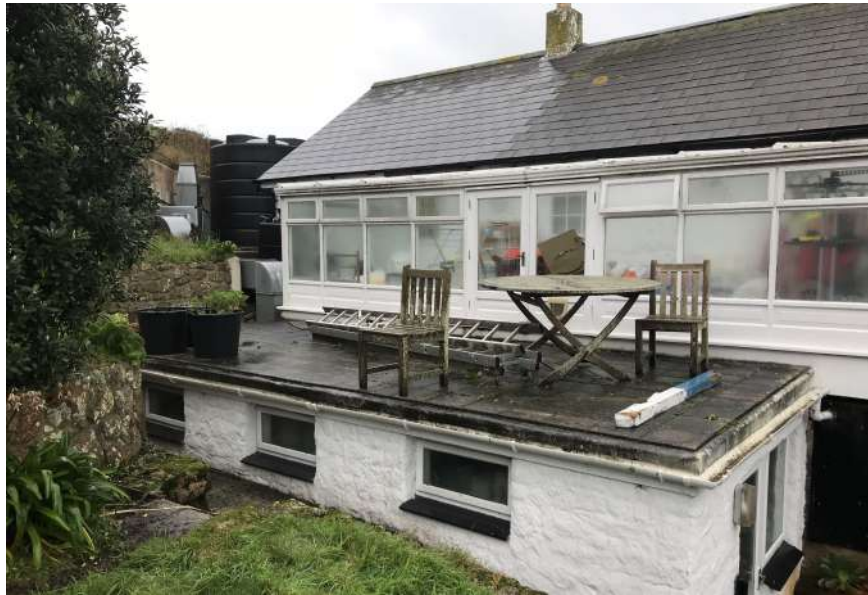
Image 6. South elevation - pub kitchen at lower level and conservatory.

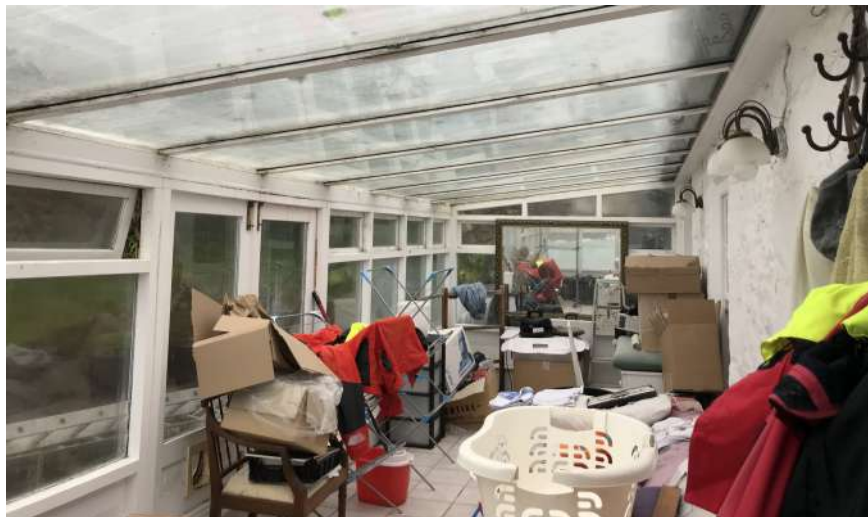
Image 7. Inside the conservatory, used as storage.

The conservatory offers a light and warm space, as respite to the original building's dark interior. However, being fully glazed it quickly becomes too hot on sunny days and too cold on cold days, and as a result it is rarely used as a living space but instead used for storage or a drying room. Being fully glazed, the inevitable clutter of stored contents are easily seen from the outside, making it

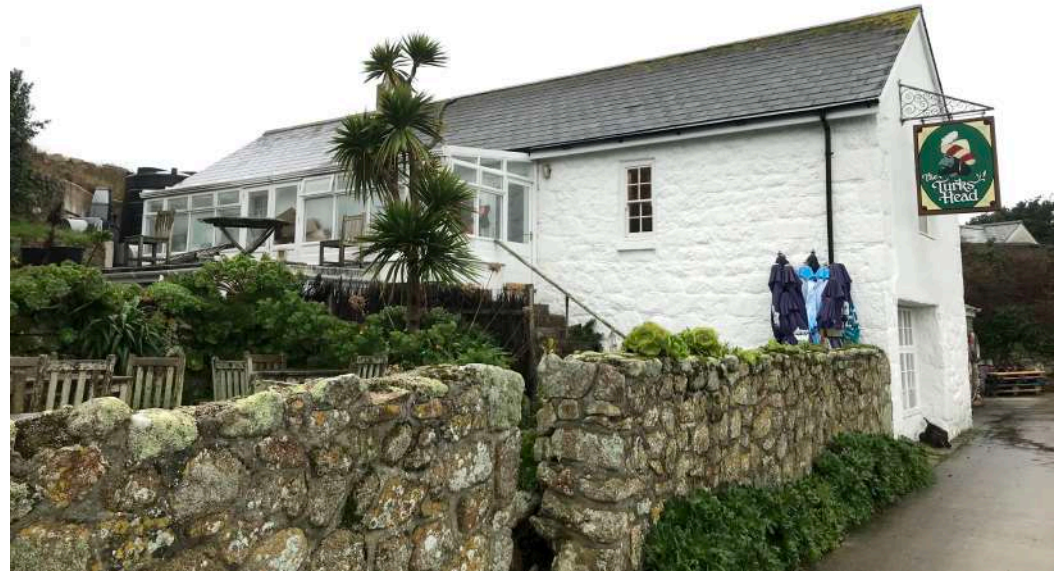
Image 8. Existing south view.

unattractive, added to its poor condition. The structure itself has no architectural value.

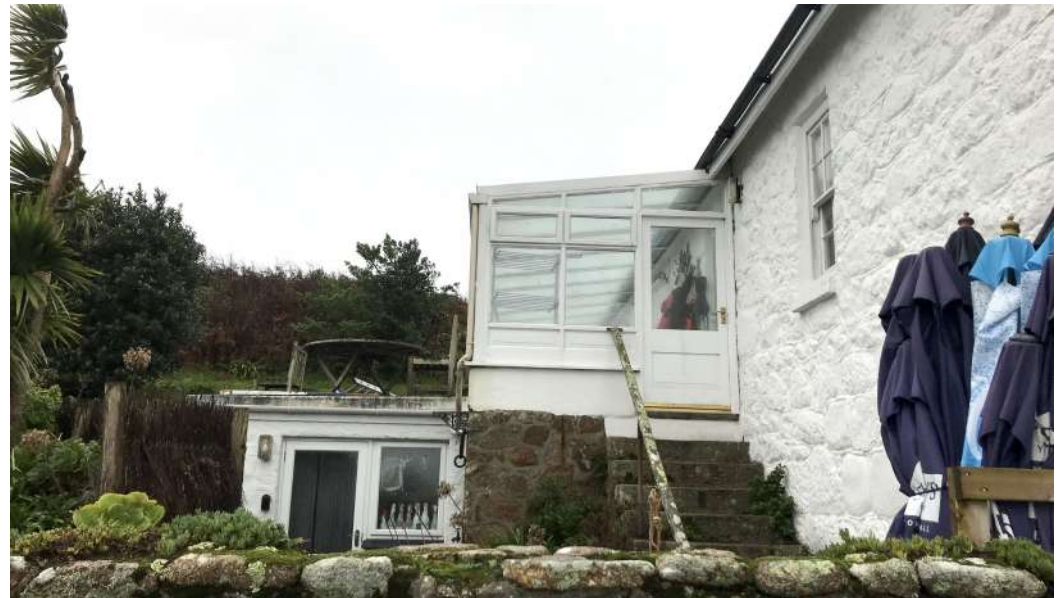
Image 9. Existing east view.

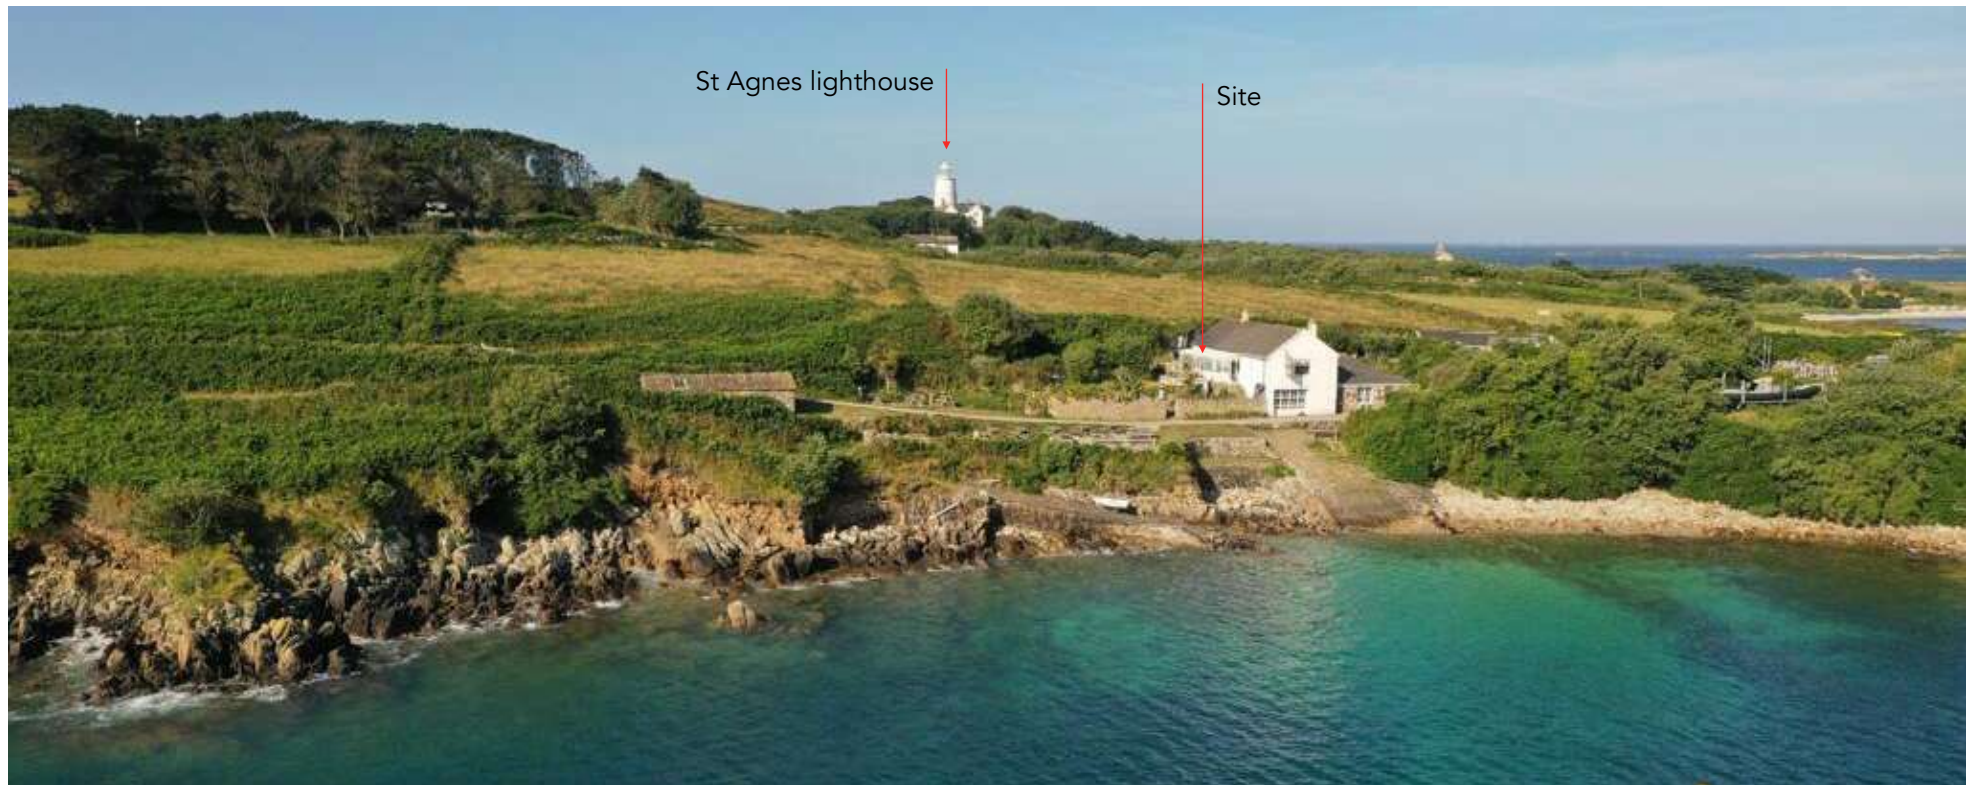
Within its setting, the white pub is one of the few buildings and its white gable islands out in the green landscape. It is in a prominent location within the bay, elevated above the slipway and at the harbour quay - the main arrival point for St Agnes, via the passenger ferry.

Image 10. Elevated view form the east. (Source: www.rightmove.co.uk)

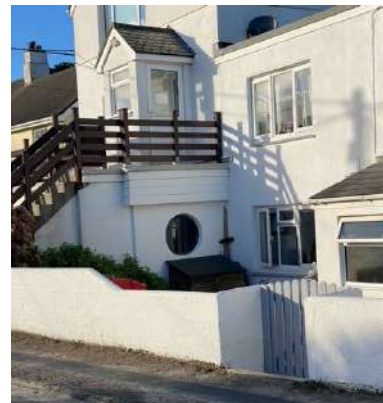
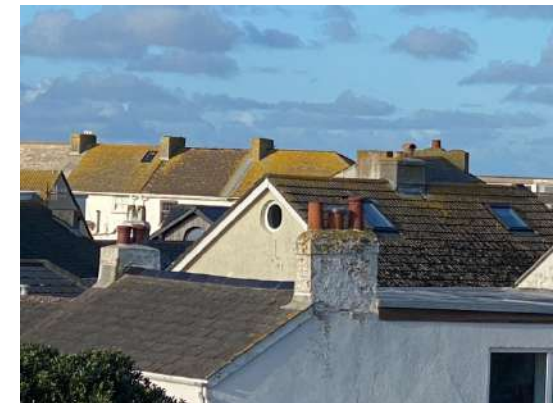
Image 13. Examples of round windows in Hugh town.

The extension's front (east) elevation provides a feature round window, other examples of which can also be found around the islands, especially in Hugh Town (see images below). Also on the front elevation is the entrance lobby, with glazed sidelight to the door, allowing the sun's warmth to dry the coats and shoes.

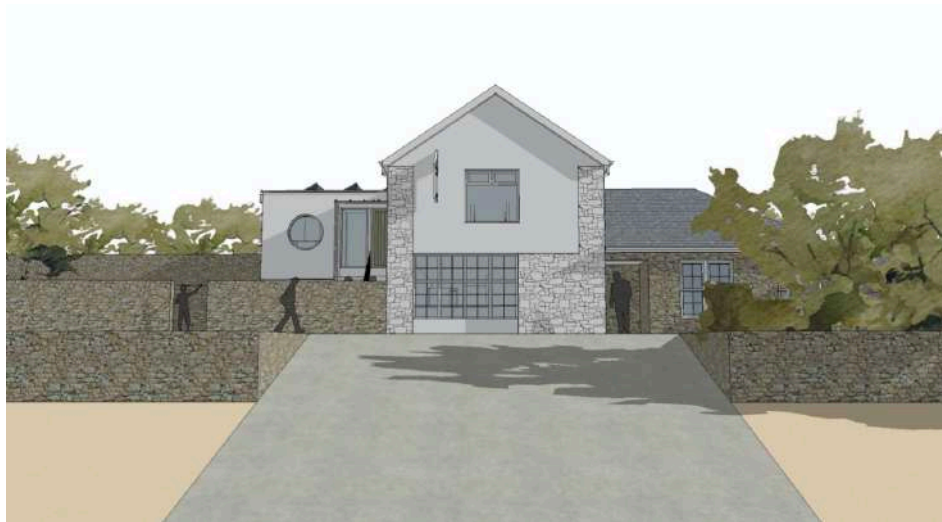
Image 13. Proposed view from the Slipway.

The extension is set back from the main building's front elevation, as well as its roof being much lower, almost level with the eaves. These elements help to emphasise the original building and minimise the impact on the Designated Area. When viewed from the north east, from the harbour, it will be largely out of view (see submitted 3D Views). The removal of the glazed conservatory will also greatly reduce sunlight reflection into the landscape.
